## SECTION 14 INCIDENT REPORT (*Waste Management and Pollution Control Act*)

| <b>Person / Company:</b> | Power and Water Corporation ( <b>PWC</b> ) |
| <b>Incident:</b> | Discharge of treated effluent from Alpururulam (Lake Nash) Waste Stabilisation Pond (WSPs). |

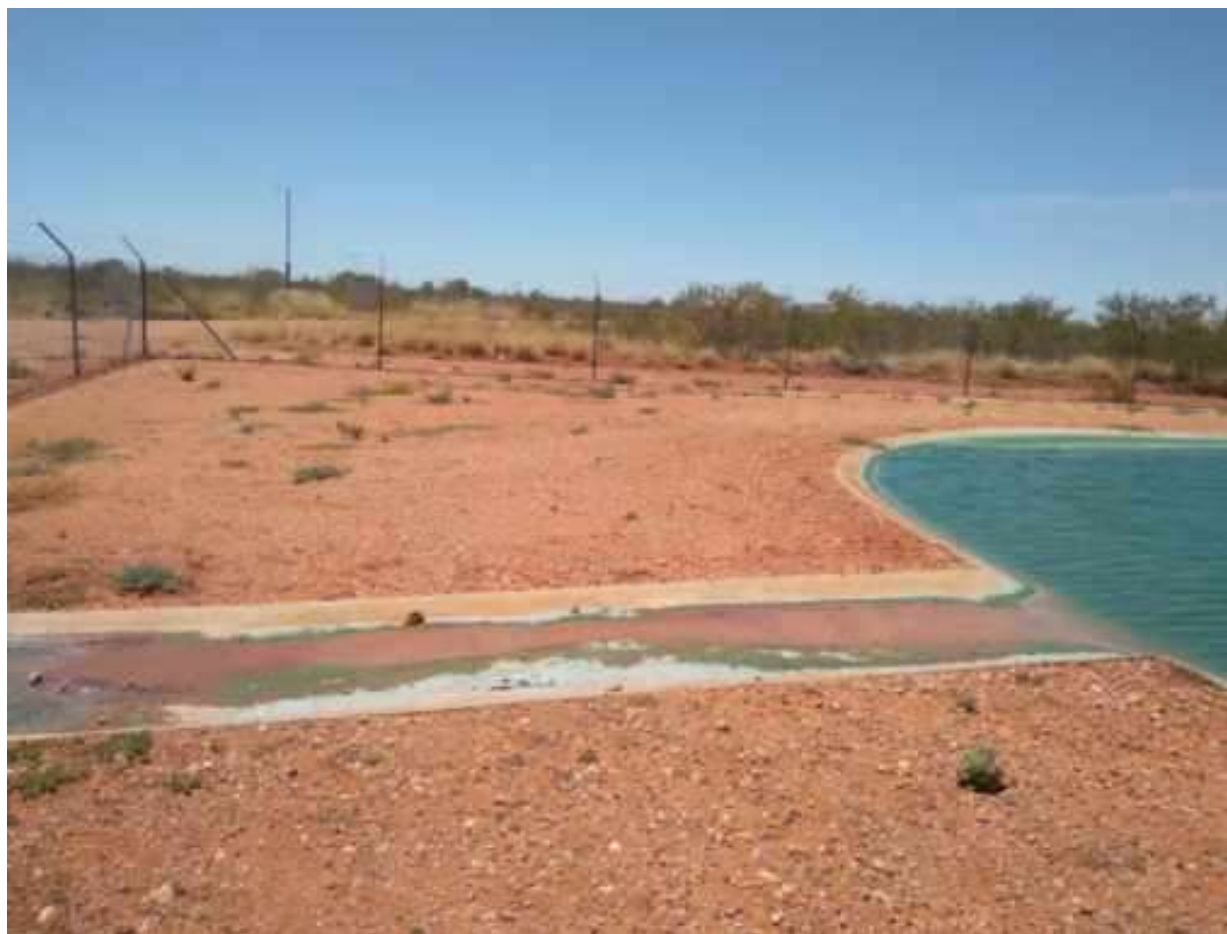
| <b>(b) the place where the incident occurred</b> | <p><i>i. Description of the PWC asset from which the discharge occurred.</i></p> <p>Lake Nash Wastewater Stabilisation Ponds – as per map below.</p> <p><i>ii. GPS coordinates of the discharge point from the PWC asset, and the final coordinates of the final discharge point.</i></p> <p>Overflow Channel location: 20.9787021 S, 137.8341843 E<br/> Pooling location: 20.9779435 S, 137.8339299 E</p> <p>The overflow was caused by a failure of the irrigation pump due to a blockage of the intake. As the irrigation pumped was blocked, the</p> |

| | <p>pond level continued to rise until an overflow occurred from the emergency overflow channel.</p> <p><i>iii. Indicate any locations nearby to the discharge point where public can gain ready-access, such as public open spaces through which the discharge moves.</i></p> <p>Public access is available throughout the area due to nearby bushland surrounding the WSP's, however public access is not believed to occur regularly. Road closed signs have been placed on both ends of the only access track effected to deter access by the public.</p> |

Figure 2 – Emergency overflow channel

| <b>(e) the attempts made to prevent, reduce, control, rectify or clean up the pollution or resultant environmental harm caused or threatening to be caused by the incident</b> | <p>The pump intake has been partially cleared allowing pumping to the irrigation area again. Contractors will be mobilising from Alice Springs on Mon 21<sup>st</sup> December to overhaul the system and further increase pumping capacity.</p> <p><i>i. Confirmation signage and fencing has been erected, as appropriate.</i></p> <p>The site is not fenced off to the public due to its large size. Road closed signs have been positioned on both of the access points to the overflow site to deter access by the public.</p> <p><i>ii. Decontamination of the site as appropriate.</i></p> |

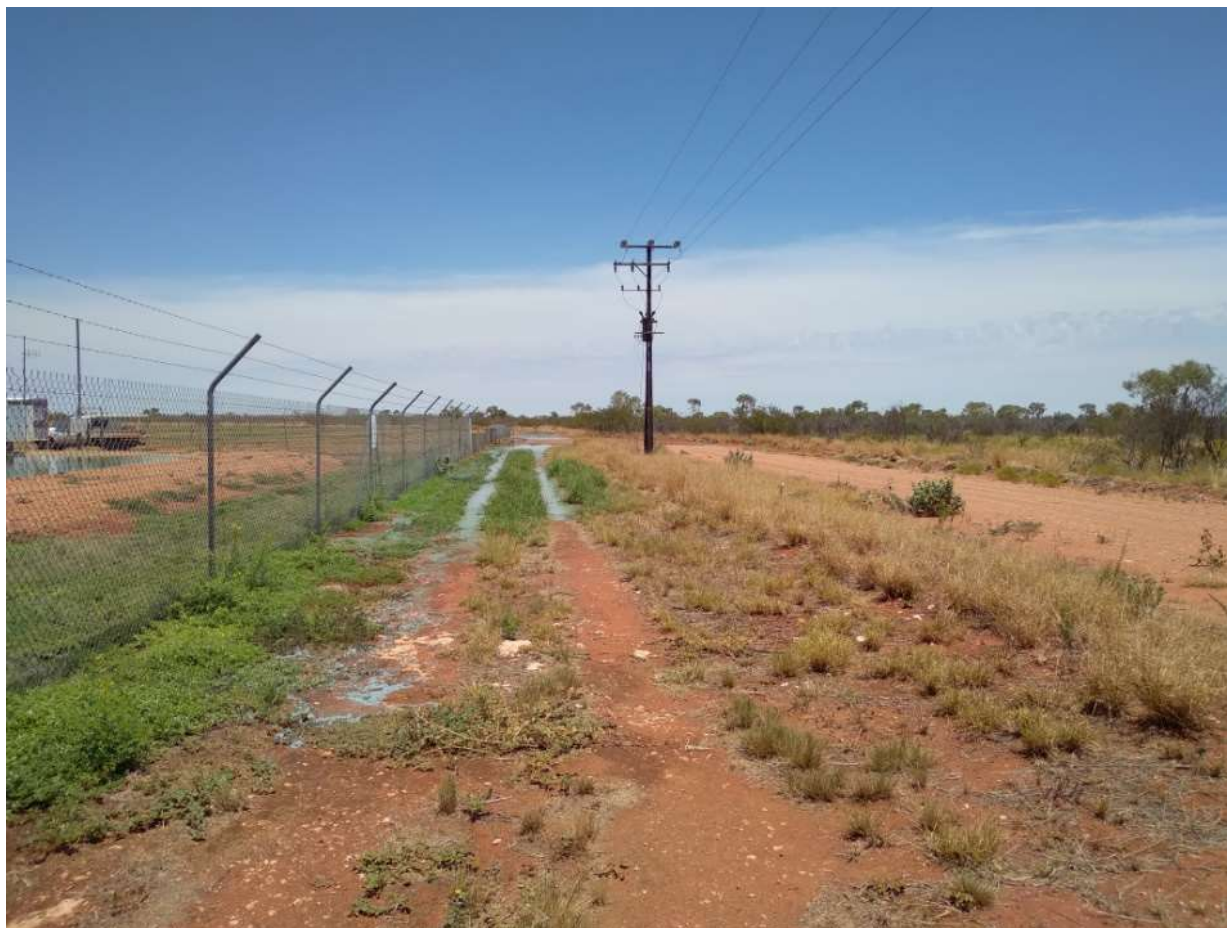
| <b>(a) the incident causing or threatening to cause pollution</b> | <p><i>i. Description of the waste that was discharged.</i></p> <p>Treated effluent (no gross pollutants).</p> <p><i>ii. Indicative wastewater quality for the discharge.</i></p> <p>We do not have any analysis results from the site for treated wastewater quality, however estimates from modelling are attached below. Pond performance statistics for this pond set can be found in Table 1 below.</p> <p><i>iii. Volume of the waste that was discharged.</i></p> <p>The estimated volume of waste discharged is approximately 250kL. No telemetric monitoring occurs at the discharge site.</p> <p>The overflow was observed by the local Essential Services Operator and PWC staff. The overflow was observed at approx.. 8.30 am on 16<sup>th</sup> December 2020. The overflow was stopped at approx.. 13.30pm on 17<sup>th</sup> December 2020.</p> <p>The discharge of treated effluent occurred from the emergency overflow channel on the third and final pond of the pond set, and discharged to the land directly beside the facility – as per photos below.</p> |

Figure 3 – Overflow site facing towards pooling

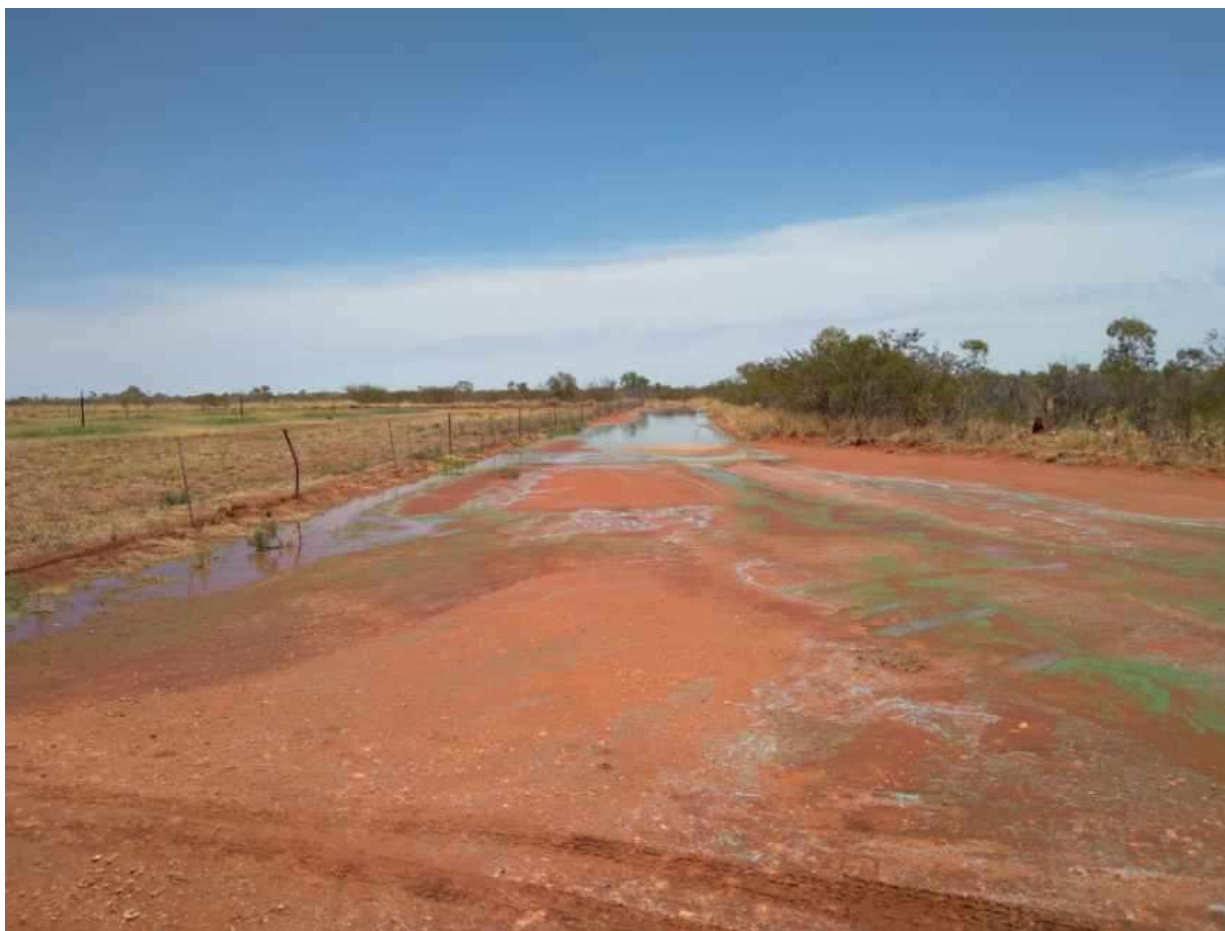
| | Site has been monitored for gross pollutants however none identified. Final ponds are generally free of these types of materials. Road closed signs and overflow signs will remain in place five days post evaporation of the pooling. Daily monitoring of the site will occur until this point in time. |

Figure 4 - Pooling

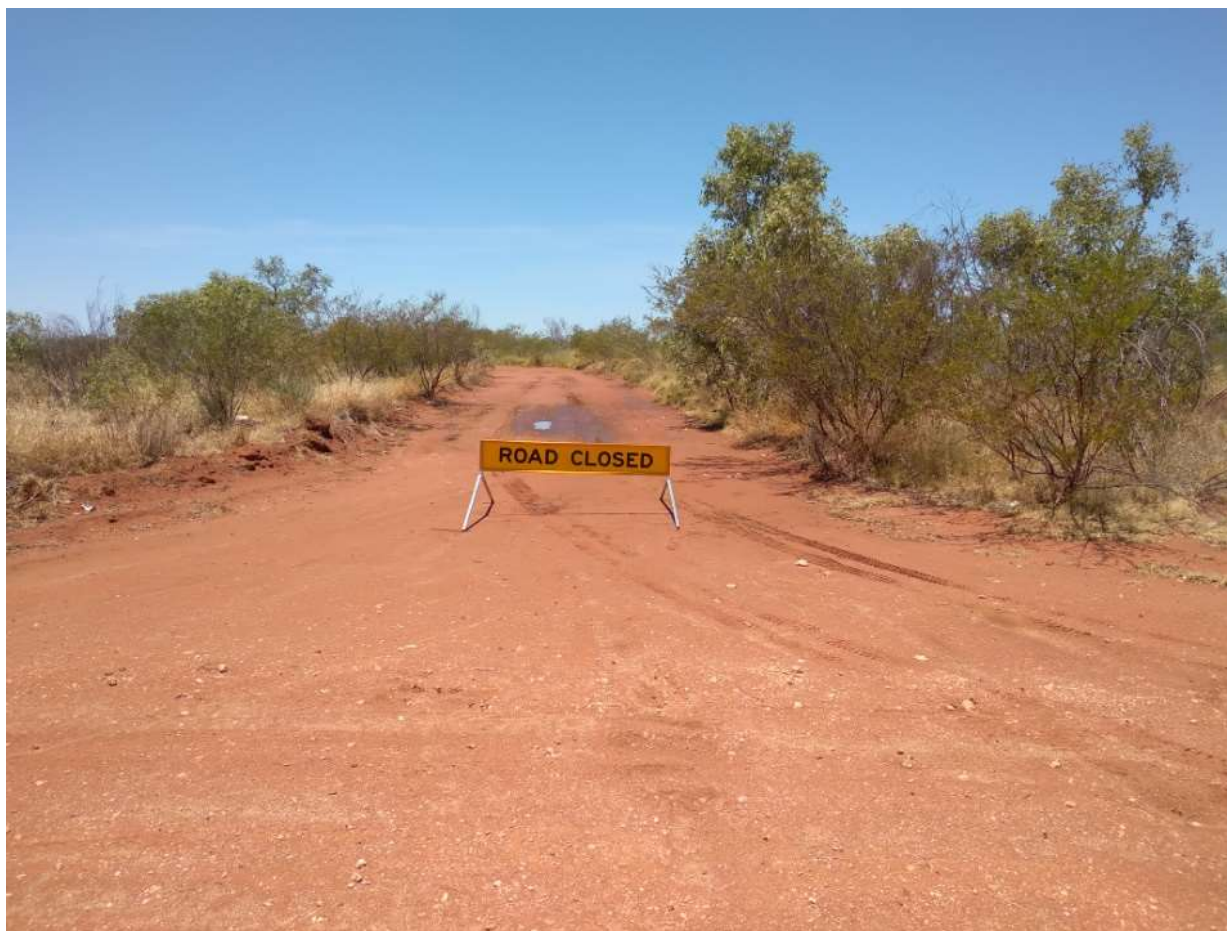
Figure 5 – Road closed sign 1

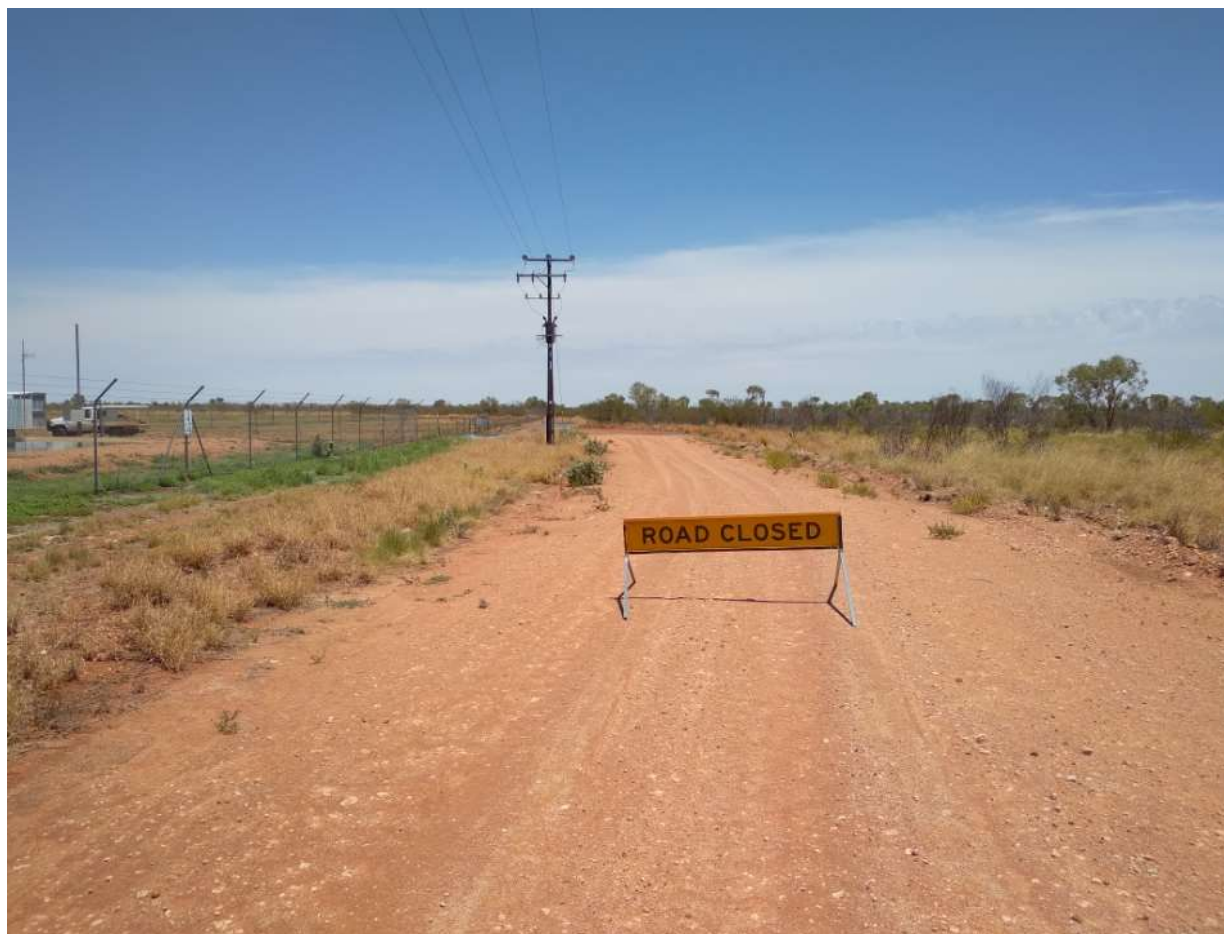
Figure 6 – Road closed sign 2
