## SECTION 14 INCIDENT REPORT (*Waste Management and Pollution Control Act*)

| <b>Person / Company:</b> | Power and Water Corporation ( <b>PWC</b> ) |
| <b>Incident:</b> | Discharge of raw sewage from sewerage network (broken sewer rising main) |

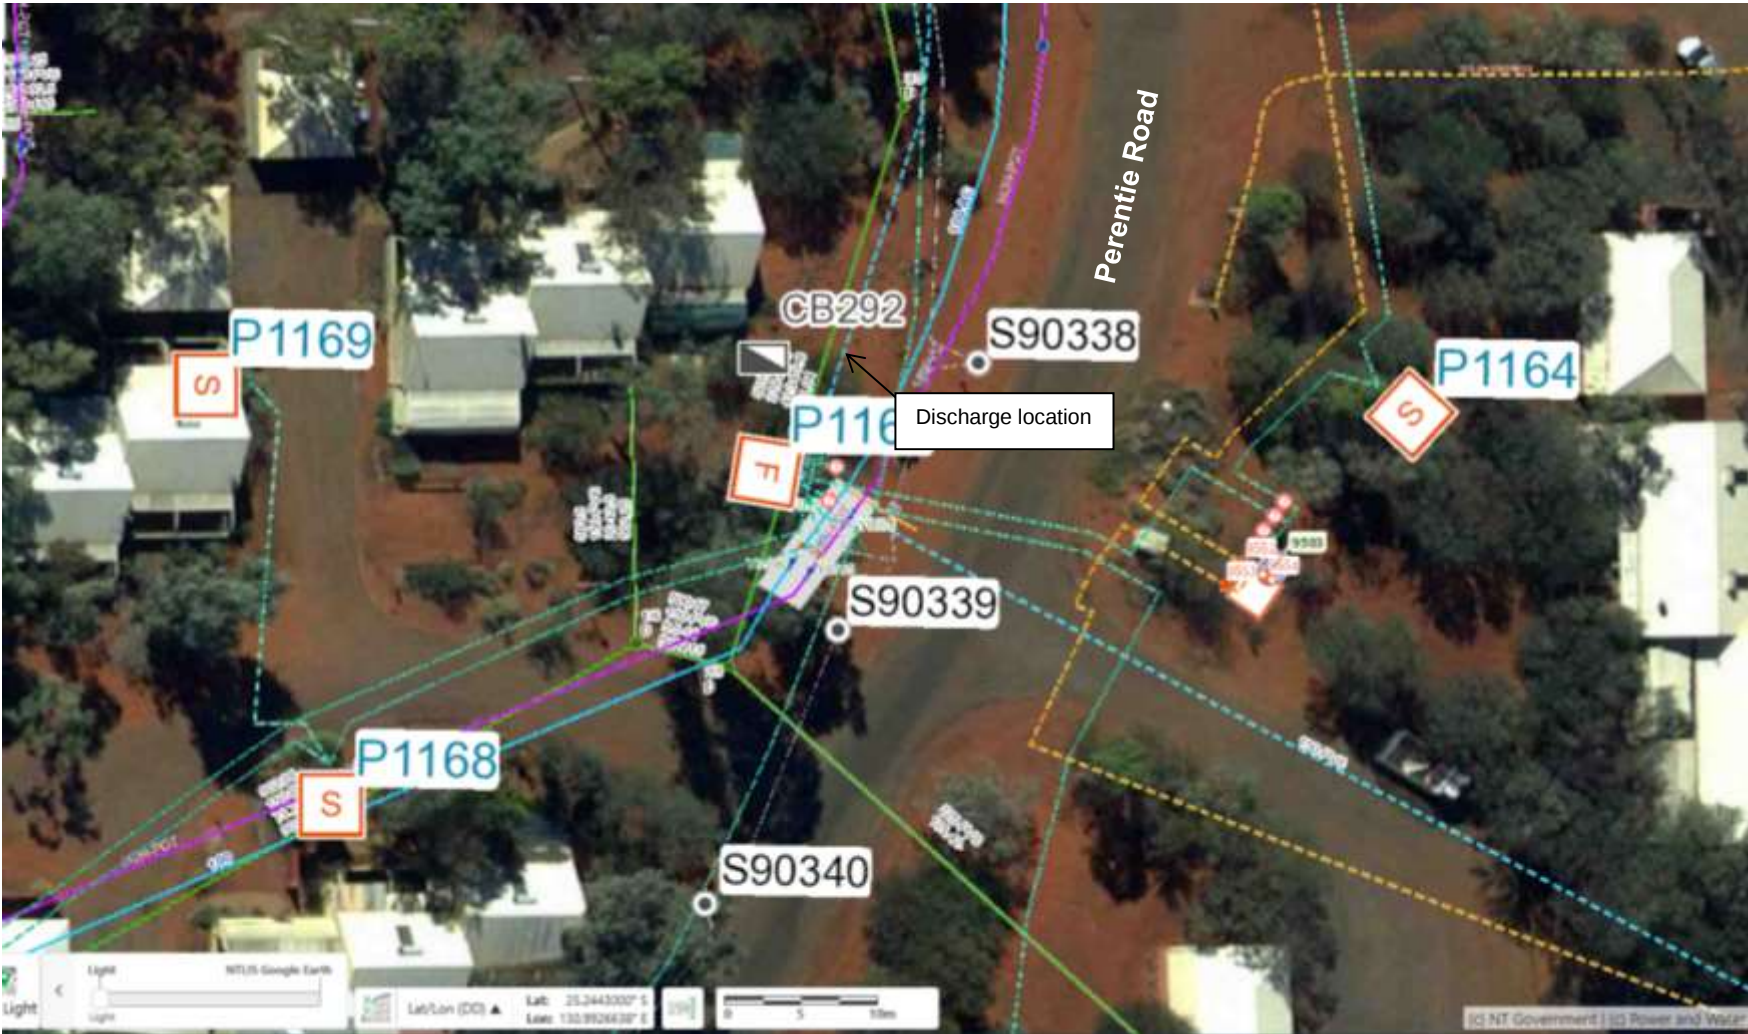
Photo 1 – Pre-clean up, showing initial response

| <b>(e) the attempts made to prevent, reduce, control, rectify or clean up the pollution or resultant environmental harm caused or threatening to be caused by the incident</b> | <p>Once the ESO was notified, he immediately created earthen bunds to contain the spill. As previously mentioned, the spill only occurred when the sewage pumping station was pumping, and once it stopped again, the majority of the sewage flowed back into the line. The clean-up was undertaken as per Sewage Spills/Overflow Response Work Instruction. Contaminated soil was taken to a hard stand within the community's wastewater treatment plant, the excavation was then backfilled with clean soil and a chlorine solution was applied to the area to ensure complete disinfection.</p> <p><i>i. Confirmation signage and fencing has been erected, as appropriate.</i></p> <p>The site was fenced and warning signage was displayed during the entire time of the repair and clean up.</p> <p><i>ii. Decontamination of the site as appropriate.</i></p> <p>Clean up consistent with Sewage Spills/Overflow Response Work Instruction as appropriate to the location, and to minimise risk to the environment. Vacuum truck was used to remove the wastewater and contaminated soil from around the broken pipework, the area was</p> |

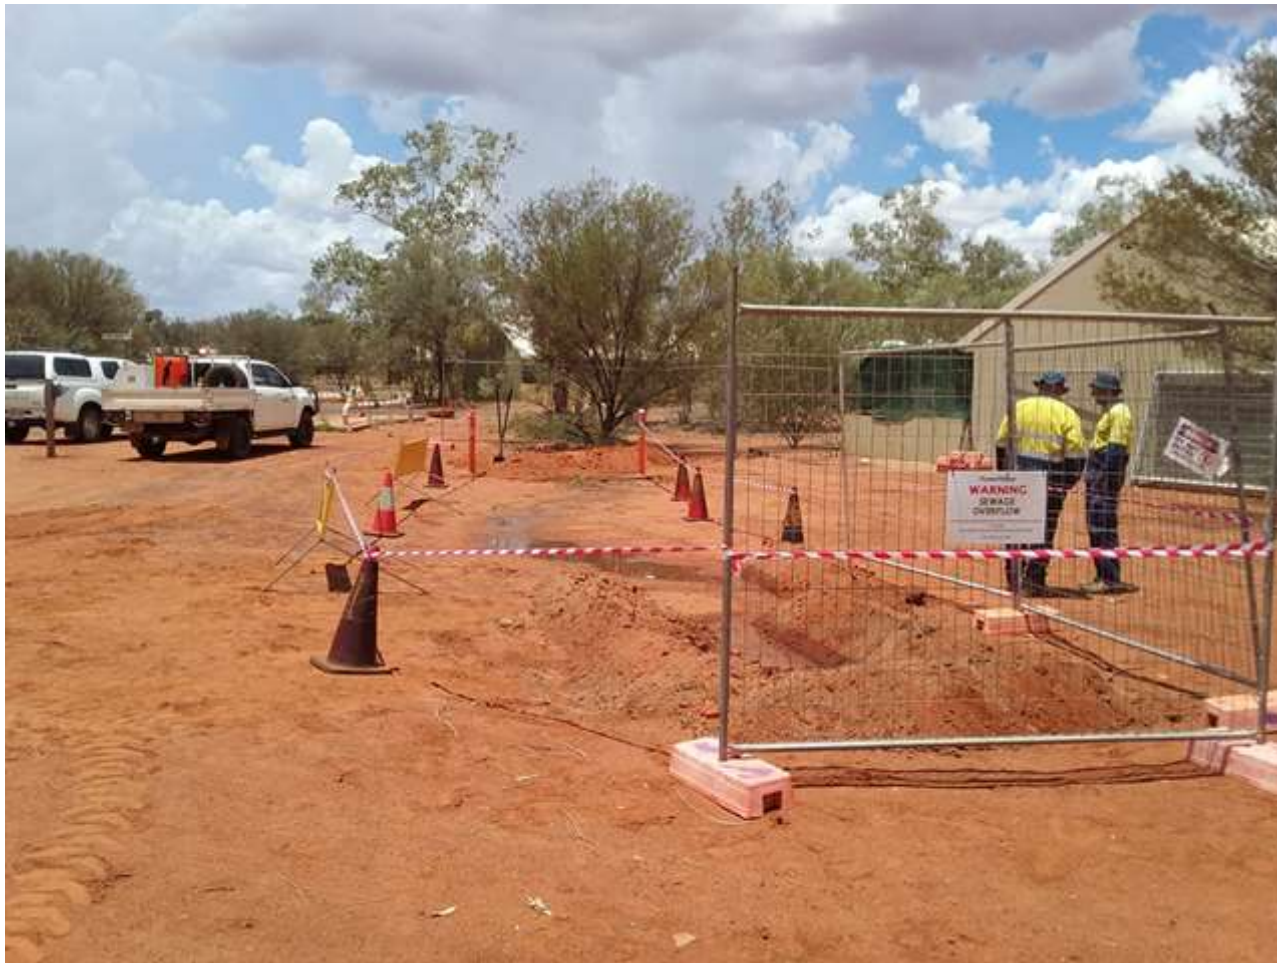
Photo 2 – Pre-clean up, showing initial response (earthen bund)

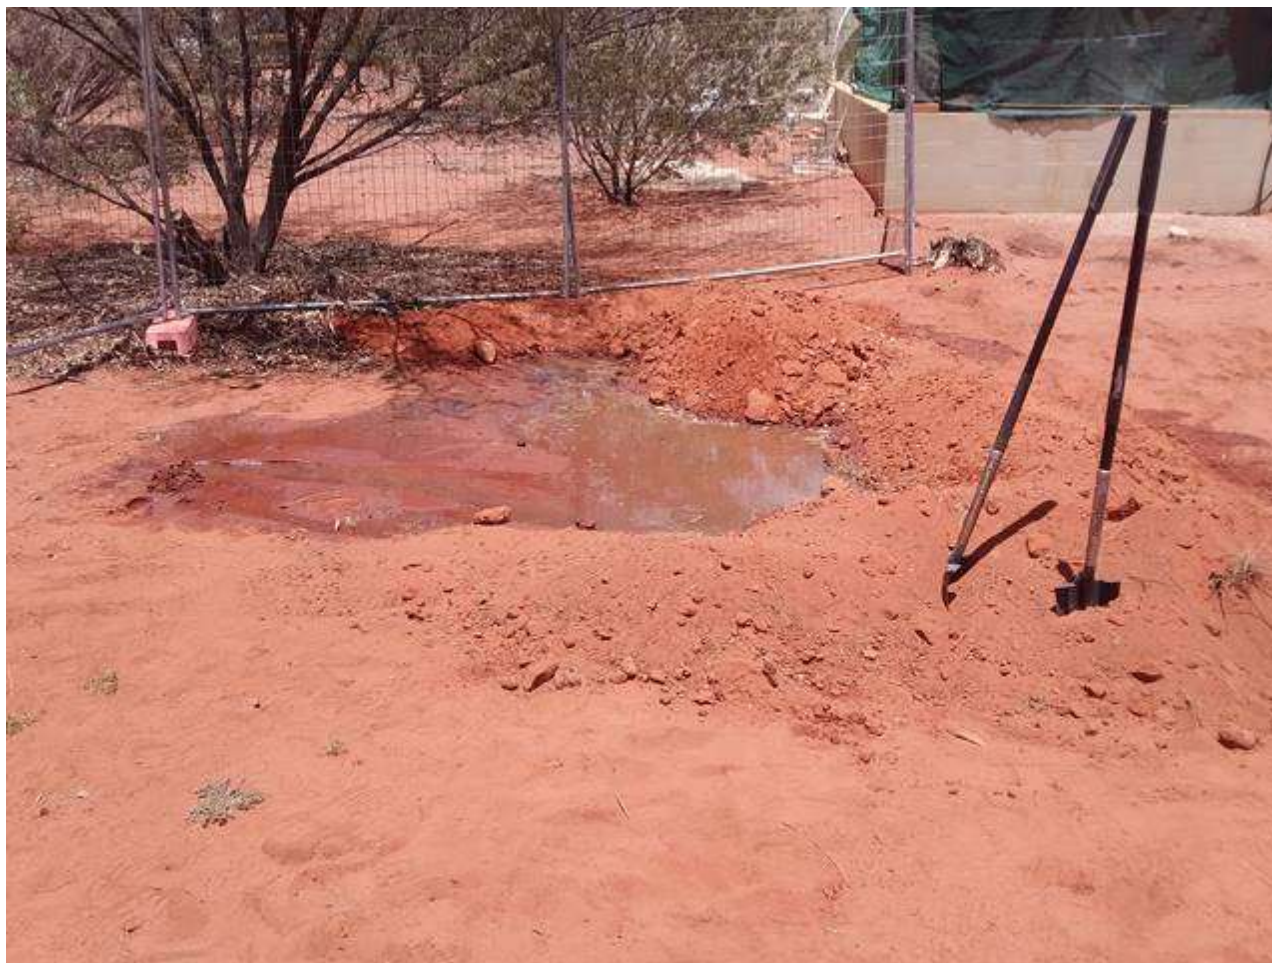
Photo 3 – Pre-clean up, showing initial response (warning signage)

| | <p>Access to the public was possible at the site of the spill and repair, however it was promptly fenced, or had danger tape erected around it, with warning signs also prominently displayed. In addition, a PWC employee or the ESO would have been present to keep the public out.</p> |

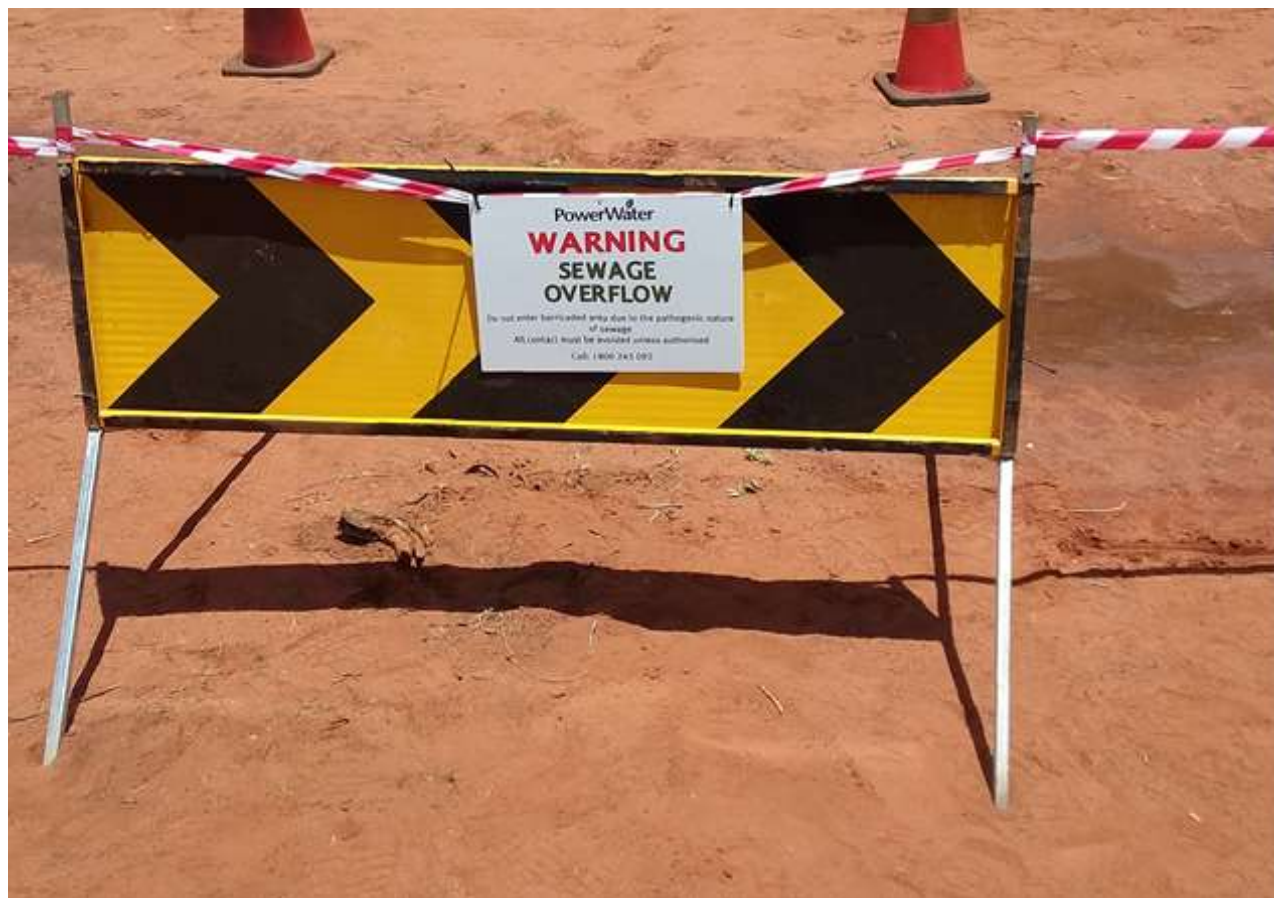
| <b>(c) the date and time of the incident</b> | <p><i>i. The time and date of commencement and cessation of the discharge.</i></p> <p>The spill occurred intermittently while the Sewer Pump Station #3 was pumping, and ceases after pumping stopped, with some of the overflowed effluent draining back into the main. The commencement time of the spill is unknown. The spill was first observed by a Yulara Resort Technical Services staff member at around 09:00am on 14/12/2020. It was then reported to the ESO and PWC shortly after. The spill was stopped at 10:00pm on the 14/12/2020. The delay in stopping the spill was due to the need to mobilise staff and equipment from Alice Springs.</p> <p><i>ii. How PWC were notified, or became aware of the discharge.</i></p> <p>The spill was first noticed by a Yulara resort staff member who notified the ESO, who then advised PWC of the issue.</p> <p><i>iii. The process by which the discharge occurred.</i></p> <p>The sewer rising main has deteriorated over time, since installation in 1983, and under the pressure of the sewage pumping station, the pipe gave way.</p> <p><i>iv. The reason why the discharge occurred.</i></p> <p>As per (c) iii. The age of the infrastructure has caused the PVC pipework to become brittle, and with the additional pressure of the sewage pumping station #3, has caused the pipework to fail.</p> |

Photo 4 – Excavation with finished repair

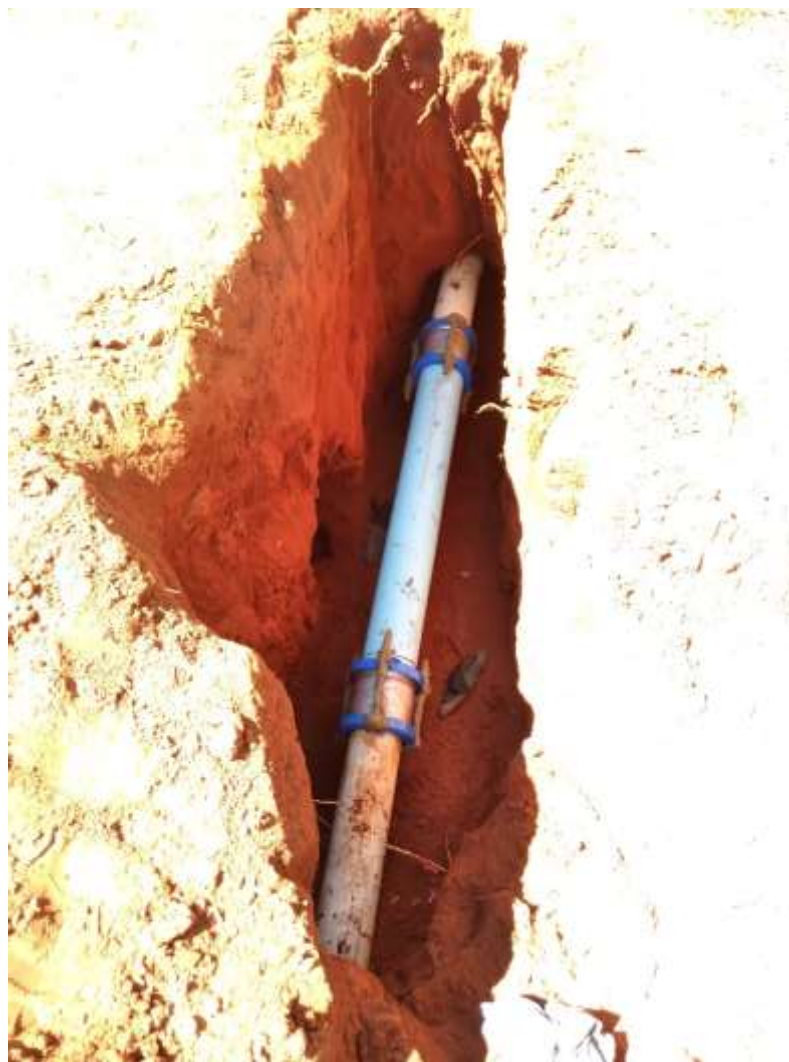
Photo 5 – Area post repair and clean-up

| | backfilled with clean soils and the area had a chlorine solution applied which was raked in. |
