## SECTION 14 INCIDENT REPORT (*Waste Management and Pollution Control Act*)

| <b>Incident:</b> | Discharge of highly diluted sewage from sewerage network due to wet weather / monsoonal conditions |

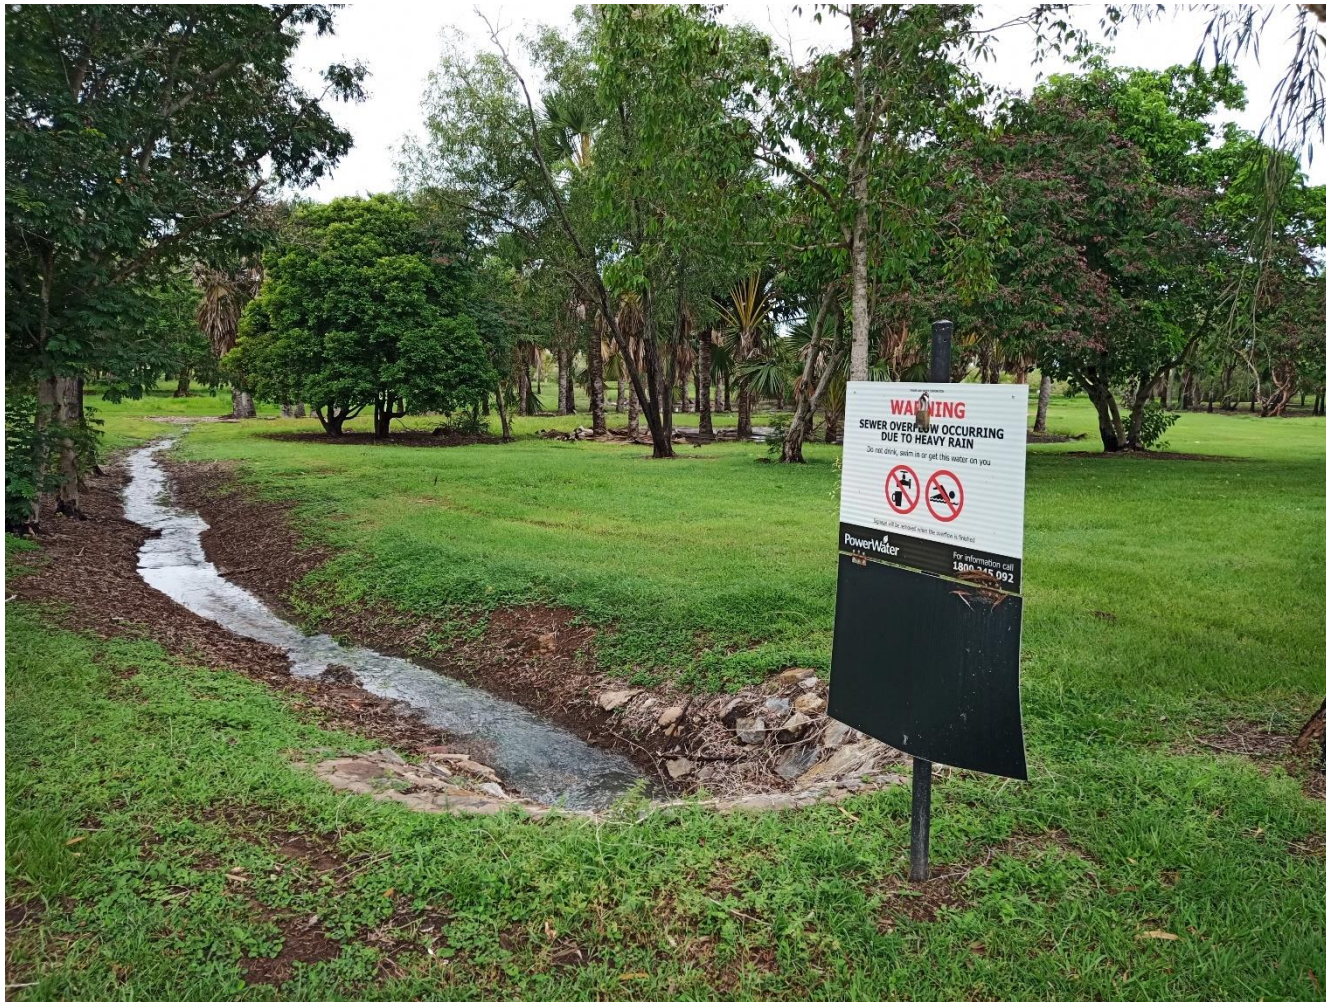
Appendix A – Photographs (Discharge point for SRV at 24 East Point Road, Fannie Bay, showing warning signage)

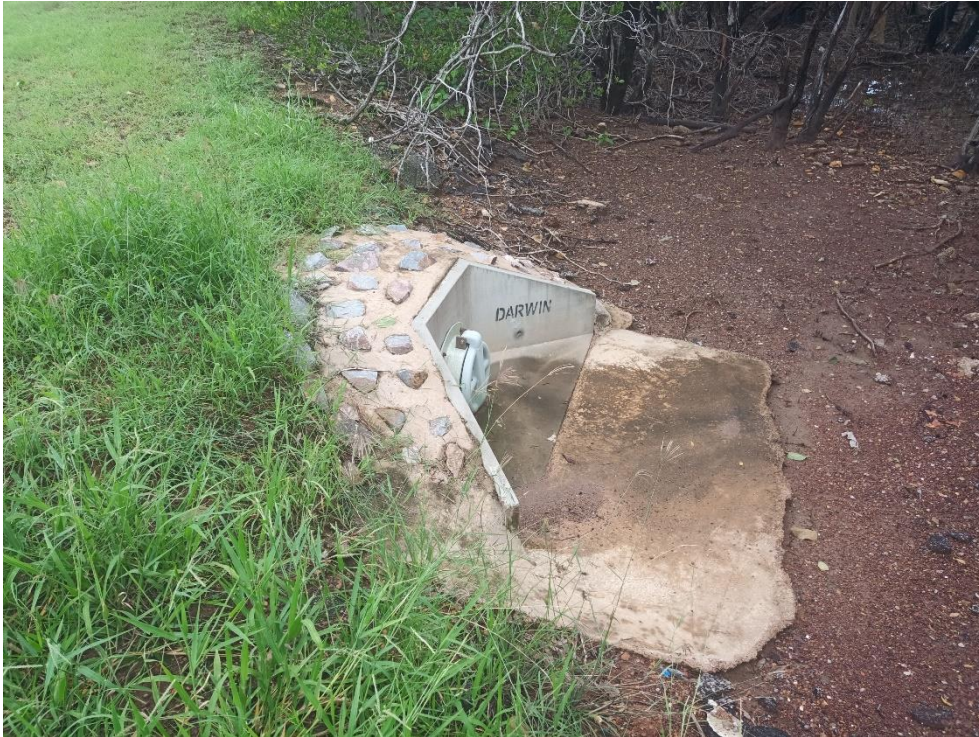
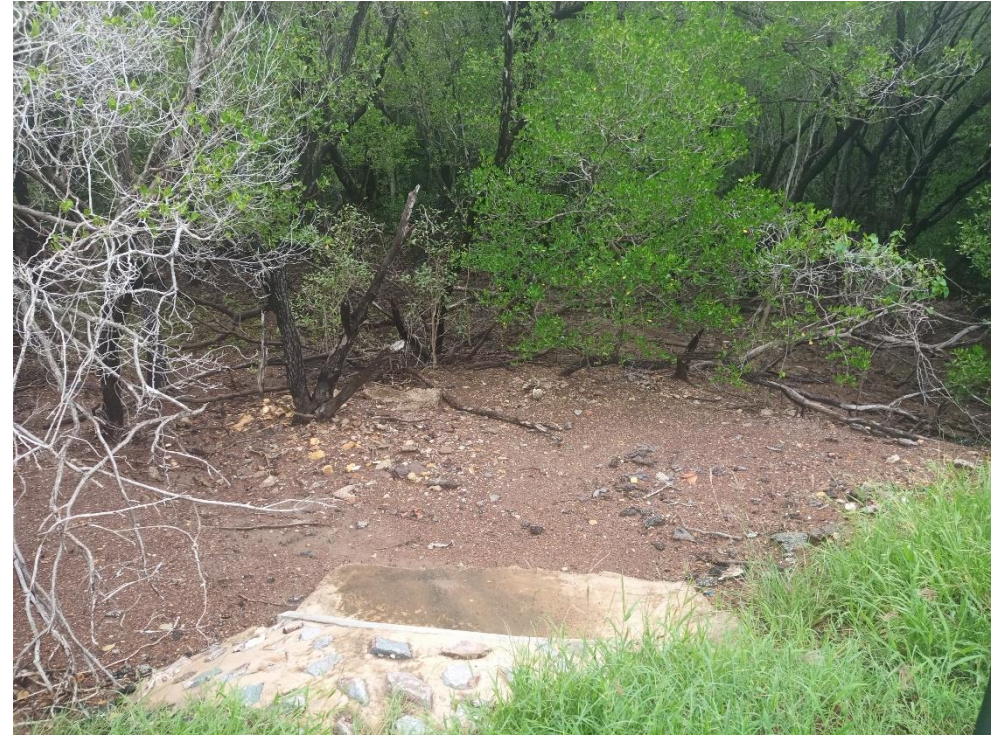
| | environment. Locations have been inspected for gross pollutants, of which none were found. |

Appendix B – Photographs (SRV discharge point for corner of Trower Road and Rapid Creek Roads, with no gross pollutants visible)
