## **SECTION 14 INCIDENT REPORT (*Waste Management and Pollution Control Act*)**

| <b>Person / Company:</b> | GEMCO Mining Pty Ltd |
| <b>Incident:</b> | The GEMCO Port Facility received rainfall that resulted in the overtopping of stormwater infrastructure for a short duration. The water from the event entered into Milner Bay. |

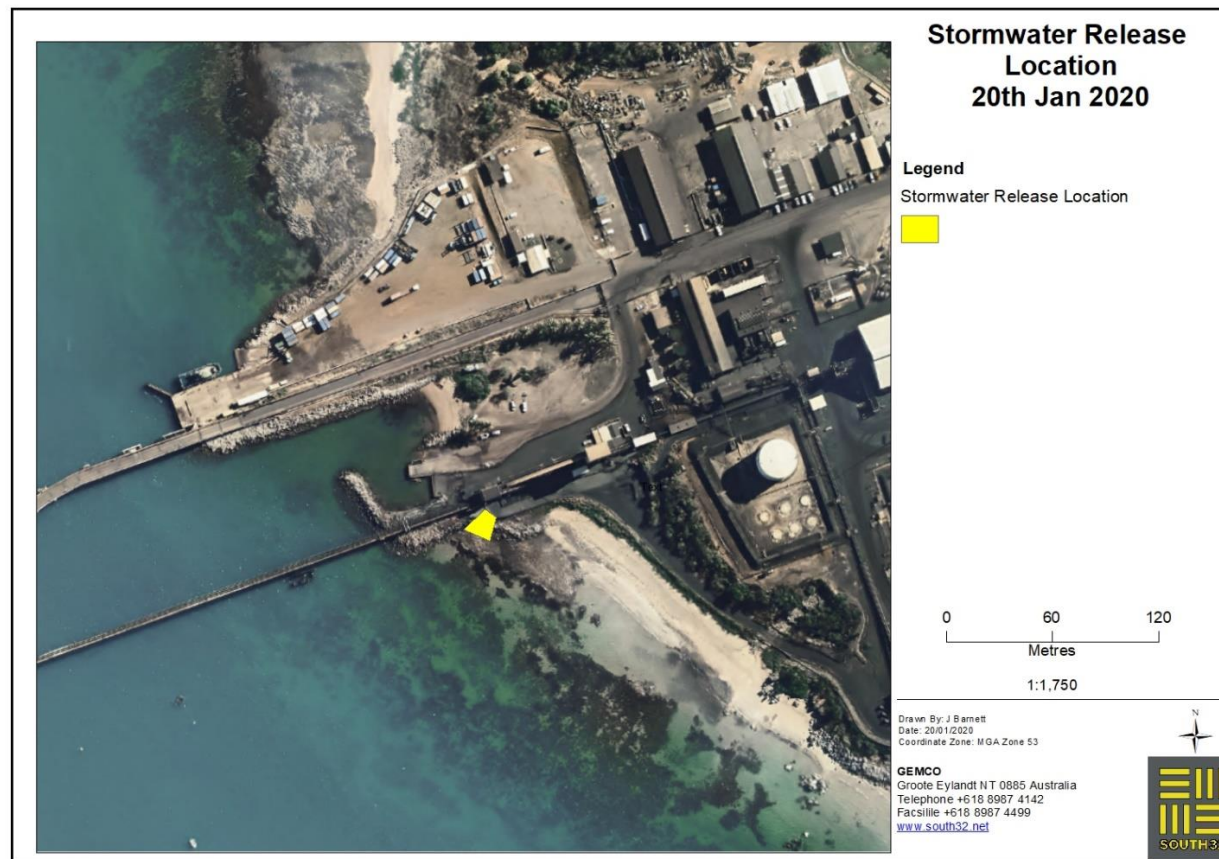
| <b>(b) the place where the incident occurred</b> | GEMCO's Port Facility (see Figure 1 below). |

Figure 1: Stormwater release location
