## SECTION 14 INCIDENT REPORT (*Waste Management and Pollution Control Act*)

| Incident: | Discharge of raw sewage from sewerage network (no gross pollutants) |

### Appendix A – Location map – Rapid Creek SPS

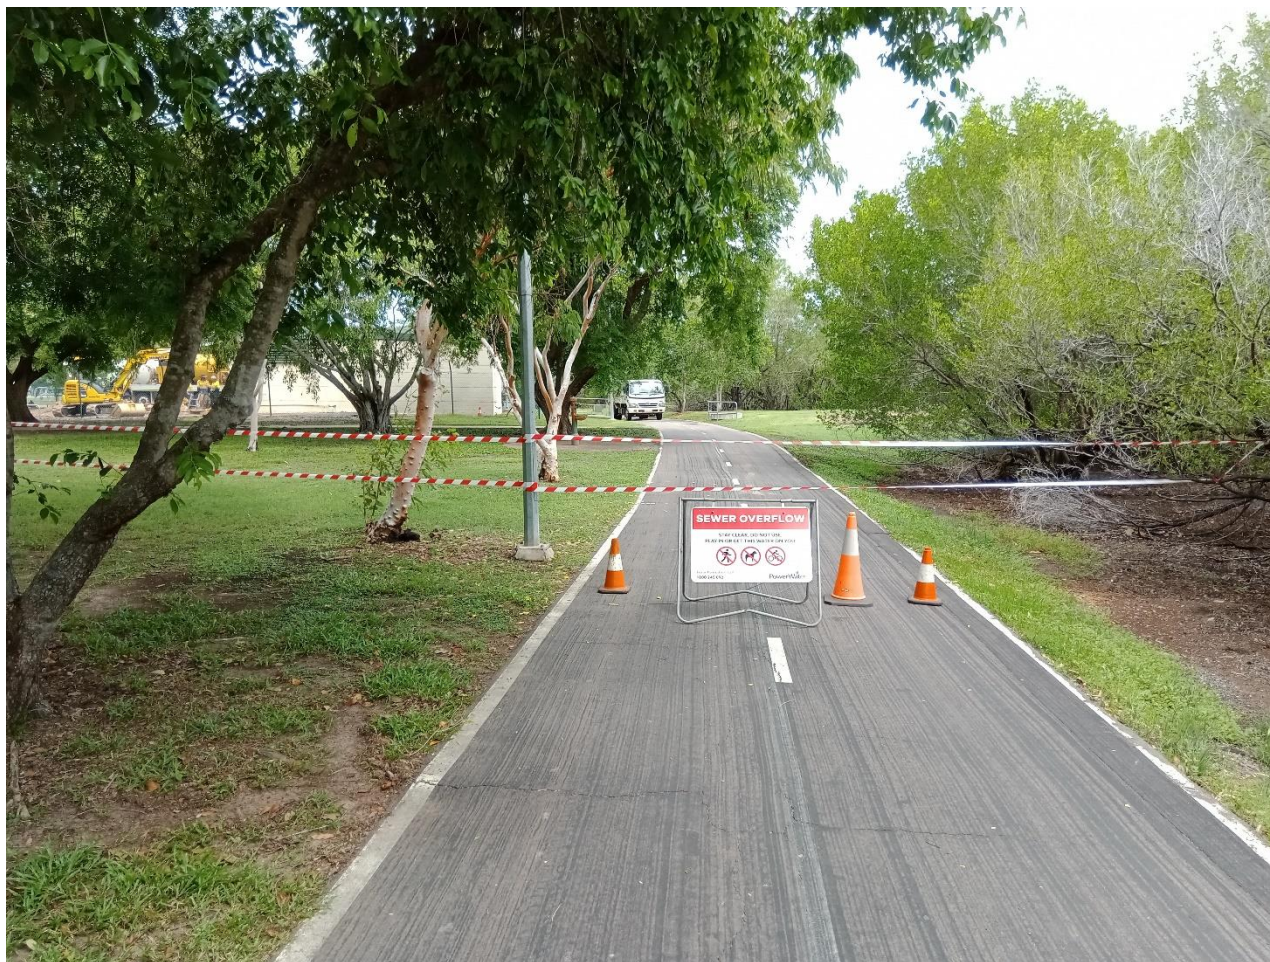
Figure 1. Warning signage erected, looking NNW along pathway

| <b>(e) the attempts made to prevent, reduce, control, rectify or clean up the pollution or resultant environmental harm caused or threatening to be caused by the incident</b> | <p><i>i. Confirmation signage and fencing has been erected, as appropriate.</i></p> <p>The site has had warning signage erected and barrier tape put up to alert the public and deter them from entering the affected area, as per Sewage Spills/Overflow Response Work Instruction.</p> <p><i>ii. Decontamination of the site as appropriate.</i></p> <p>Clean up consistent with Sewage Spills/Overflow Response Work Instruction as appropriate to the location. Dual use pathways were disinfected and pressure washed as a priority, before barrier tape was erected. The remaining affected grassed areas will be fenced off for a minimum period of 7 days to prevent public access.</p> |

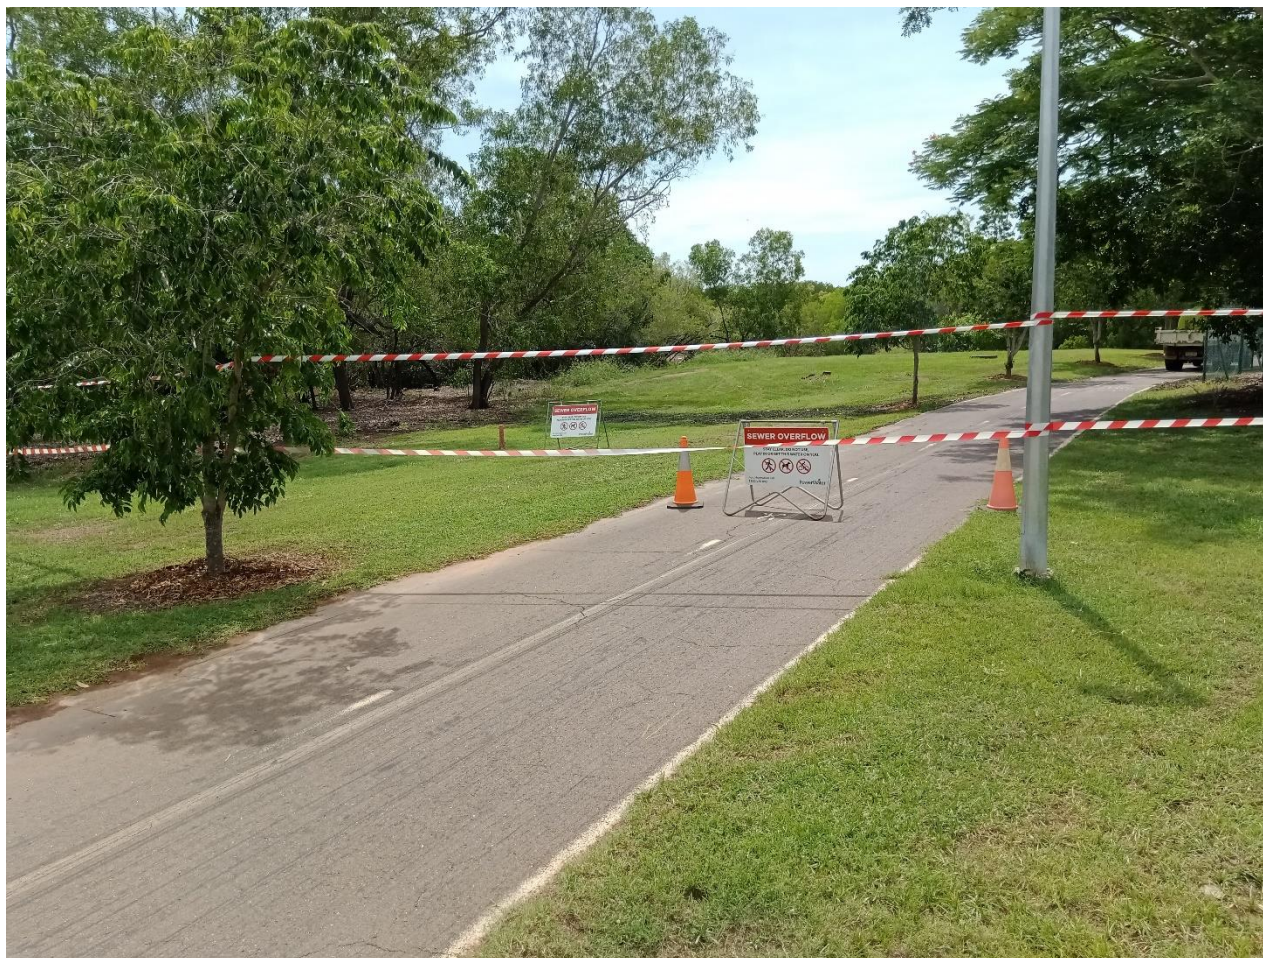
Figure 2. Warning signage erected, looking SE, from northern side of sewage pumping station.

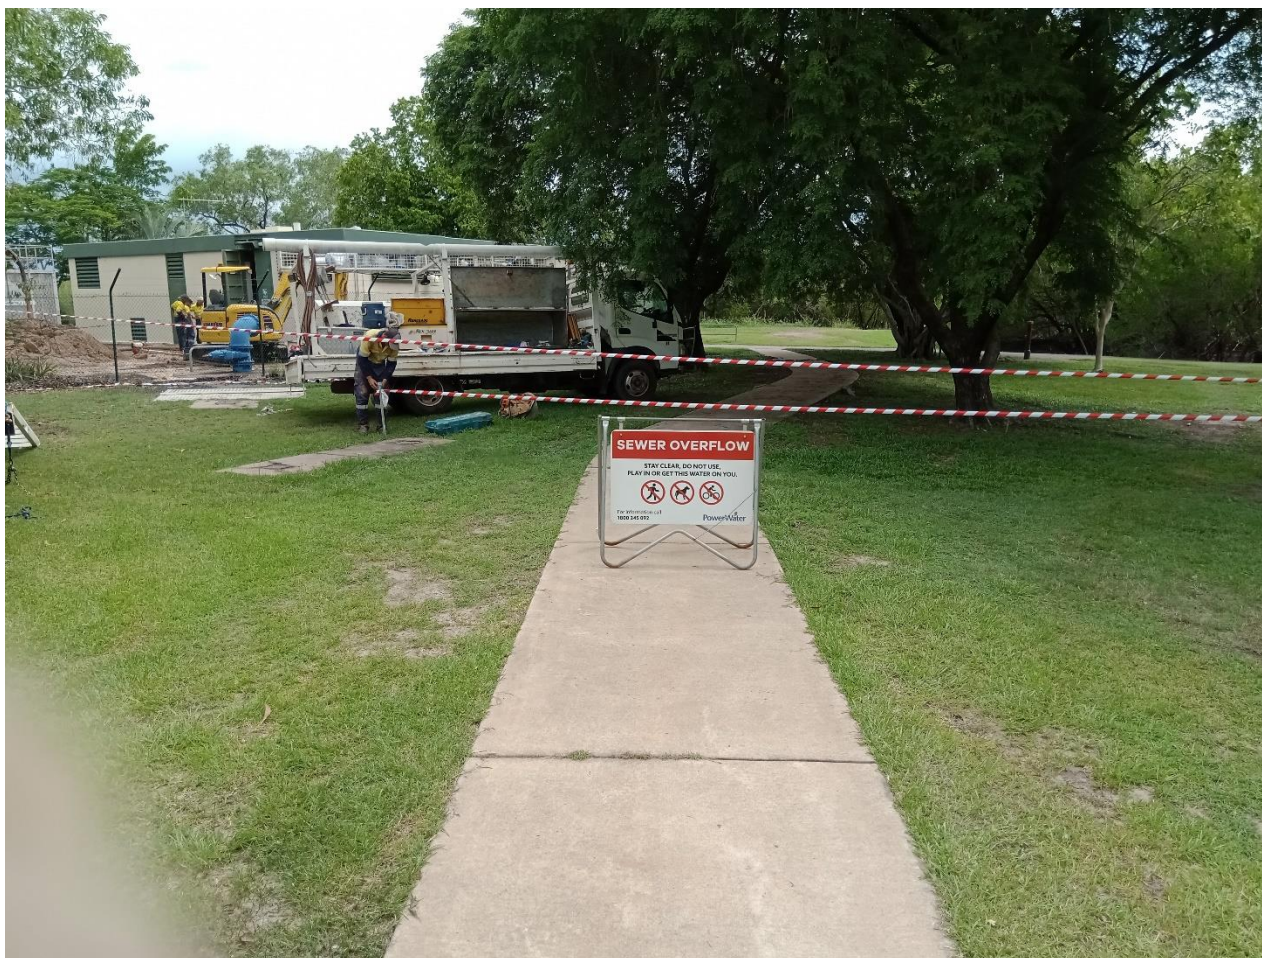
Figure 3. Warning signage erected, looking NE, from southern side of sewage pumping station.

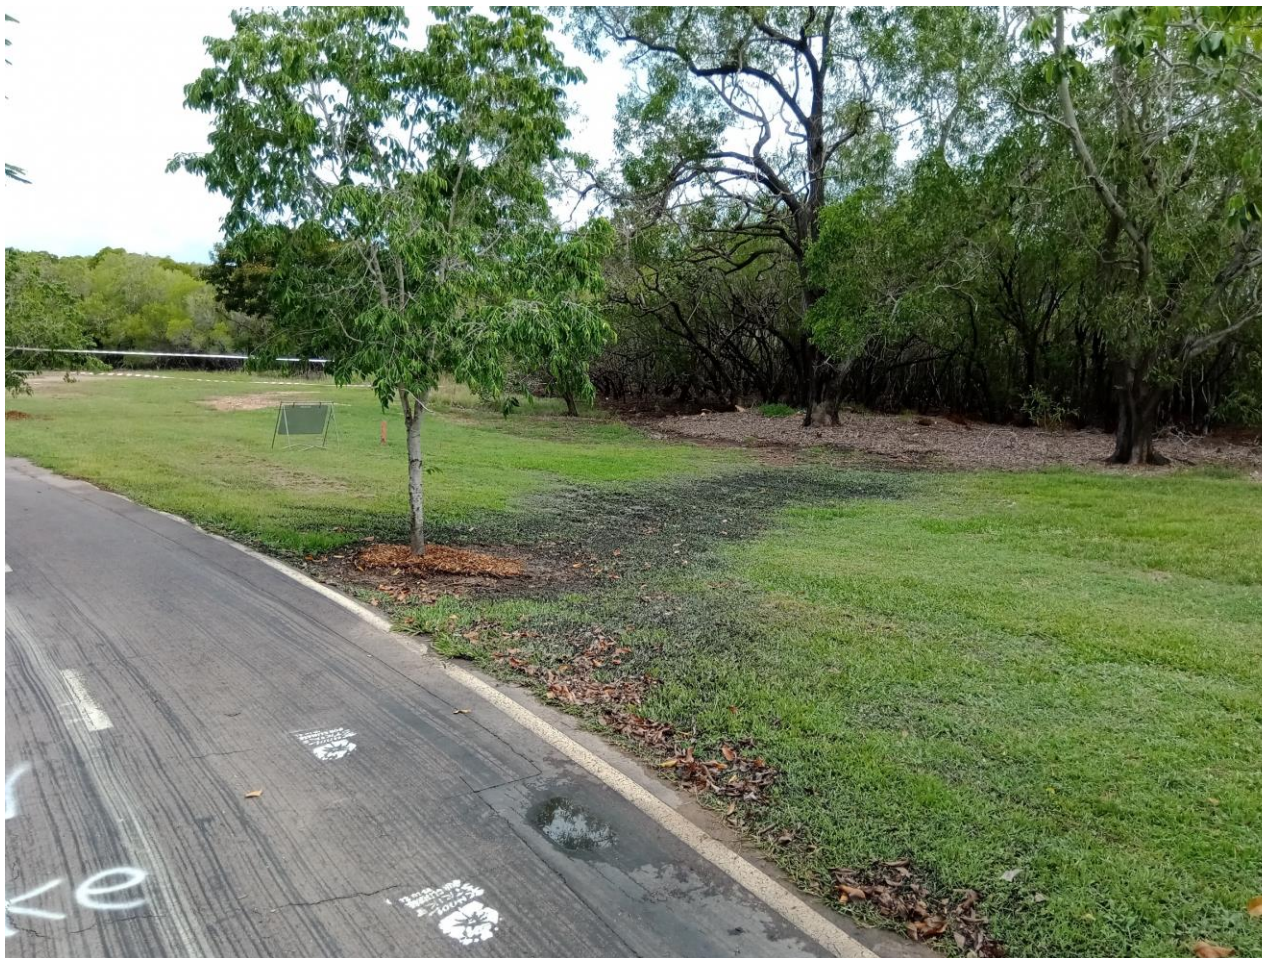
| | <p>Final discharge points: 130.8634301 E, -12.3803118 S &amp; 130.8636526 E, -12.3808750 S</p> <p><i>iii. Indicate any locations nearby to the discharge point where public can gain ready-access, such as public open spaces through which the discharge moves.</i></p> <p>Access by the public was possible, hence the barricading of the entire area to warn and discourage people from entering the area. Hence also why cleaning of the pathways was a priority. The remaining grassed areas will or already have been fenced off for a minimum period of 7 days.</p> |

*Figure 4. Sewage spill path to final discharge point (No.2 coordinates on map).*

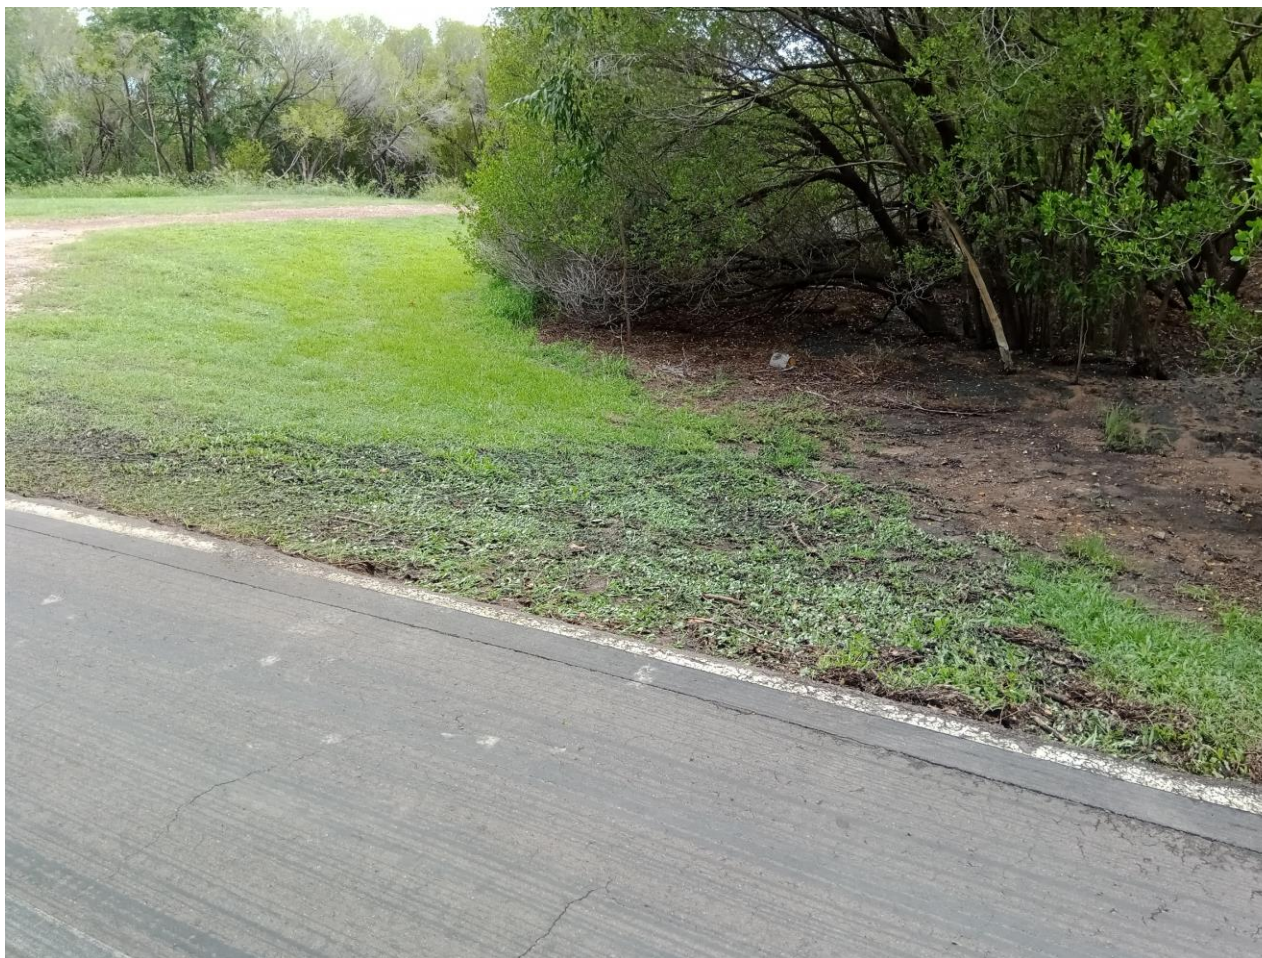
*Figure 5. Sewage spill path to final discharge point (No.3 coordinates on map).*

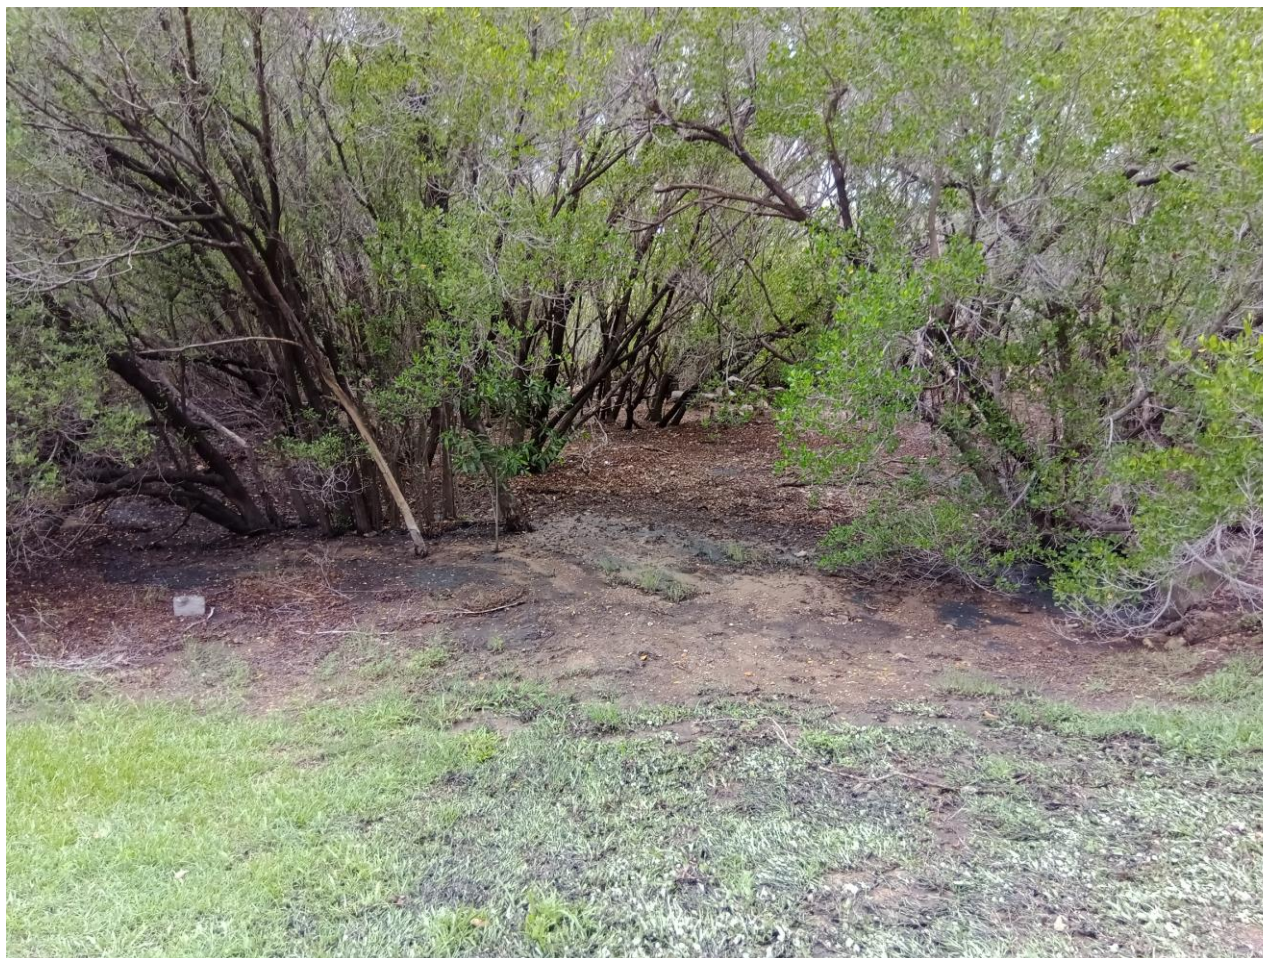
*Figure 6. Final discharge point (No.3 coordinates on map)*
