## SECTION 14 INCIDENT REPORT (*Waste Management and Pollution Control Act*)

| <b>Person / Company:</b> | Power and Water Corporation ( <b>PWC</b> ) |
| <b>Incident:</b> | Discharge of sewage from sewerage network (ORG) |

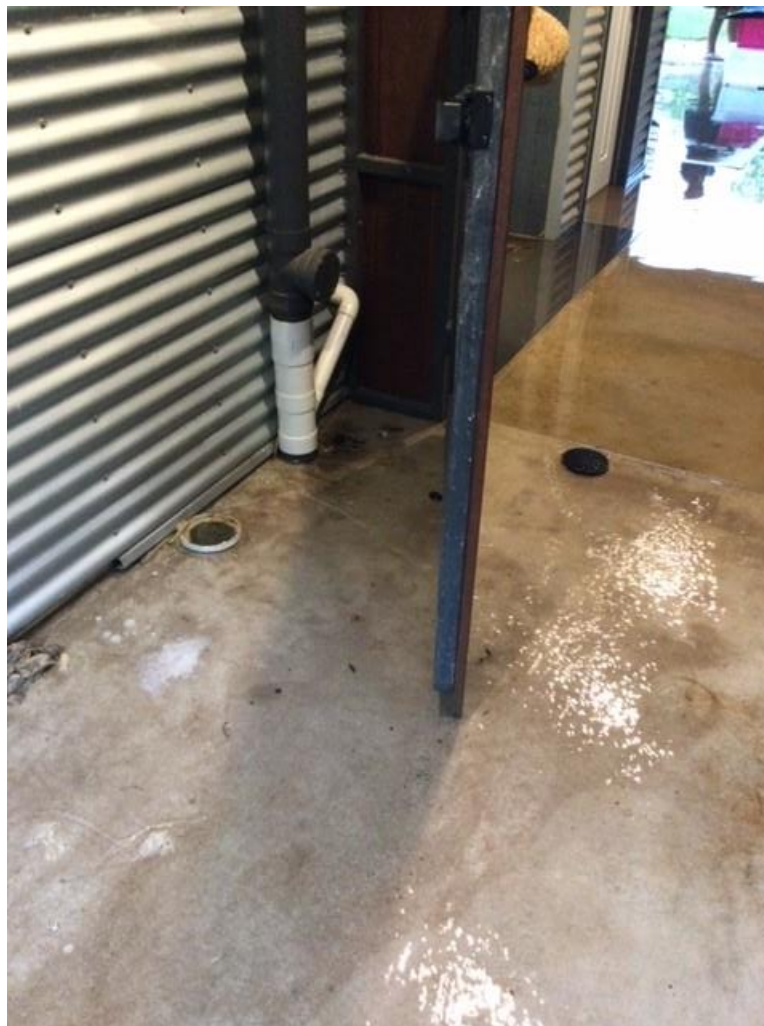
Appendix B – Photograph of the spill site, showing just how diluted the spill actually was.

| <p><b>(e) the attempts made to prevent, reduce, control, rectify or clean up the pollution or resultant environmental harm caused or threatening to be caused by the incident</b></p> | <p><i>i. Confirmation signage and fencing has been erected, as appropriate.</i></p> <p>No fencing or signage was erected in this instance, as the scene was disinfected and cleaned thoroughly; and the residents who know about the spill are the only ones able to access the spill area.</p> <p><i>ii. Decontamination of the site as appropriate.</i></p> <p>Clean up consistent with Sewage Spills/Overflow Response Work Instruction as appropriate to the location, and to minimise risk to the Environment. Blockage was cleared and upon resolution of the blockage, the site was left in a clean state, free from any gross pollutants and the surrounding surface was cleaned and disinfected.</p> |
