## SECTION 14 INCIDENT REPORT (*Waste Management and Pollution Control Act*)

Figure 1: Approximate spill locations in relation to MRM and BBLF.

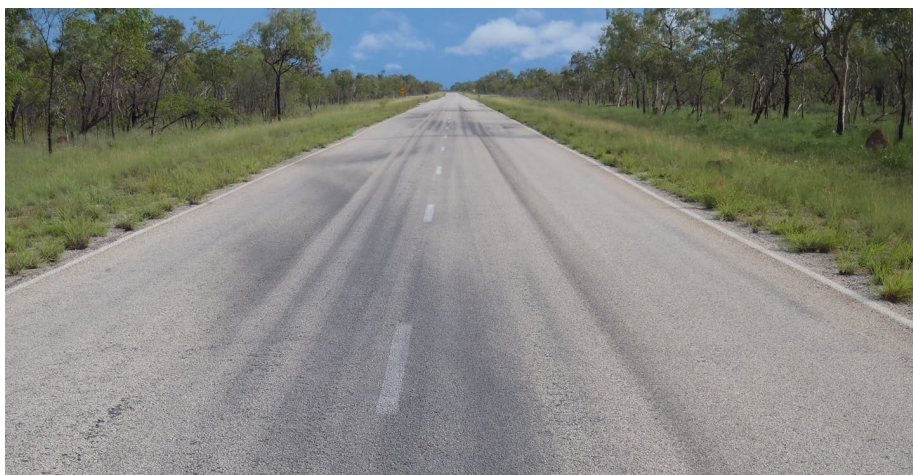
Based on the immediate inspection by MRM staff to confirm the extent of spillage and assess the environmental risk, grey material (indicative of zinc-lead concentrate) was observed at six main locations across a 28 km stretch of the Carpentaria Highway.

The concentrate was confined to the sealed bitumen for the length of the spill (Figure 2). Based on the inspections, approximately 30 kg of concentrate is estimated to have been spilt in total.

The source of the spill is likely to have been from a road train travelling from the Mine to the BBLF. The road train trailers are designed to contain the concentrate during transport. A detailed internal investigation is in progress to determine the direct cause and any contributing factors..

*Figure 2: Concentrate observed on road prior to clean up efforts.*

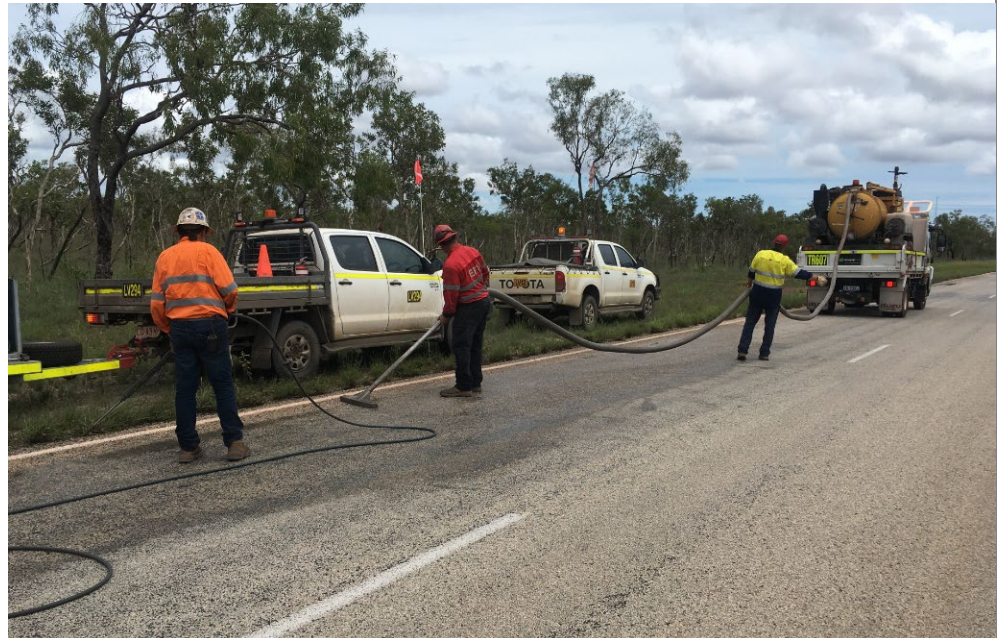
*Figure 3: Spill clean-up efforts via pressure cleaner and industrial road sweeper at one of the spill locations.*

At approximately 09:00 on 30 December 2020, a vacuum truck was deployed to clean-up the majority of material on the road. This involved pressure washing the concentrate and using a vacuum truck to collect the residue, which was transported back to the BBLF containment ponds. Dried residue remaining in the vacuum truck was sent back to the Mine for permanent disposal.

On 2 January 2021, an industrial road sweeper and pressure cleaner was deployed for approximately 10 hours to complete continuous circuits over the 28km length to ensure any undetectable residual concentrate at or between the six spill locations was completely removed (Figure 3). A small amount of residue recovered from this process was transported back to the Mine for permanent disposal.

On 6 January 2021, following the completion of the works, MRM Environment staff inspected the road and could not identify any visible signs of lead-zinc concentrate along the transport route.

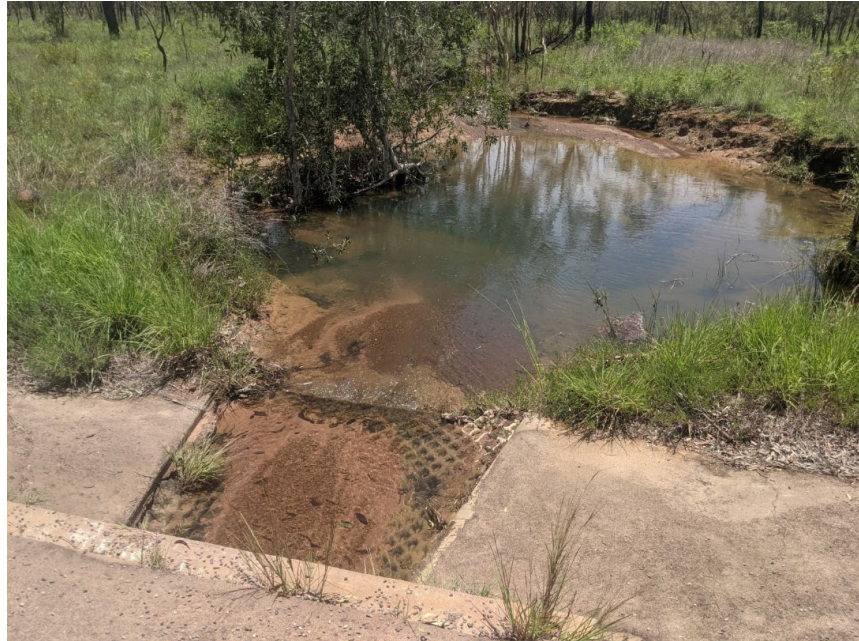
Soil samples were collected at all six locations to determine whether the concentrate had spread from the spill site as a result of any rainfall. Additionally, water samples were collected at potentially sensitive receptors identified at Site 1 (i.e. minor creek culvert) (Figure 4), and Site 5 and Site 6 (i.e. floodplain with pooled water) (Figure 5). Details of the samples are provided below.

*Figure 4: Site 1 – minor creek culvert observed next to spill location.*

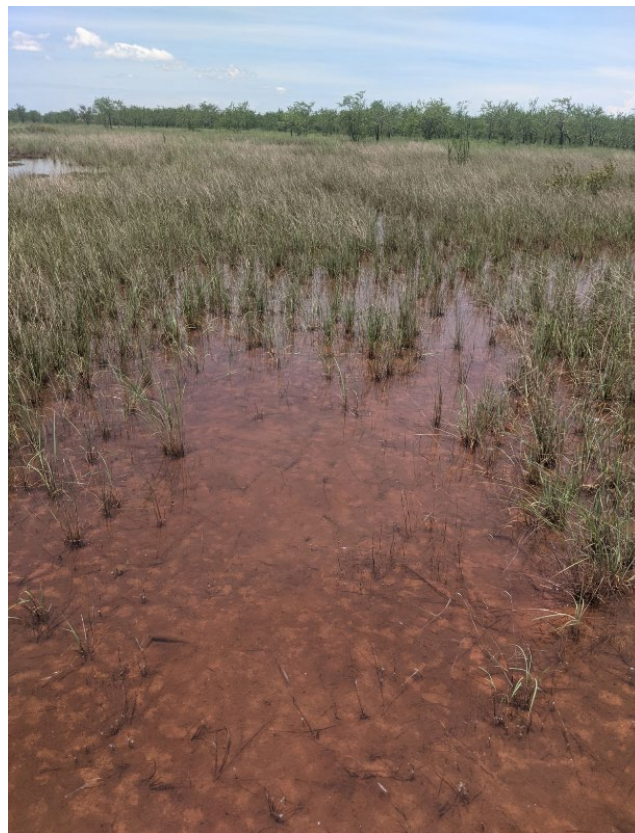
*Figure 5: Site 5 – floodplain observed next to spill location.*
