## SECTION 14 INCIDENT REPORT (*Waste Management and Pollution Control Act*)

| <b>Incident:</b> | Discharge of untreated sewage from sewerage network (scour pipe) |

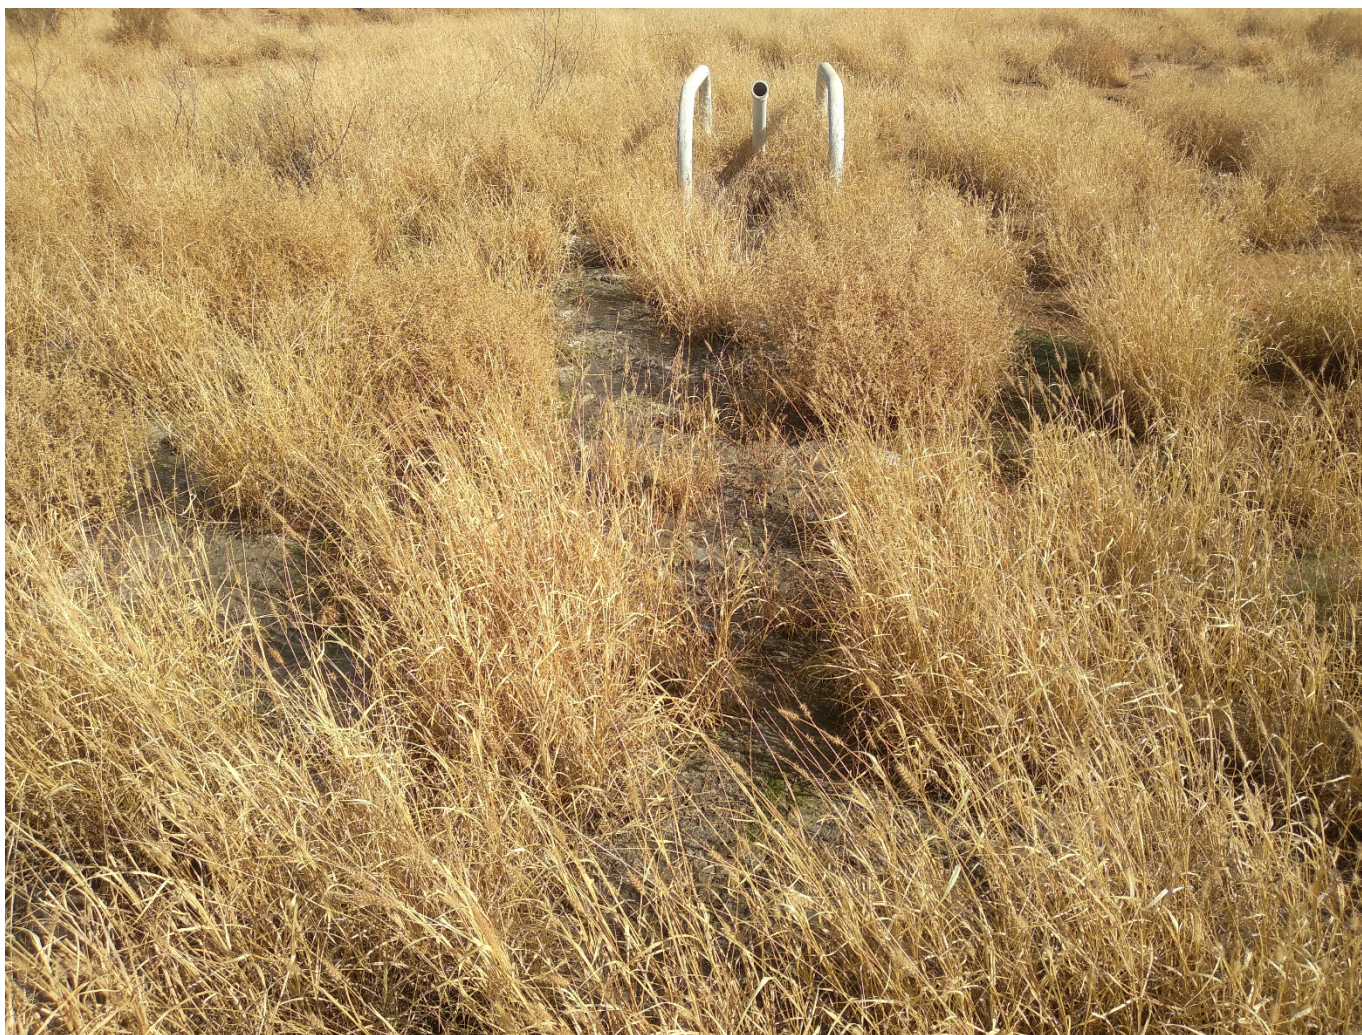
| <b>(c) the date and time of the incident</b> | <p><i>i. The time and date of commencement and cessation of the discharge.</i></p> <p>The exact commencement time of the overflow is unknown but is believed to have occurred approximately three weeks ago. The overflow was detected by PWC personnel at approximately 10:00 hrs 13/07/21 during works in the area, and was stopped at 10:00 hrs 13/07/21.</p> <p><i>ii. How PWC were notified, or became aware of the discharge.</i></p> <p>The overflow was detected by PWC personnel at approximately 10:00 hrs 13/07/21 during works in the area.</p> <p><i>iii. The process by which the discharge occurred.</i></p> <p>The cause of the incident is due to a sewer scour being incorrectly opened, as it was mistaken for a water scour, during works on a water main in the area. As the nearby sewer pump station engaged, sewage was released from the scour pipe intermittently over the past three weeks. It should be noted it was not a continuous release of sewage from the scour pipe, it occurred intermittently only during pump operating times. PWC Operations estimate approximately 315,000 litres of sewage was released in total over the three week period the scour pipe was open.</p> <p><i>iv. The reason why the discharge occurred.</i></p> <p>As per (c) iii.</p> |

Photo 1 – Scour pipe and overflow area

| <b>(e) the attempts made to prevent, reduce, control, rectify or clean up the pollution or resultant environmental harm caused or threatening to be caused by the incident</b> | <p>Upon detection, the scour pipe valve was closed stopping the overflow.</p> <p><i>i. Confirmation signage and fencing has been erected, as appropriate.</i></p> <p>The area is being cordoned off with bunting /flagging tape to prevent public access. These restrictions will remain in place for five days post clean up.</p> <p><i>ii. Decontamination of the site as appropriate.</i></p> |

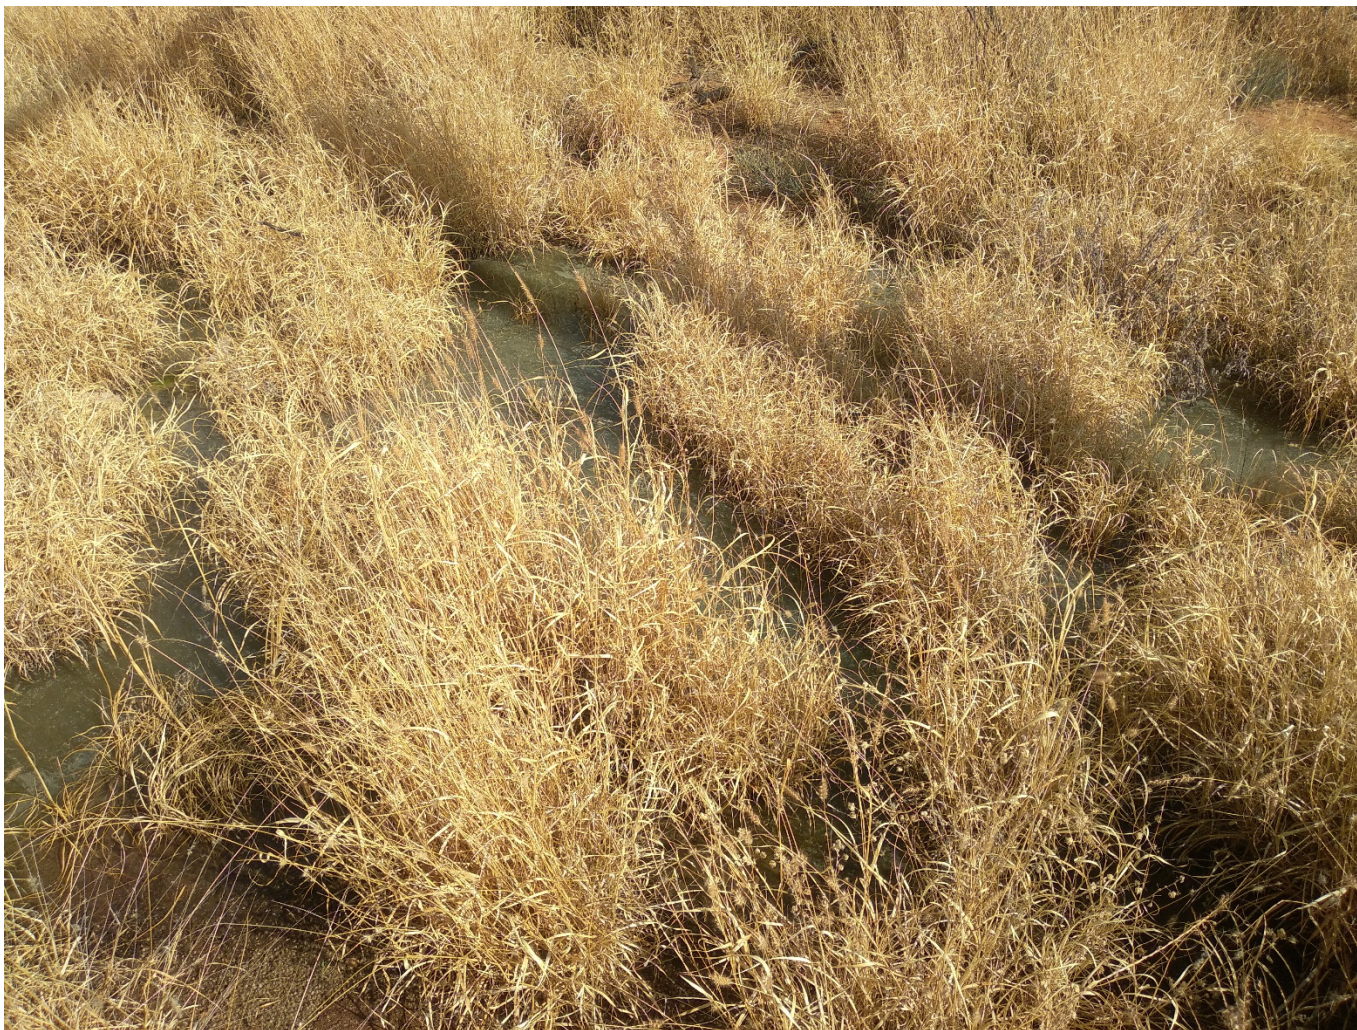
Photo 2 – Overflow area (before clean-up)

| | The area was inspected for gross pollutants and removed as identified. Contaminated soil is being removed, followed by application of lime and clean top soil. |
