## SECTION 14 INCIDENT REPORT (*Waste Management and Pollution Control Act*)

| <b>Incident:</b> | Overflow of diluted fully treated effluent |

| Angurugu Wastewater Ponds, Angurugu – Groote Eylandt. |

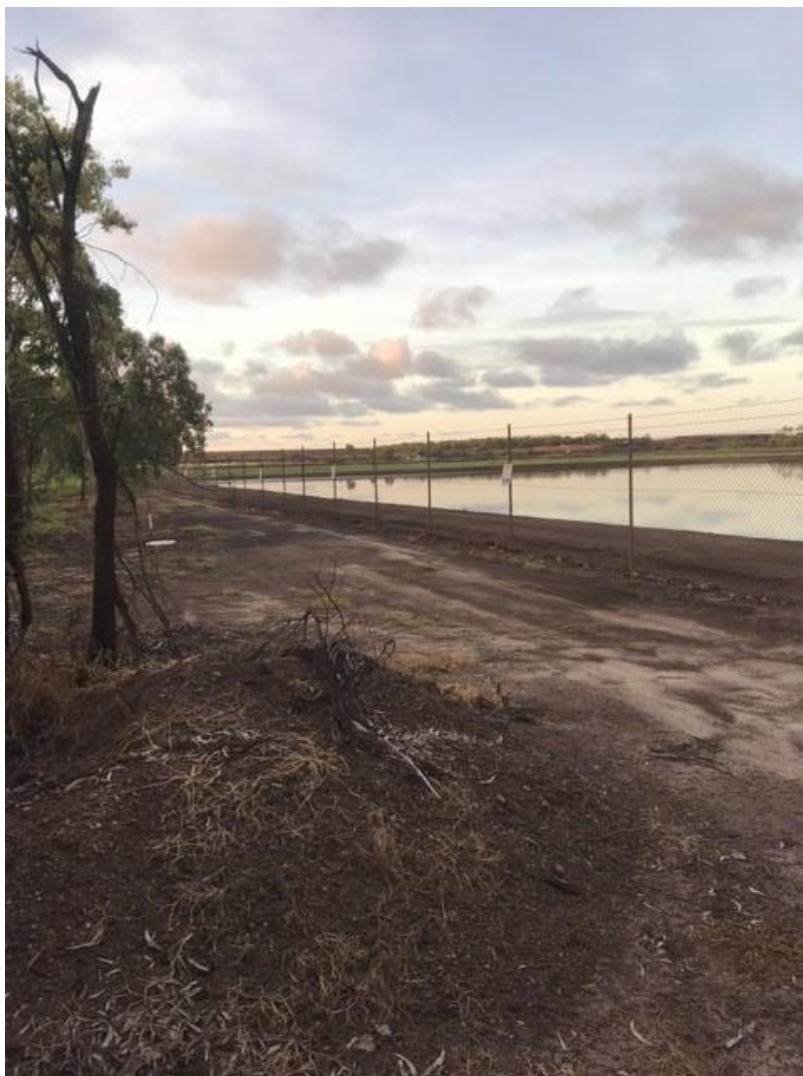
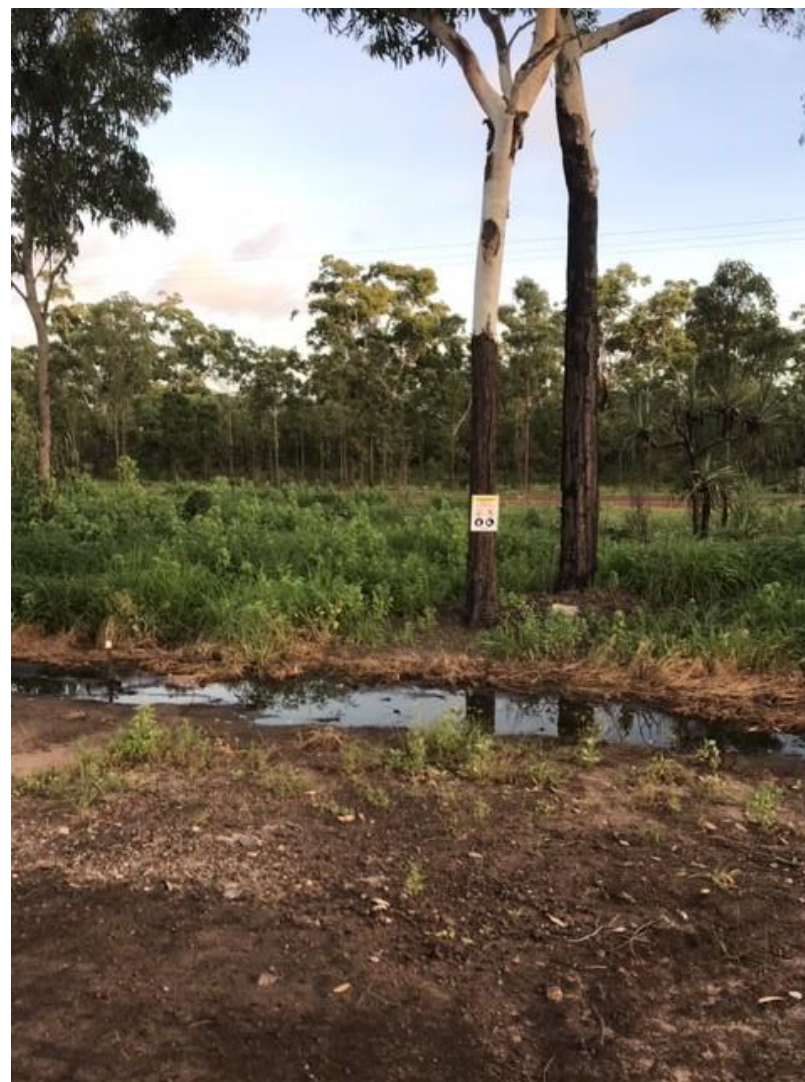
Appendix B – Photographs of warning signage along facility fence and spill path

| | <p><i>iii. Indicate any locations nearby to the discharge point where public can gain ready-access, such as public open spaces through which the discharge moves.</i></p> <p>Overflow is from the infiltration basin and the irrigation field after treatment ponds, so effluent is “fully” treated.<br/>Discharge is to a purpose built drain, which flows across an unnamed mine access road and ultimately to Angurugu Creek, that is accessible to the public. Communication is in place including appropriate signage along the drain to alert the public and prevent them coming in close proximity, see attached photographs.</p> |

| <b>(e) the attempts made to prevent, reduce, control, rectify or clean up the pollution or resultant environmental harm caused or threatening to be caused by the incident</b> | <p><i>i. Confirmation signage and fencing has been erected, as appropriate.</i></p> <p>Fencing not appropriate in this instance, with no anticipated access by the public. Warning signage has been erected, see attached photographs.</p> <p>Diversion drains in place to direct the effluent from the ponds across the road and into bushland. Signage has been placed within the area to alert the public and the overflow area is located within a restricted road reducing the probability of the public coming in contact with the wastewater. The PWC Technical Coordinator will also be investigating options for improving onsite controls such as bunding/earthworks prior to wet seasons to improve containment of overflows on site.</p> <p>Irrigation issues rectified, such as unblocking of sprinkler heads, and improved management of run times. An investigation of the inflow rates and water balance options will also be undertaken to determine options for upgrading the irrigation system and potentially increase sprinkler capacity on site.</p> <p>Power and Water management will also be having a meeting in early July with a representative of the Anindilyakwa Land Council to discuss opportunities of reusing some of the wastewater on a nearby tree lot, to help reduce pressure on the infiltration and irrigation fields. The feasibility of this idea is still to be determined.</p> <p><i>ii. Decontamination of the site as appropriate.</i></p> <p>Overflow is diluted and treated effluent, sewage debris is not present. Natural processes (UV disinfection) will provide disinfection of the discharge. Mosquito larvae baiting has also been undertaken since the overflows began, to prevent an increase in biting insects within the community.</p> |
