## SECTION 14 INCIDENT REPORT (*Waste Management and Pollution Control Act*)

| <b>Incident:</b> | Discharge of highly diluted sewage from sewerage network due to wet weather |

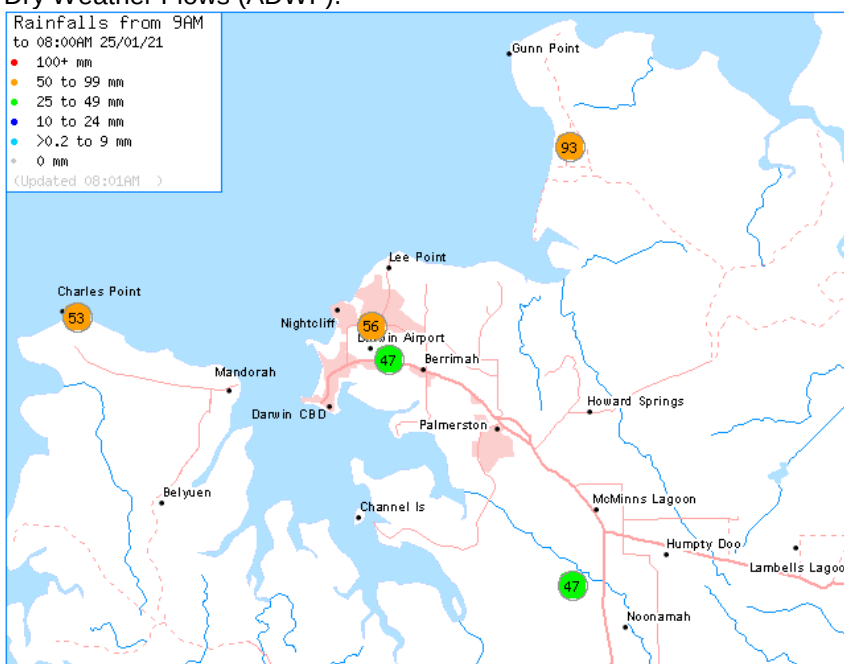
Indicative wastewater quality for this overflow can be found in Table 1. Rainfall leading up to the overflow was 93.8mm for the previous 3 days (Darwin Airport Weather Station – 014015), with high rainfall events occurring within short timeframes – as shown in Figure 1 below. As a result inflows of up to 43ML/day were received at Ludmilla Wastewater Treatment Plant (WWTP) equating to >3x Average Dry Weather Flows (ADWF).

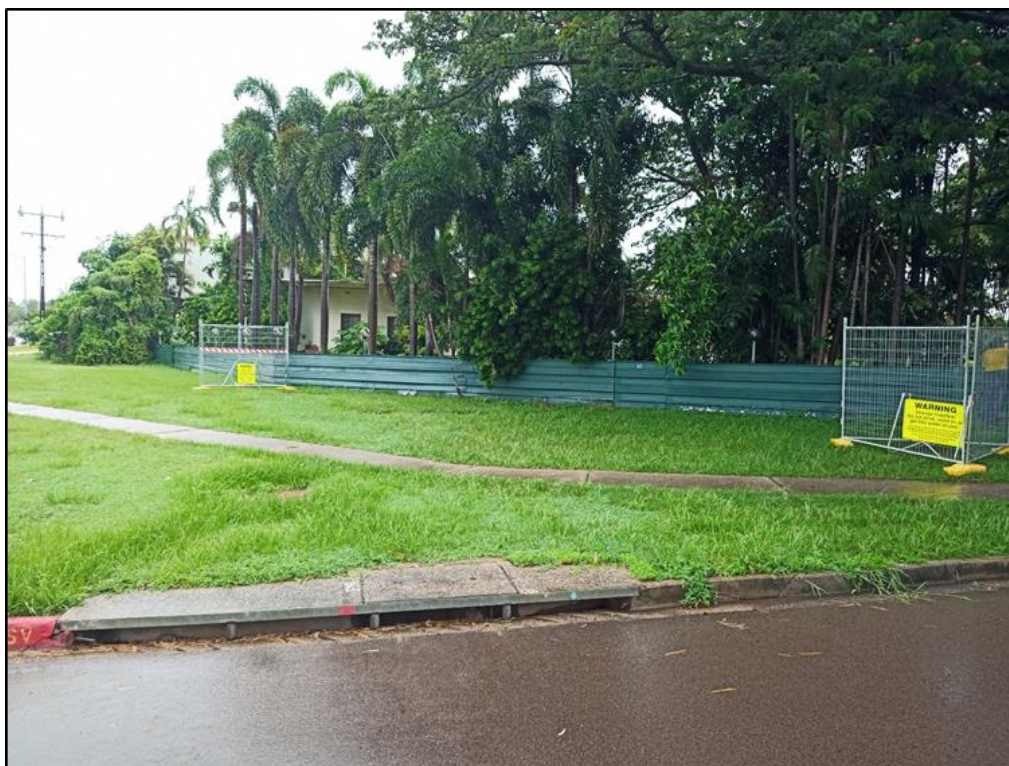
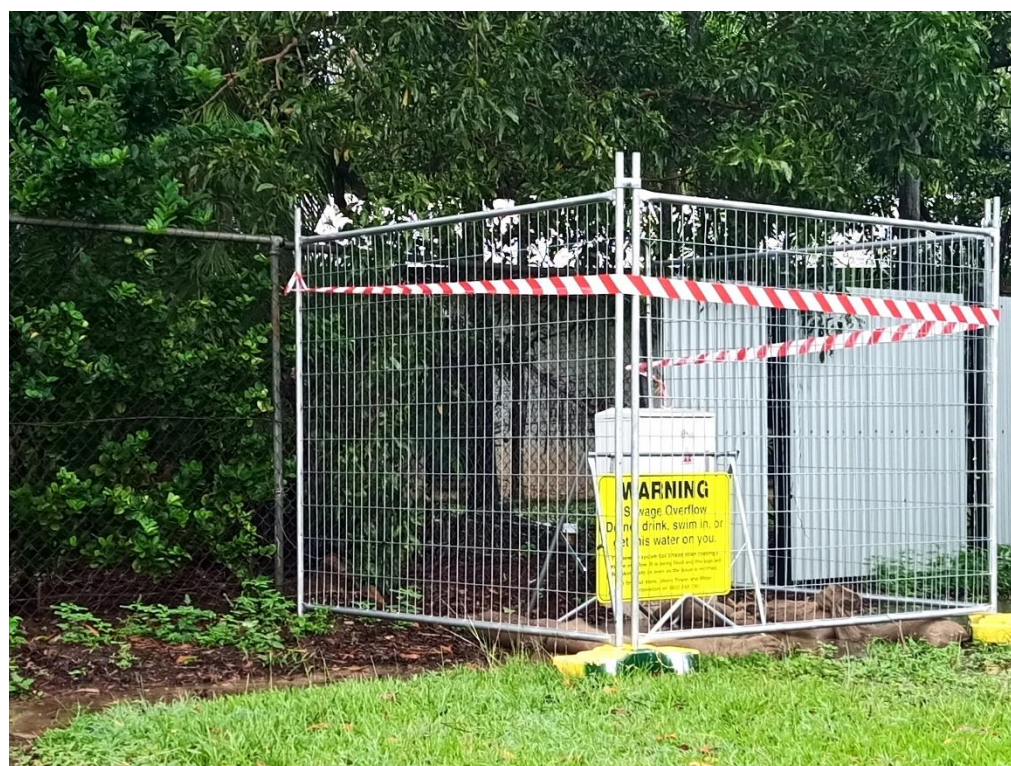
Fencing and signage at manholes - corner Gregory Street & East Point Road, Parap  
and  
5 Roberts Place, Millner

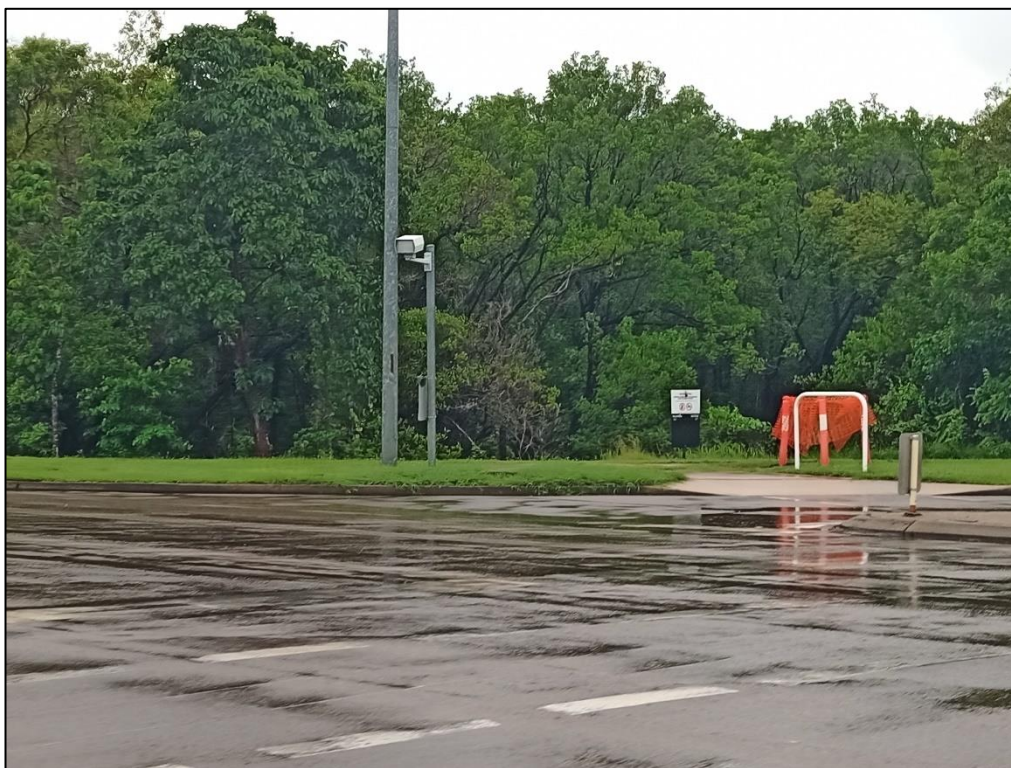
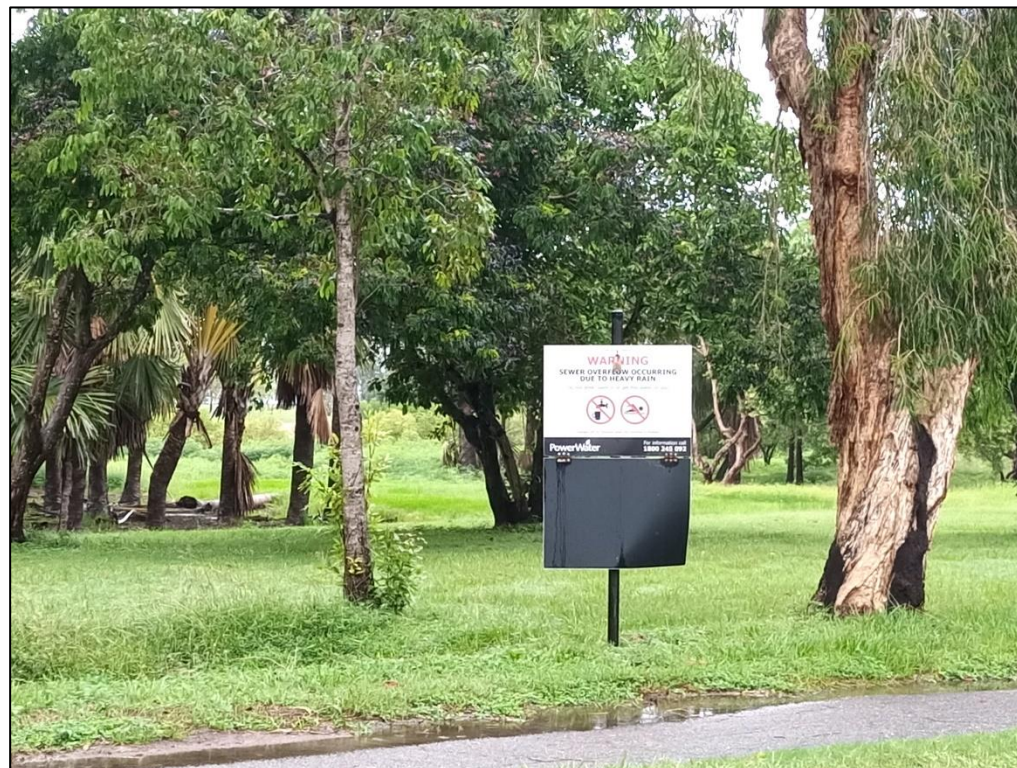
Signage being displayed at sewer overflow relief points - Corner of Trower Road and Rapid Creek Road, Rapid Creek  
and  
Opposite 24 East Point Road, Parap
