## SECTION 14 INCIDENT REPORT (*Waste Management and Pollution Control Act*)

| Incident: | Discharge of highly diluted sewage from sewerage network due to wet weather |

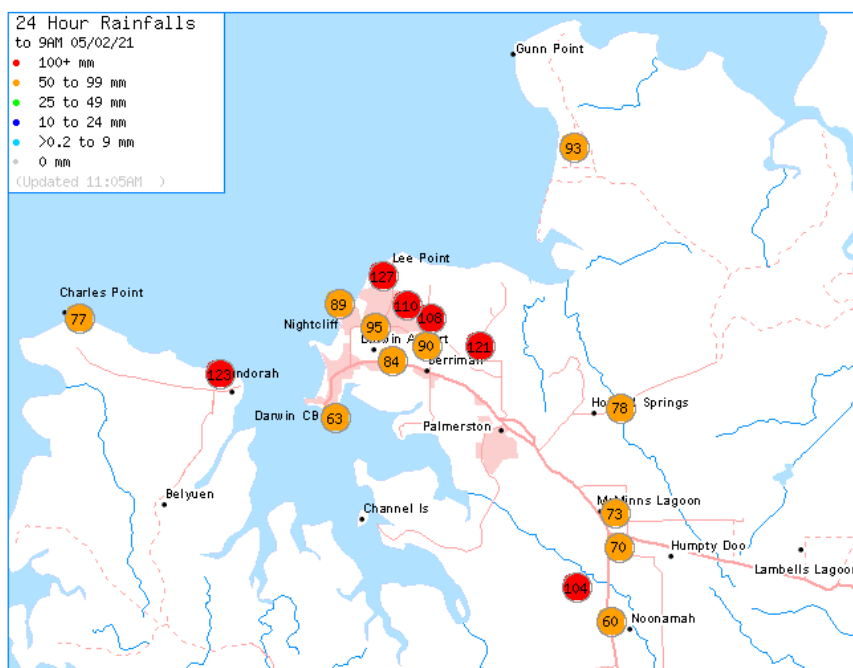
Indicative wastewater quality for these overflows may be extrapolated from Table 1. The rainfall total for the month of February to date is 113.0mm. (Darwin Airport Weather Station – 014015), with high rainfall events having occurred last night within short timeframes – as shown in Figure 1 below. As a result inflows of up to 4.31ML/hour were received at Ludmilla Wastewater Treatment Plant (06:00hrs), equating to ~104ML/day or **>8x Average Dry Weather Flows (ADWF)**.
