## SECTION 14 INCIDENT REPORT (*Waste Management and Pollution Control Act*)

| <b>Incident:</b> | Discharge of raw sewage from sewerage network (Sewage Pumping Station (SPS)) |

| <p><b>(b) the place where the incident occurred</b></p> | <p><i>i. Description of the PWC asset from which the discharge occurred.</i></p> <p>Old-timer sewage pumping station (SP730) – 245 Stuart Highway, Alice Springs (Lot 446).</p> <p><i>ii. GPS coordinates of the discharge point from the PWC asset, and the final coordinates of the final discharge point.</i></p> <p>Discharge Point:<br/>133.8703236E, 23.7416555S (SPS730 – Lot 446)</p> <p>Final Discharge Point:<br/>133.8707117E, 23.7416169S (dry river bed – Lot 8288)</p> <p><i>iii. Indicate any locations nearby to the discharge point where public can gain ready-access, such as public open spaces through which the discharge moves.</i></p> <p>Public access is generally available to the overflow site, however upon resolution of the overflow fencing has been installed to prevent access. The land was checked for gross pollutants of which none were visible.</p> |

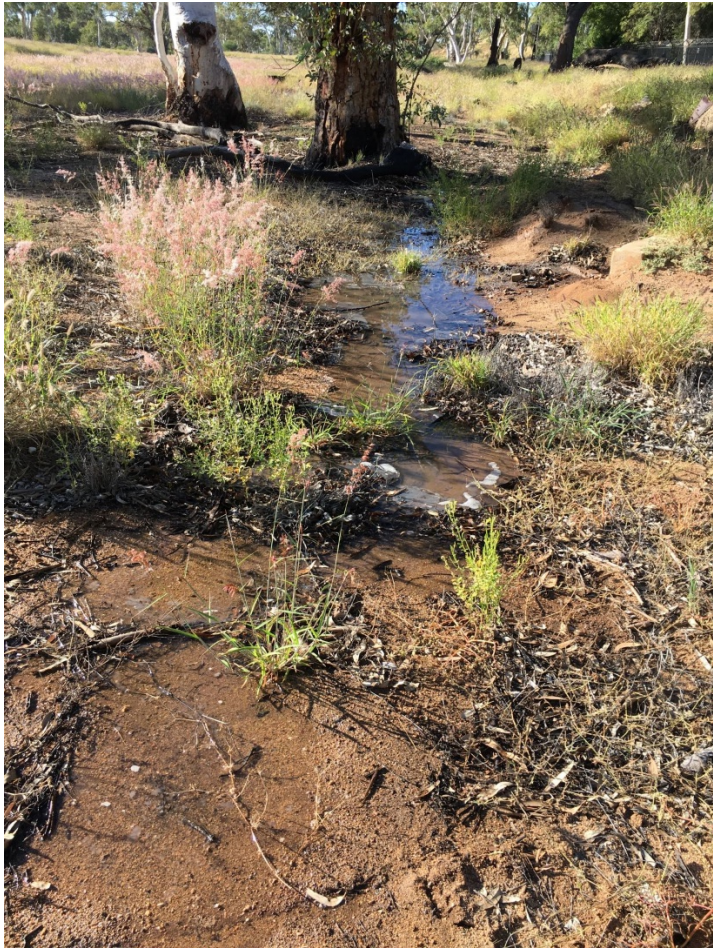
Overflow site

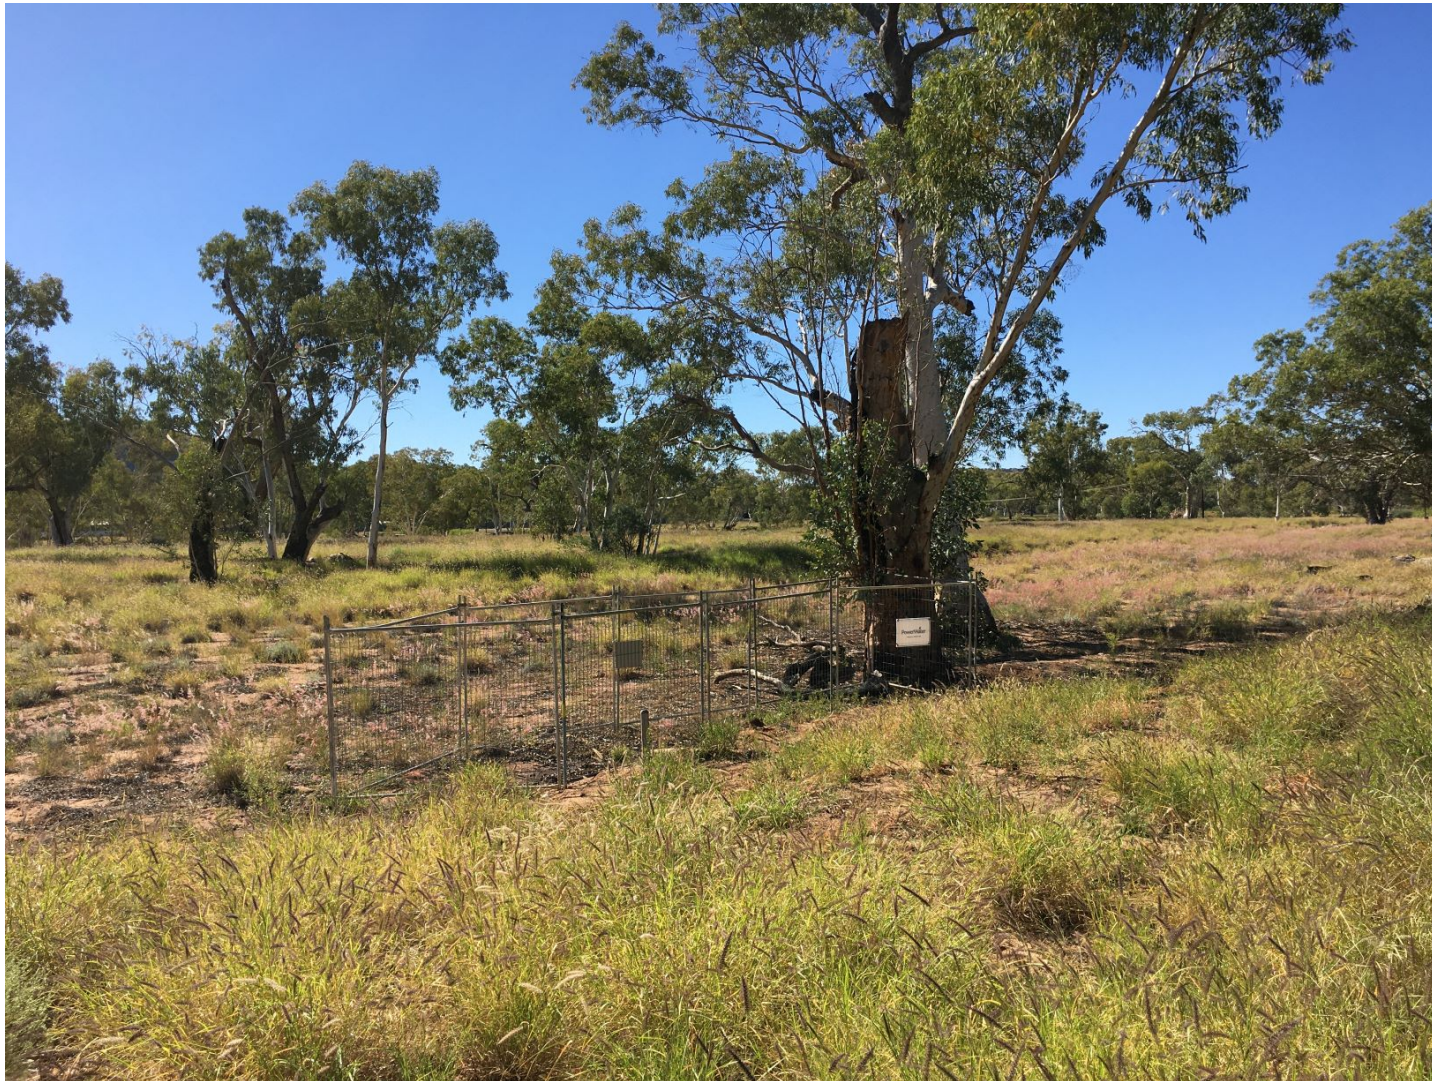
Fenced-off Overflow Site

| <b>(e) the attempts made to prevent, reduce, control, rectify or clean up the pollution or resultant environmental harm caused or threatening to be caused by the incident</b> | <p><i>i. Confirmation signage and fencing has been erected, as appropriate.</i></p> <p>Upon arrival to site by PWC officer and resolution of overflow, fencing has been installed to prevent access by the public.</p> <p><i>ii. Decontamination of the site as appropriate.</i></p> <p>Site was inspected for any wastewater gross pollutants, of which none were observed.</p> |
