## SECTION 14 INCIDENT REPORT (*Waste Management and Pollution Control Act*)

| <b>Person / Company:</b> | Power and Water Corporation ( <b>PWC</b> ) |
| <b>Incident:</b> | Discharge of raw sewage from sewerage network |

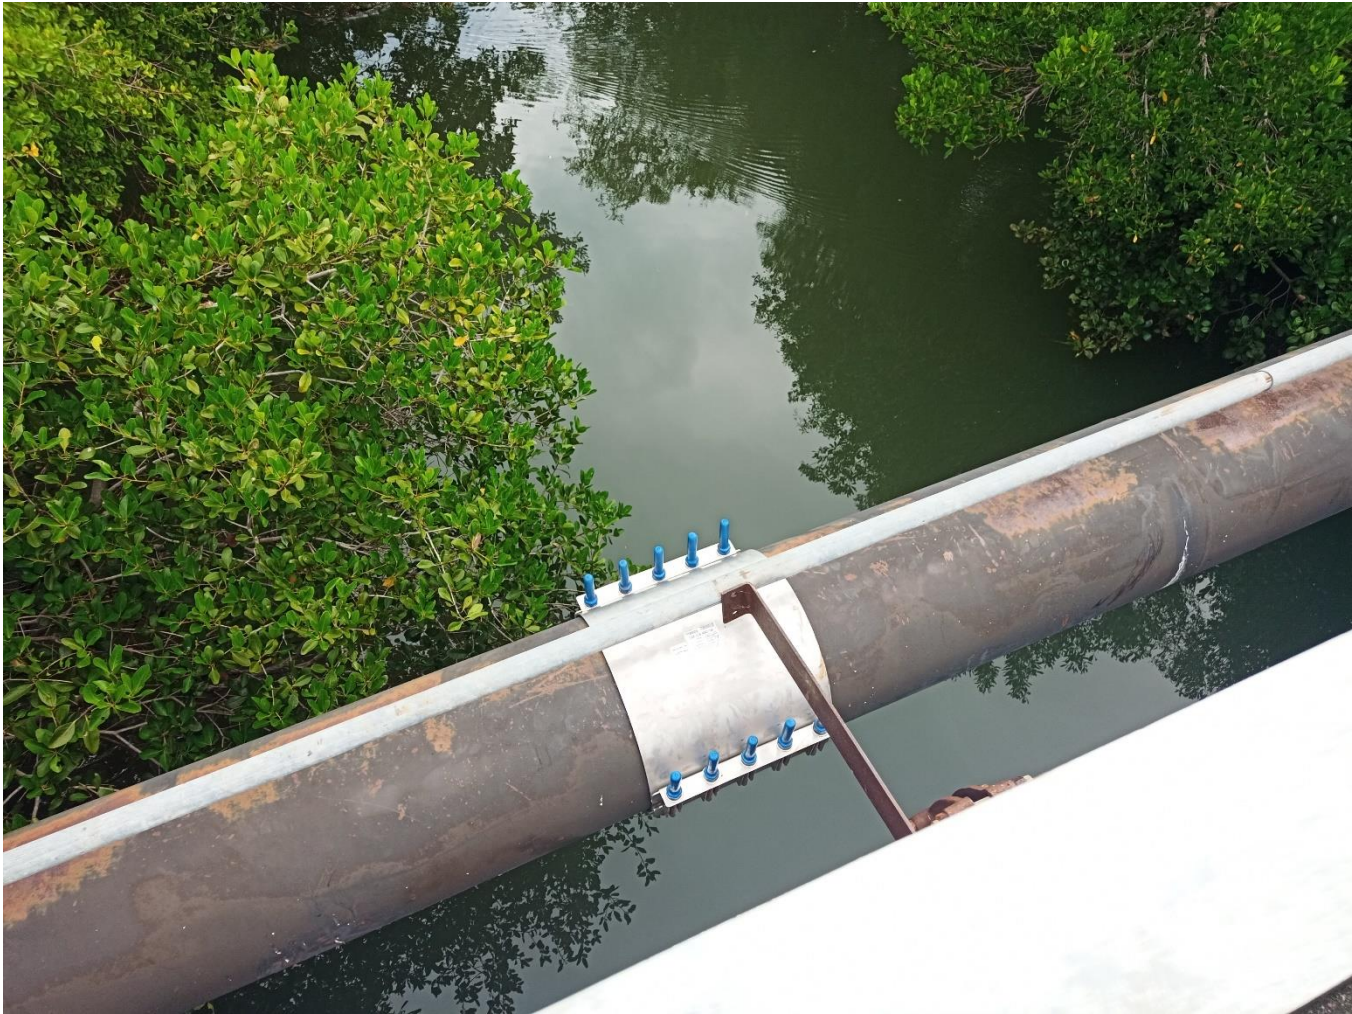
| <b>(c) the date and time of the incident</b> | <p><i>i. The time and date of commencement and cessation of the discharge.</i><br/>The time and date of when the spill started is unknown, but it is believed to have commenced in the early hours of the 15/04/2021. It was first noticed by a PWC employee around 05:00hrs, 15/04/2021 and had stopped shortly before 08:30hrs 15/04/2021.</p> <p><i>ii. How PWC were notified, or became aware of the discharge.</i><br/>A PWC employee noticed the spill around 05:00hrs, whilst out jogging.</p> <p><i>iii. The process by which the discharge occurred.</i><br/>A combination of corrosion and normal deterioration that occurs over time caused a weak point in the pipework, which eventually gave way under the pressure of the sewage pump station's pumping pressure. Once the section of pipework is replaced, to prevent a reoccurrence, the old pipework will be examined to confirm actual causal factors for the pipe failure.</p> <p><i>iv. The reason why the discharge occurred.</i><br/>As per (c) iii. Failure of infrastructure.</p> |

Appendix B – Photographs - (Patched sewer pipe)

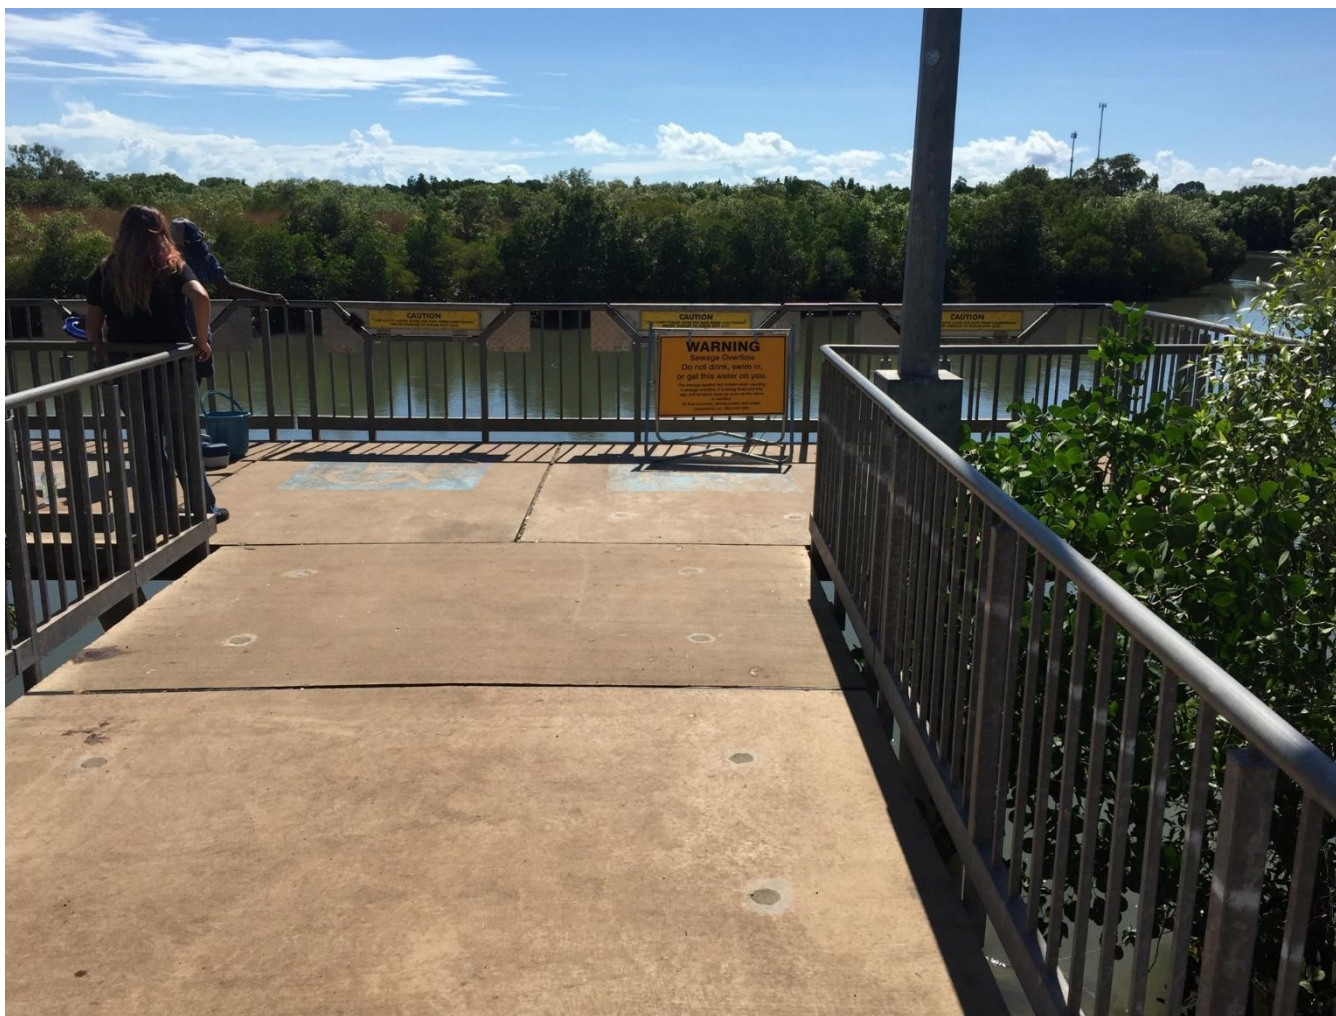
Appendix B – Photographs – (Warning sign at Rapid Creek's fishing platform)

| <b>(e) the attempts made to prevent, reduce, control, rectify or clean up the pollution or resultant environmental harm caused or threatening to be caused by the incident</b> | <p><i>i. Confirmation signage and fencing has been erected, as appropriate.</i><br/>Signage has been erected at the fishing platform, to warn of the presence of the spill, and to avoid contact.</p> <p><i>ii. Decontamination of the site as appropriate.</i><br/>Clean up consistent with Sewage Spills/Overflow Response Work Instruction as appropriate to the location, and to minimise risk to the Environment. Sites were inspected for any gross pollutants of which none were observed.</p> |
