## SECTION 14 INCIDENT REPORT (*Waste Management and Pollution Control Act*)

| <b>Incident:</b> | Discharge of highly diluted sewage from sewerage network due to wet weather / monsoonal conditions |

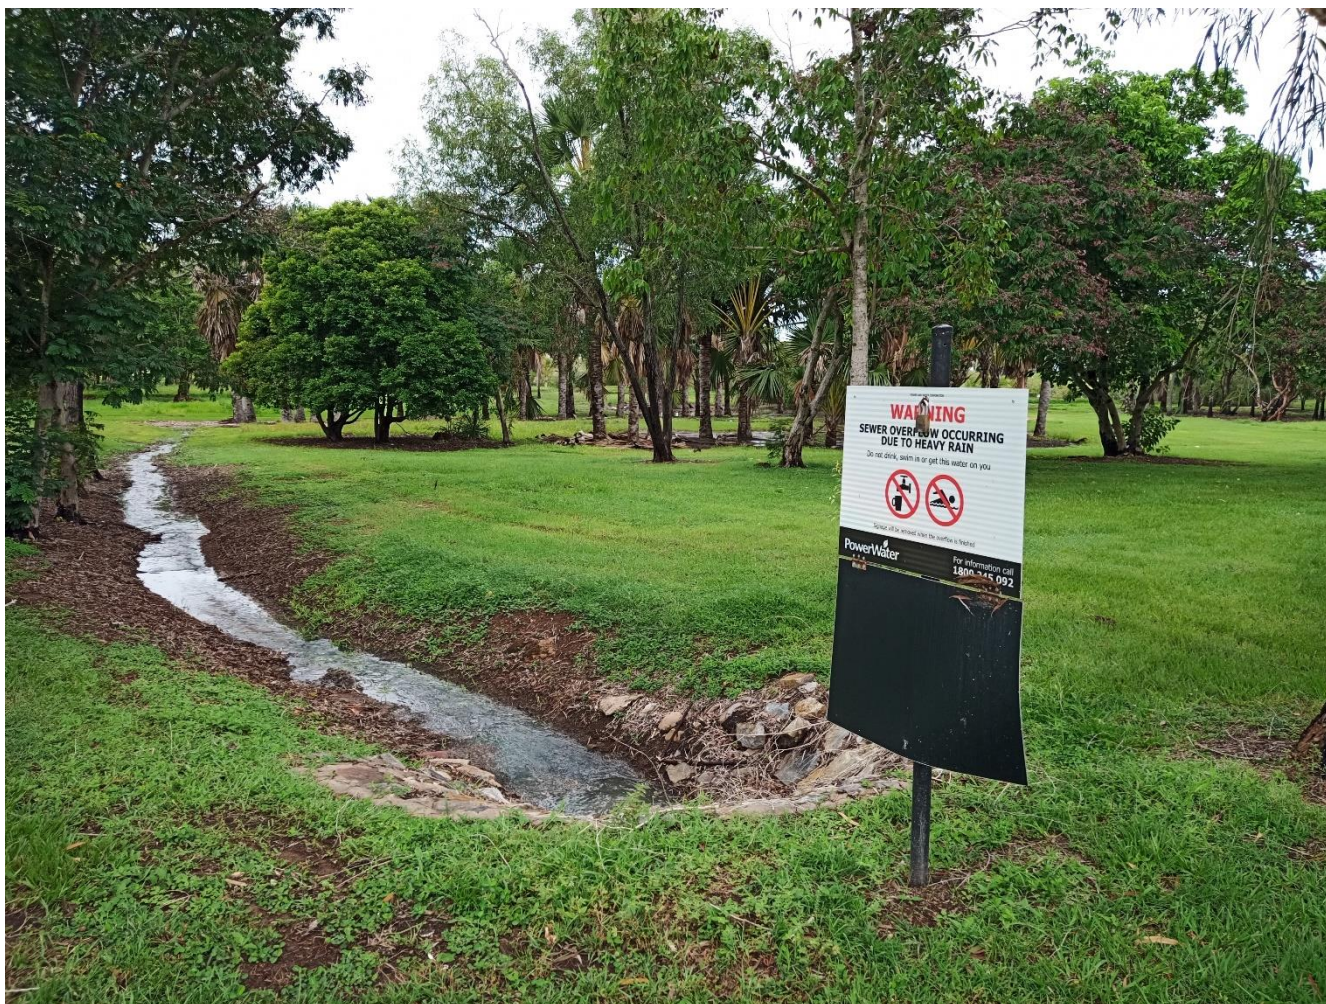
Appendix B – Photographs (Discharge point for SRV at 24 East Point Road, Fannie Bay, showing warning signage)
