SECTION 14 INCIDENT REPORT (*Waste Management and Pollution Control Act*)

Date and Time of Notification:	Initial notification (email) – 22 January 16:46															
Person / Company:	McArthur River Mining Pty Ltd (MRM)															
Incident:	Spillage of bulk zinc-lead concentrate on the Carpentaria Highway. The source of the spill is likely to have been from a road train travelling from McArthur River Mine (the Mine) to the Bing Bong Loading Facility (BBLF).															
(a) the incident causing or threatening to cause pollution	A total of approximately 20 kilograms (kg) of bulk zinc-lead concentrate was released at four main locations across 20 kilometres (km) of the Carpentaria Highway, between the Mine and the BBLF. All concentrate was confined to the sealed bitumen.															
(b) the place where the incident occurred	<p>The Global Positioning System (GPS) points for the four spill locations are listed in Table 1 below and shown in Figure 1.</p> <p style="text-align: center;"><i>Table 1 – GPS Coordinates of all spill locations.</i></p>

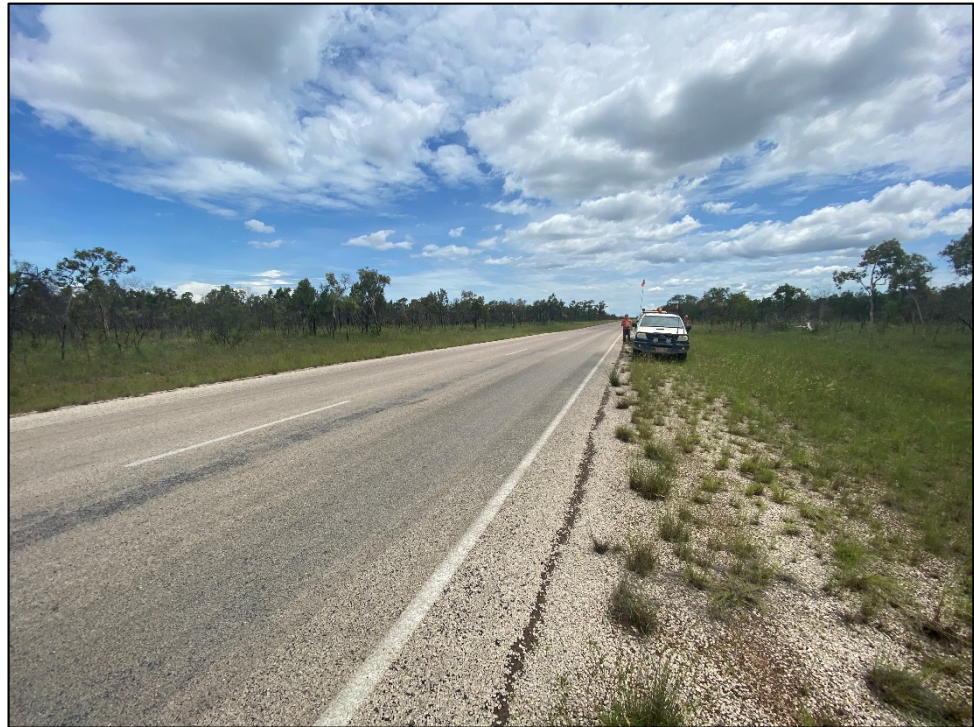
The concentrate was mostly confined to the sealed bitumen for the length of the spill (Figure 2) presenting a low risk of pollution or environmental harm. Based on the inspections, approximately 20 kg of concentrate is estimated to have been spilt in total.

Figure 2: Concentrate observed on road prior to clean up efforts.

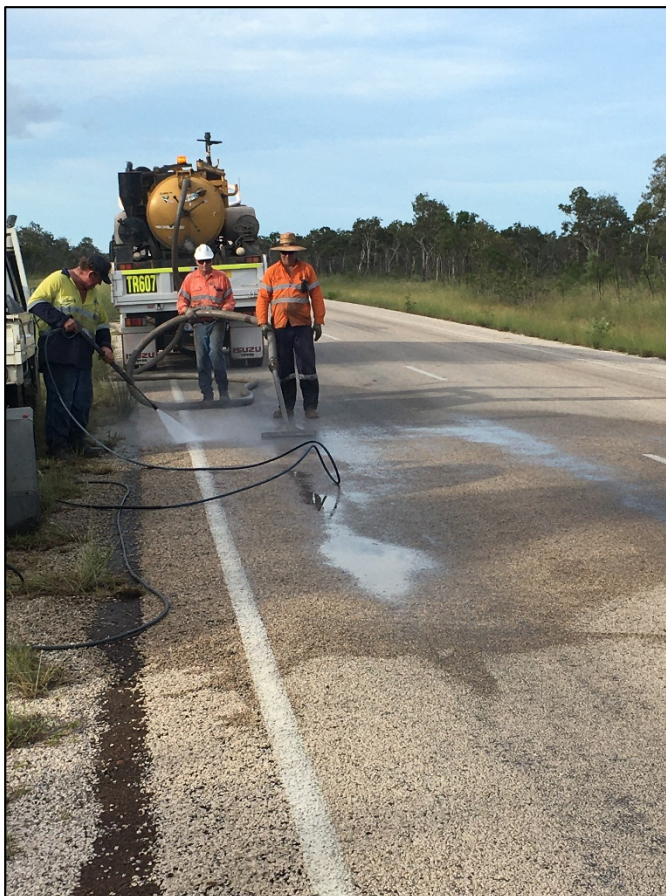
Figure 3: Spill clean-up efforts via pressure cleaner and industrial road sweeper at site 2.

At approximately 12:30 on 21 January 2021, a vacuum truck was deployed to clean-up all of the material on the road and the small amount at Site 2A that was off the sealed bitumen (Figure 3). This involved pressure washing the concentrate and simultaneously using a vacuum truck to collect the residue, which was transported back to the BBLF containment ponds.

On 23 January 2021, following the completion of the works, MRM Environment staff inspected the road and could not identify any visible signs of lead-zinc concentrate along the transport route.

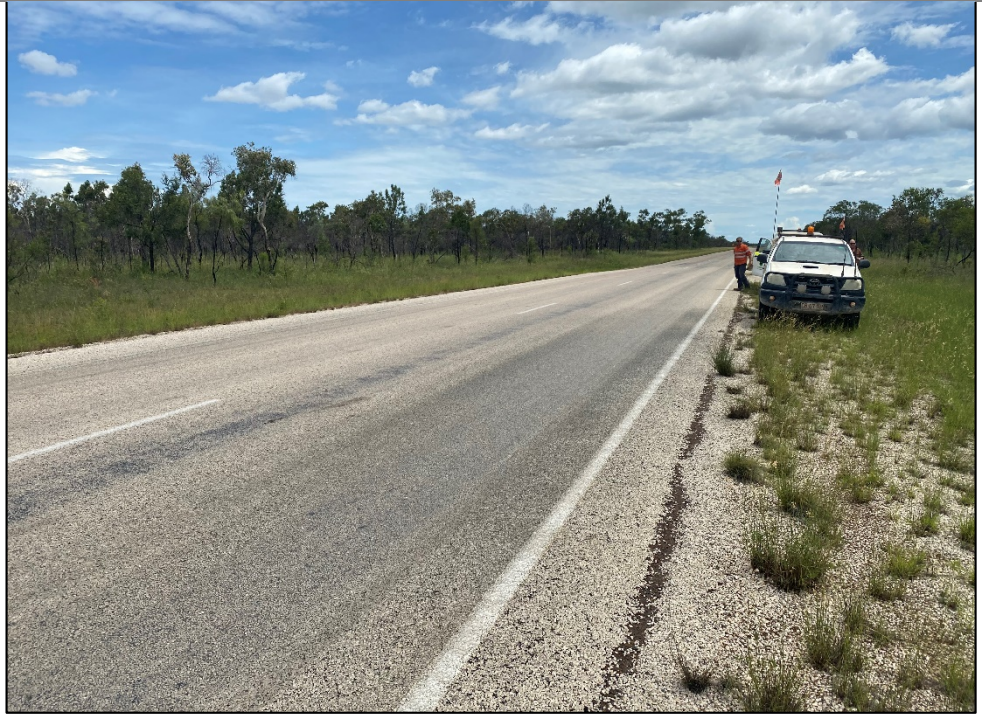
Figure 4: Site 2 – concentrate observed on road prior to clean-up efforts.

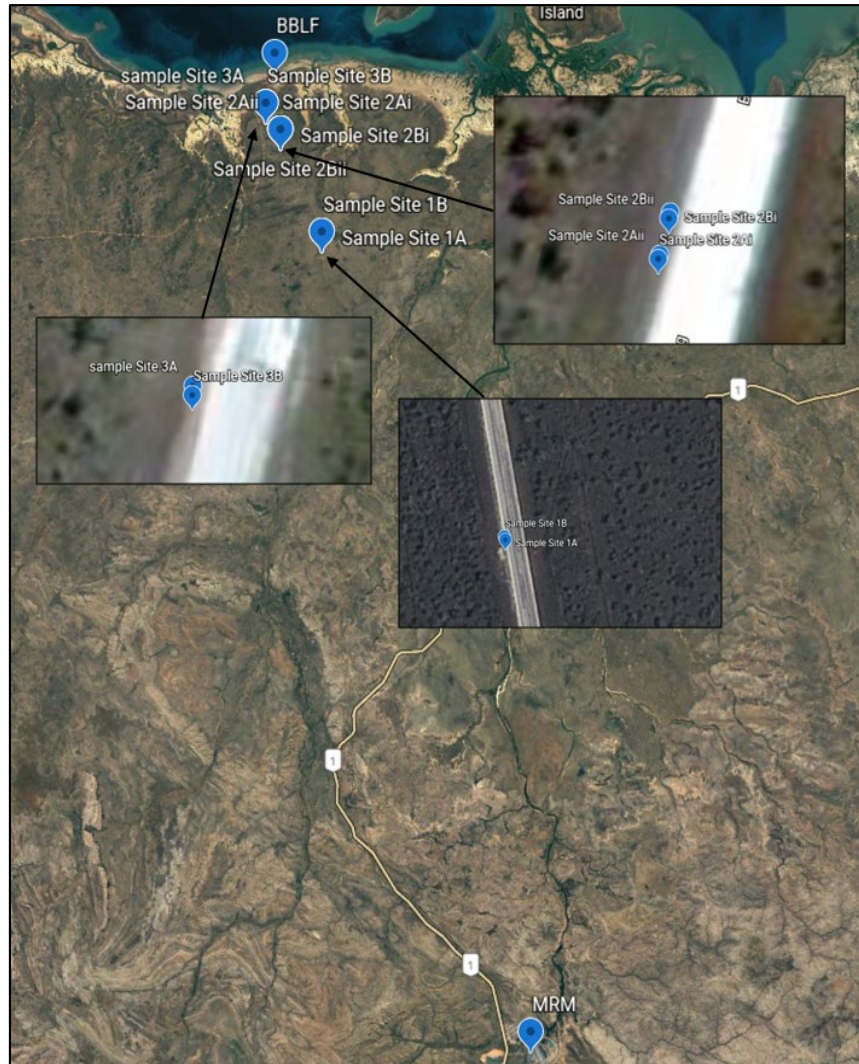
On 23 January 2021, eight soil samples were collected in total at the four spill locations (Figure 6) in accordance with *Australian Standard 4482.1-2005: Guide to the investigation and sampling of sites with potentially contaminated soil*.

Figure 6: Sampling locations at the spill sites between MRM and BBLF.
