## SECTION 14 INCIDENT REPORT (*Waste Management and Pollution Control Act*)

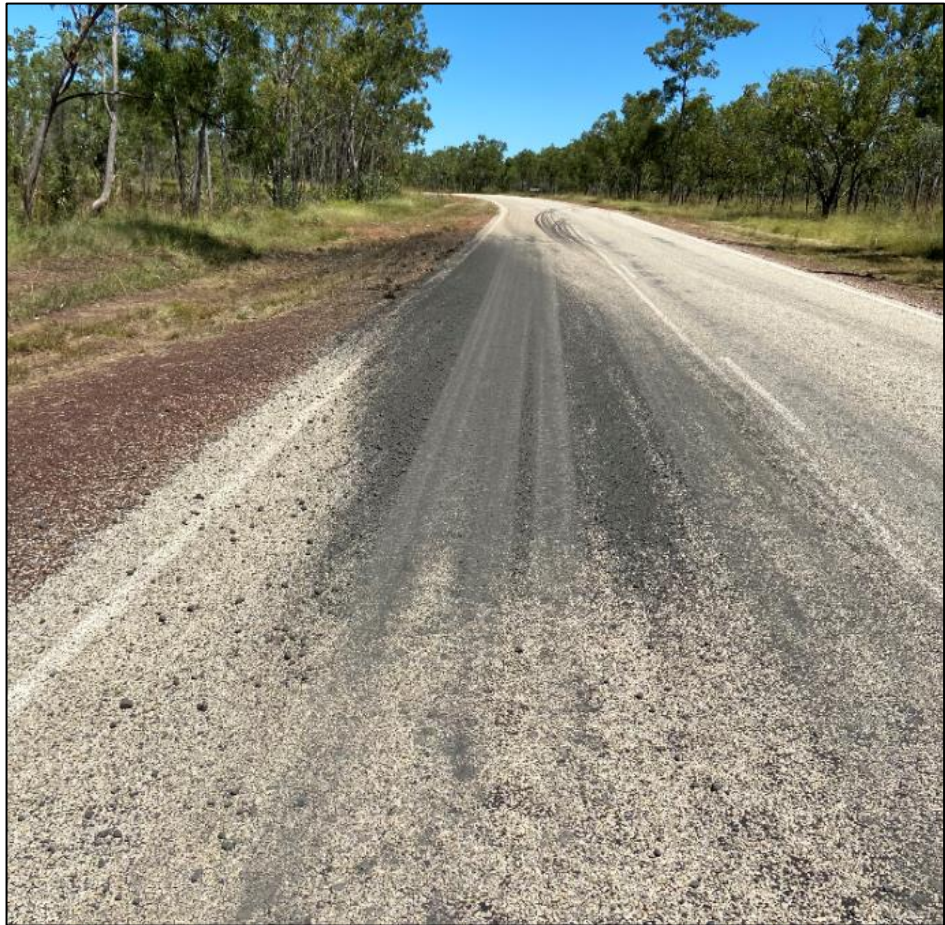
The concentrate was confined to the sealed bitumen and the roadside (Figure 2) presenting a low risk of pollution or environmental harm. Based on the inspection, less than 100 kg of concentrate is estimated to have been spilt.

*Figure 2: Bulk concentrate observed on the road surface prior to clean-up efforts.*

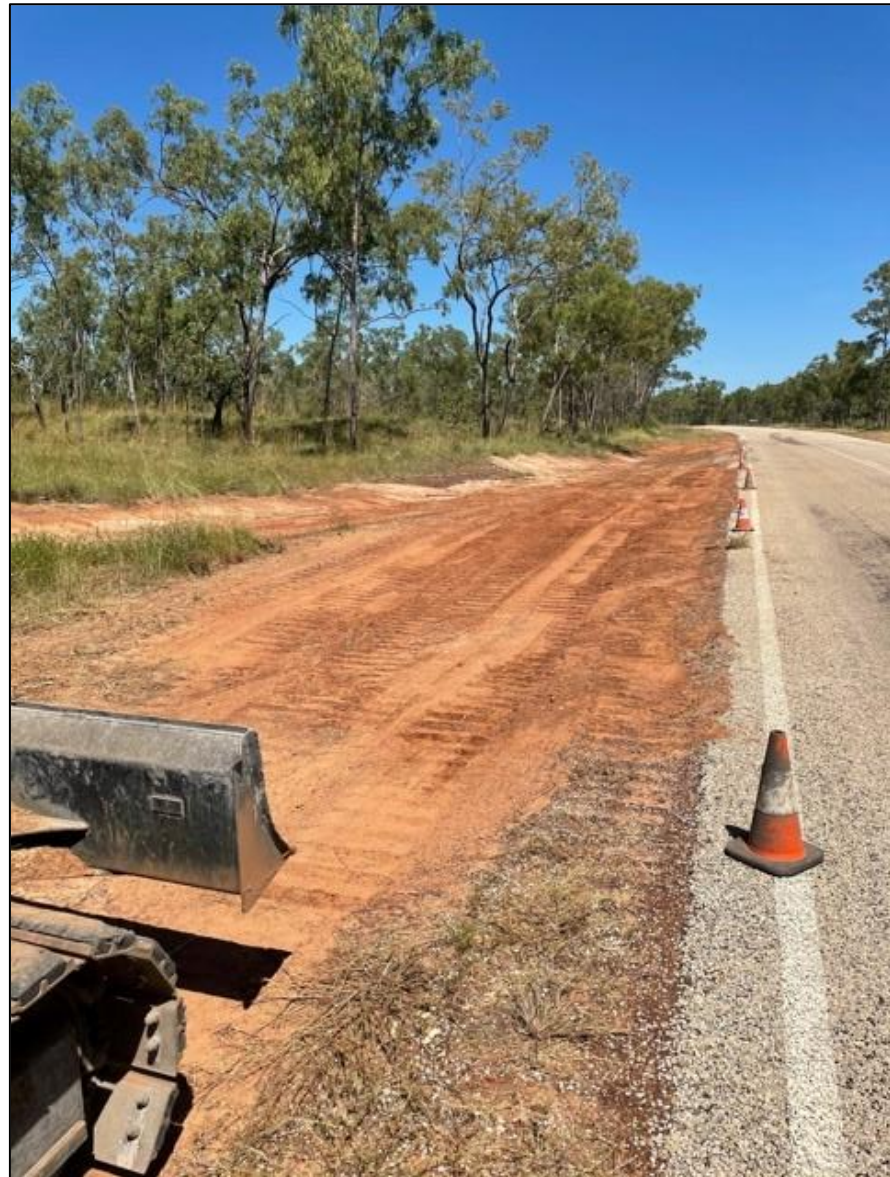
*Figure 3: Incident location during clean-up efforts.*

On April 16, clean-up of the bulk concentrate commenced, and was completed later that day. An excavator was used to remove any impacted soil within the roadside (Figure 3). The road surface was cleaned using a vacuum truck and a high pressure cleaner. All impacted material was transported back to the Mine and was disposed of within the Tailings Storage Facility.

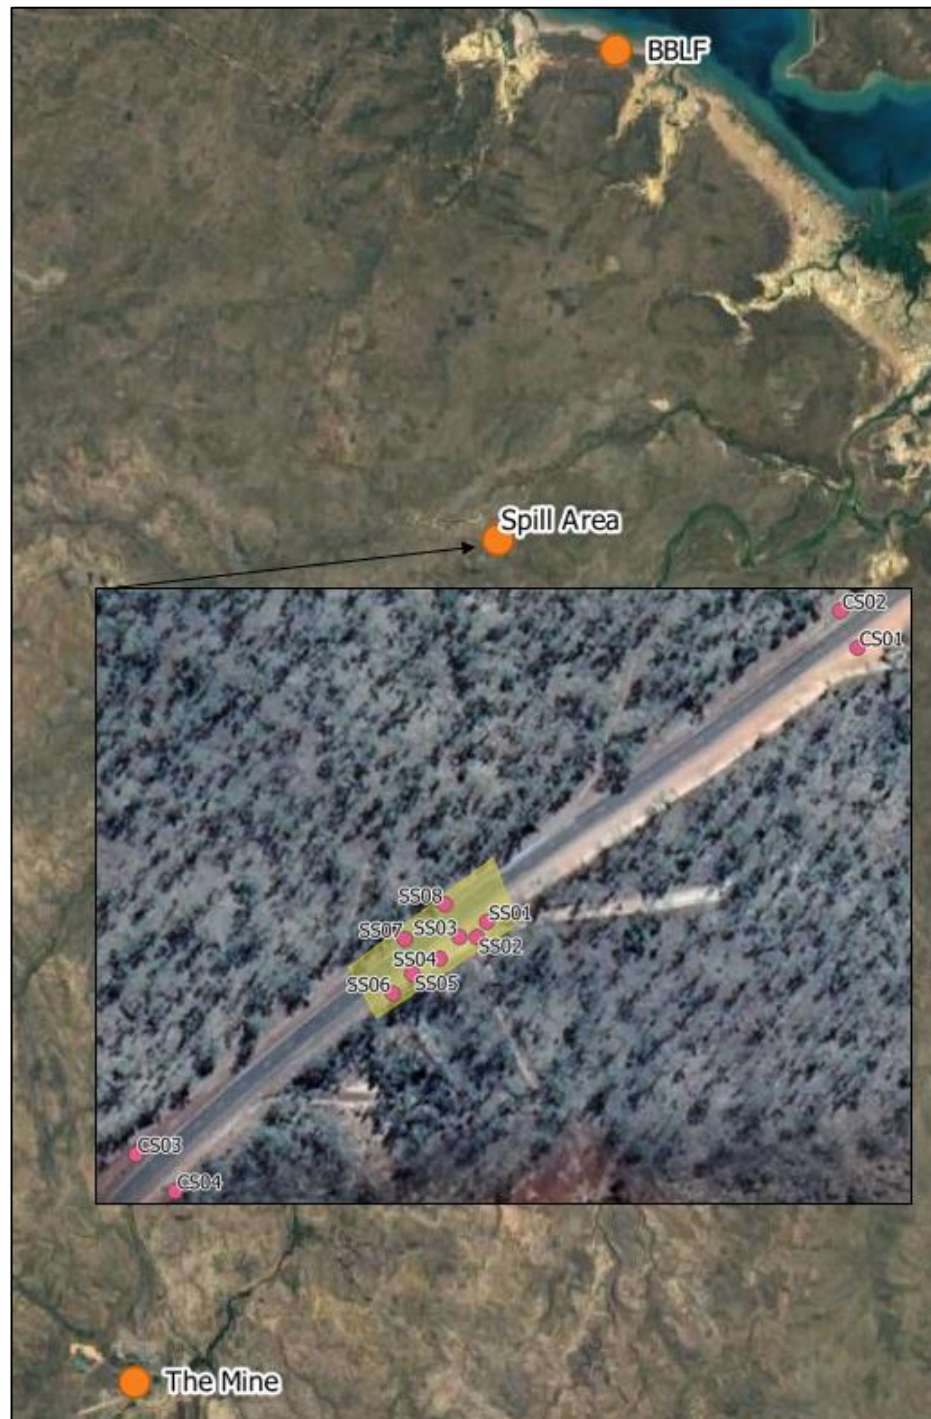
Figure 4: Soil sampling locations at the incident location.

On 17 April 2021, soil samples were collected at the incident location (Figure 4) in accordance with *Australian Standard 4482.1-2005: Guide to the investigation and sampling of sites with potentially contaminated soil*.
