## SECTION 14 INCIDENT REPORT (*Waste Management and Pollution Control Act*)

| <b>Incident:</b> | Oil spill from Lucy Ring Main Unit (RMU) and oil leak from an oil filled cable at the Ben Hammond Complex, Woolner. |

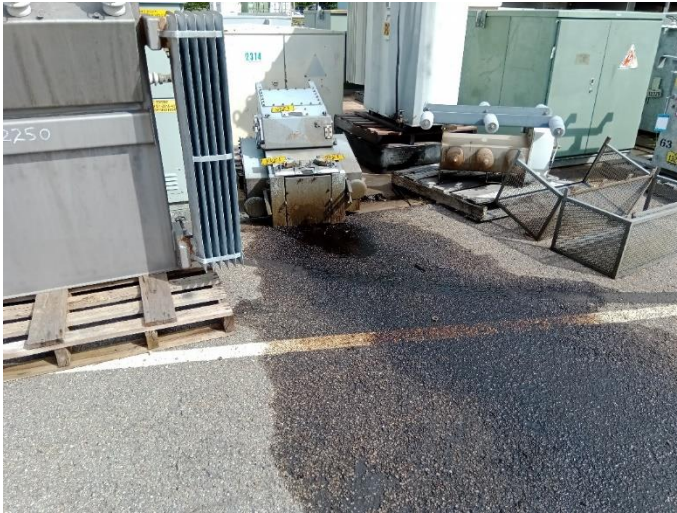
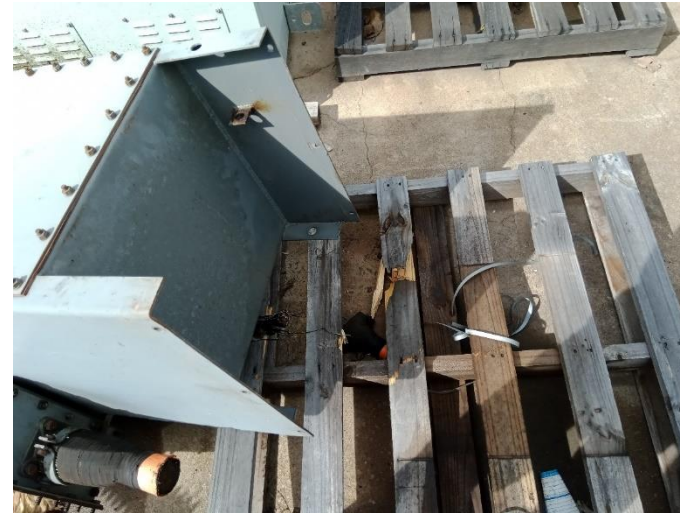
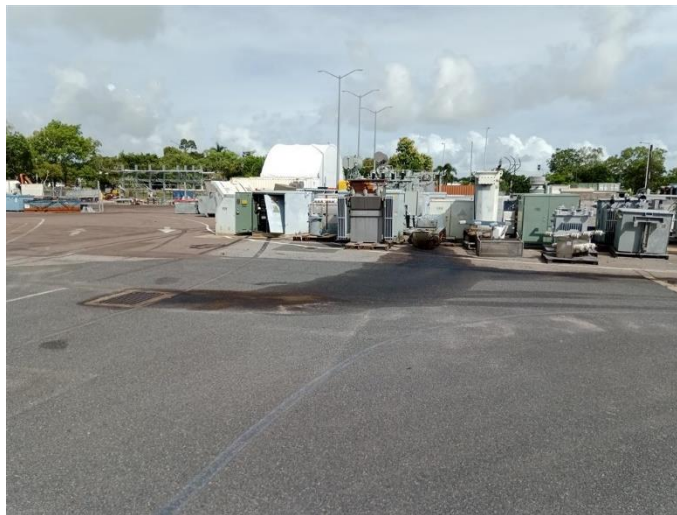
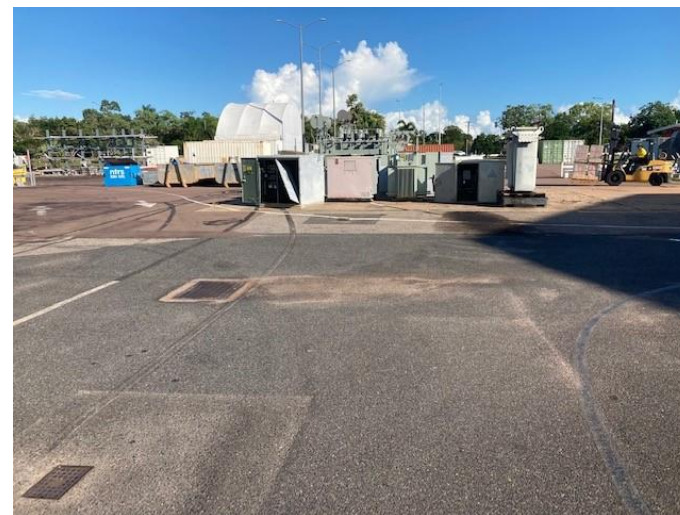
| <b>(c) the date and time of the incident</b> | <p><i>i. The time and date of commencement and cessation of the discharge.</i></p> <p>The commencement time of the spills is unknown but the Lucy RMU transformer oil spill was first observed on the 4<sup>th</sup> January 2022, and the Oil-filled cable insulating oil spill was observed on the 24<sup>th</sup> January 2022.</p> <p><i>ii. How PWC were notified, or became aware of the discharge.</i></p> <p>A PWC employee working at the Ben Hammond Complex observed the spills whilst undertaking informal inspections.</p> <p><i>iii. The process by which the discharge occurred.</i></p> <p>The Lucy RMU was being stored on a wooden pallet that was insufficient for the load it was carrying and had deteriorated over time, and eventually gave way causing the RMU to fall over.</p> <p>The Oil-filled cable leaked due to damage to the copper pipe that connects the oil reservoir to the cable, possibly due to the rope that holds the end of the cable onto the cable reel being deteriorated.</p> <p><i>iv. The reason why the discharge occurred.</i></p> <p>Both items were stored outside the dedicated bunded area used for storing oil-filled assets, as the bund was at capacity.</p> |

Appendix C – Photographs of the Lucy RMU spill, failed wooden pallet, spill pre and post clean-up.

| <b>(e) the attempts made to prevent, reduce, control, rectify or clean up the pollution or resultant environmental harm caused or threatening to be caused by the incident</b> | <p><i>i. Attempts made to prevent, reduce or control the discharge</i></p> <p>In both instances, spill kits were deployed once the spills were noticed, with booms being placed around stormwater drain inlets grates. Assets were either righted to prevent further oil loss or had the cable end repositioned to prevent further oil loss.</p> <p>A great deal of work has also gone into making room within the bunded area, by processing all Board of Survey (BOS) assets. BOS allows assets at end of life to be recycled or disposed of.</p> |

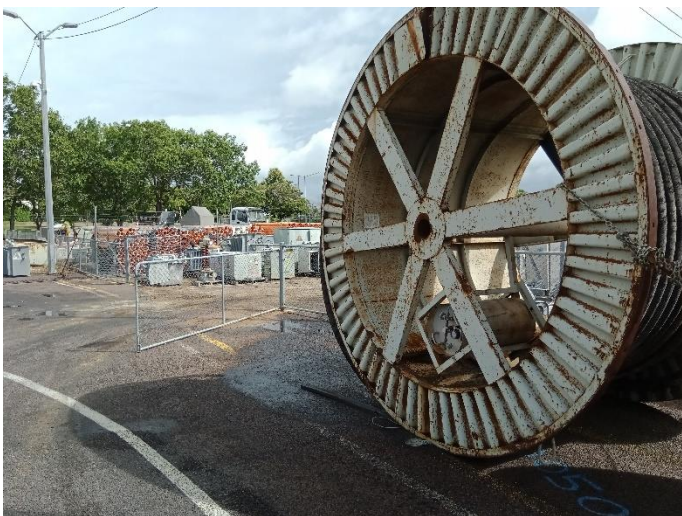
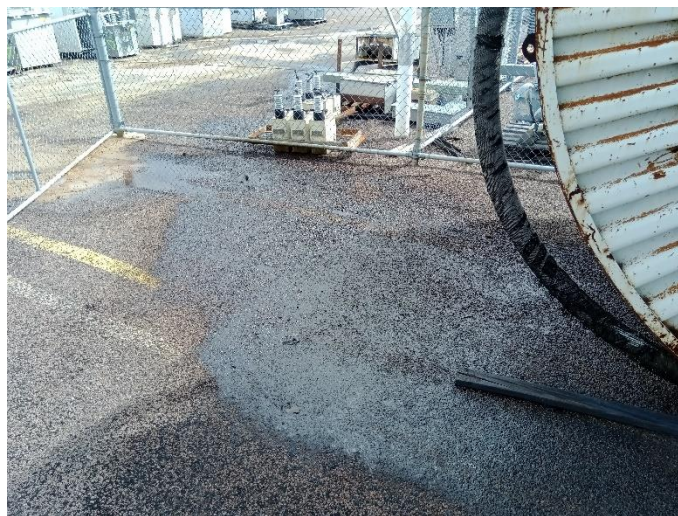
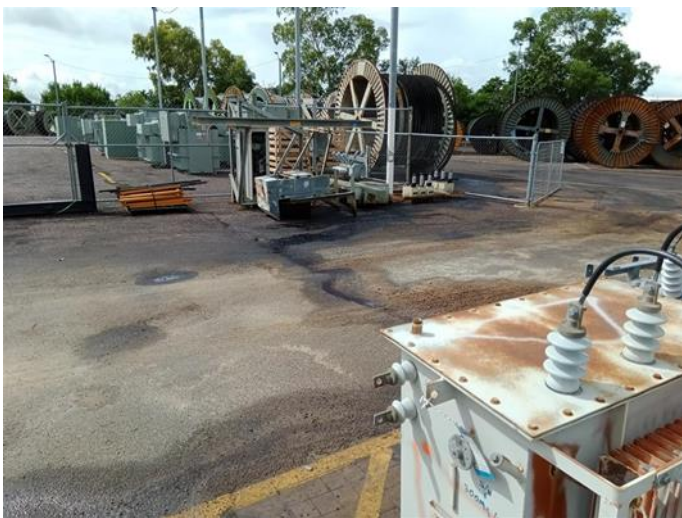
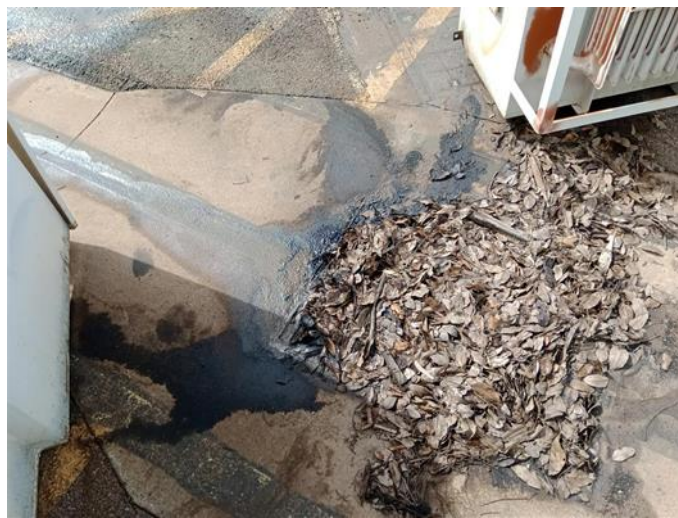
Appendix D – Photographs of the oil-filled cable spill.

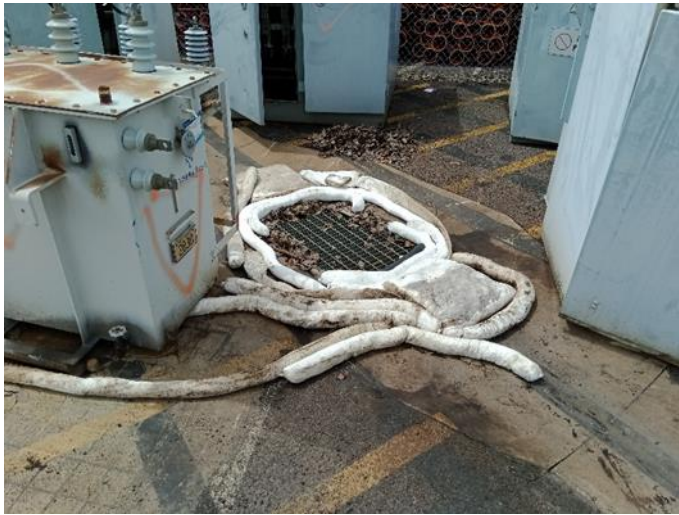
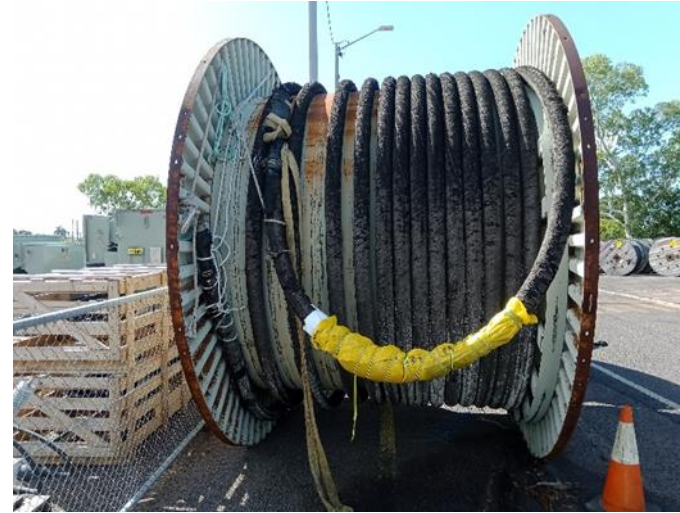
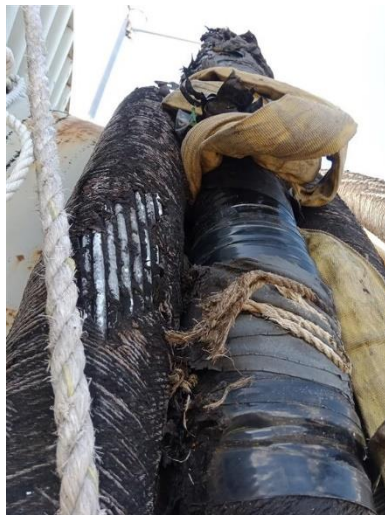
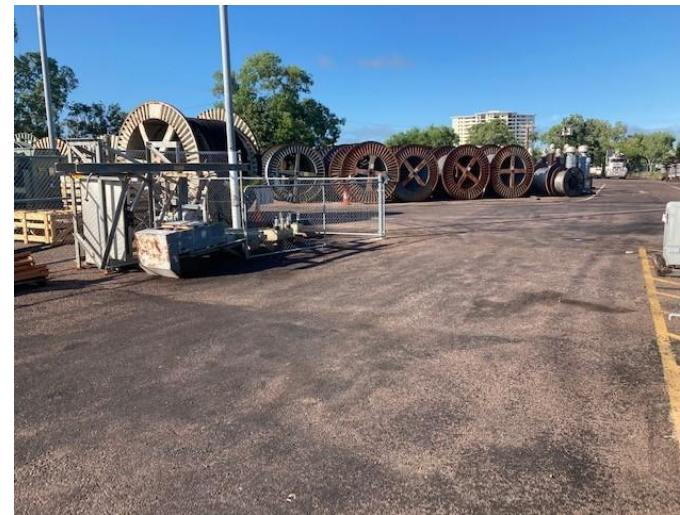
Appendix E – Photographs of the oil-filled cable spill response, deteriorated rope and area post clean-up.
