## SECTION 14 INCIDENT REPORT (*Waste Management and Pollution Control Act*)

| <b>Person / Company:</b> | Power and Water Corporation ( <b>PWC</b> ) |
| <b>Incident:</b> | Diesel Fuel Spill Galiwinku Power Station |

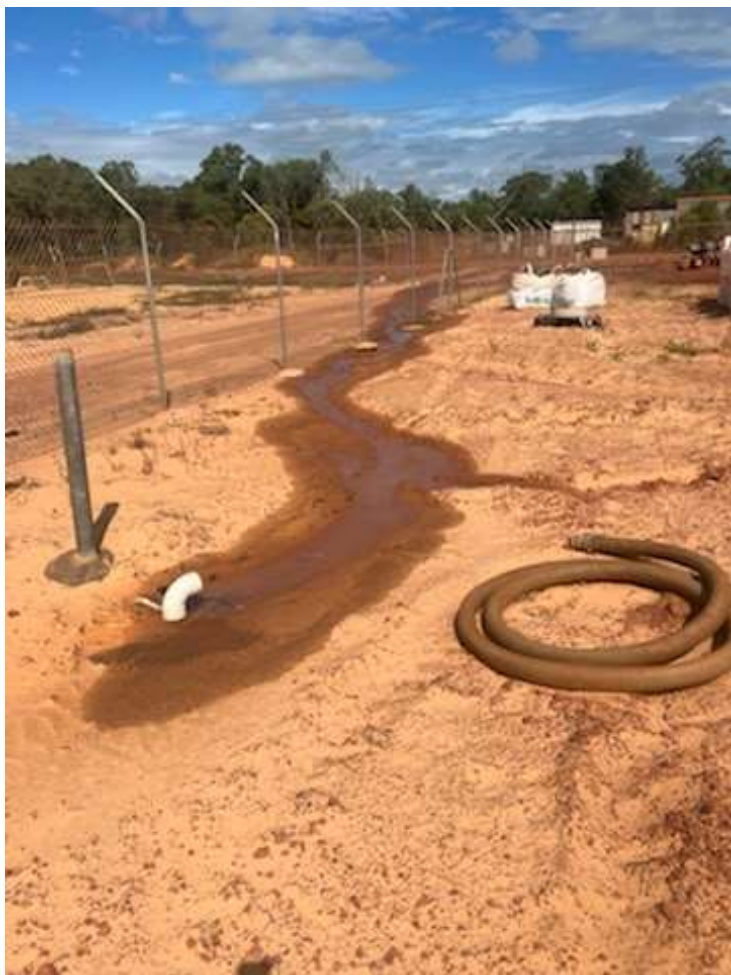
| | <p>transfer pumps that transfer fuel from the bulk tank to the day tank. The incorrect activation of the transfer pump led to the fuel spilling.</p> <p>Secondly, the fuel bund stormwater outlet valve has been left open which resulted in the diesel exiting the bund into the environment (Pic 1).</p> <p>Investigations are ongoing.</p> <p>iv. The reason why the discharge occurred.</p> <p>Unauthorised access to the fuel transfer pumps, along with the fuel bund stormwater valve in open position.</p> |

Pic 1: Fuel bund stormwater outlet

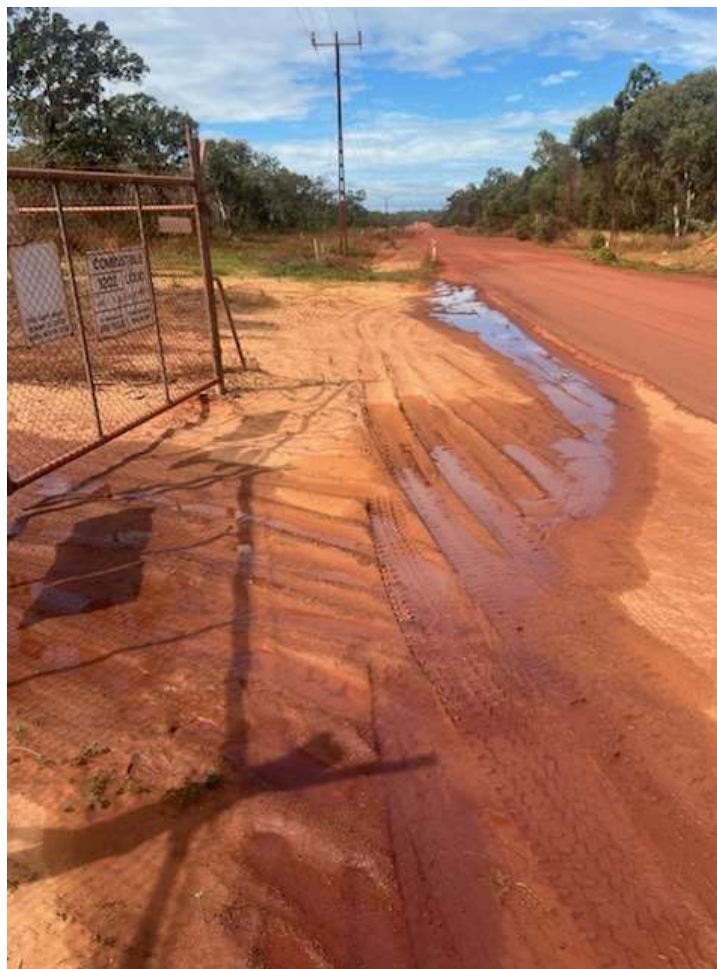
| <b>(b) the place where the incident occurred</b> | <p>i. Description of the PWC asset from which the discharge occurred.</p> <p>Fuel storage tanks within generator compound.</p> <p>ii. GPS coordinates of the discharge point from the PWC asset, and the final coordinates of the final discharge point.</p> <p>Discharge Point: 12.0302365 S, 135.5692669 E<br/>Final Discharge Point: 12.0307475 S, 135.5694465 E</p> <p>iii. Indicate any locations nearby to the discharge point where public can gain ready-access, such as public open spaces through which the discharge moves.</p> <p>Fuel spilled across site and into public roadside in front of power station compound (see attached photos).</p> |

Pic 2: Final discharge location along roadside

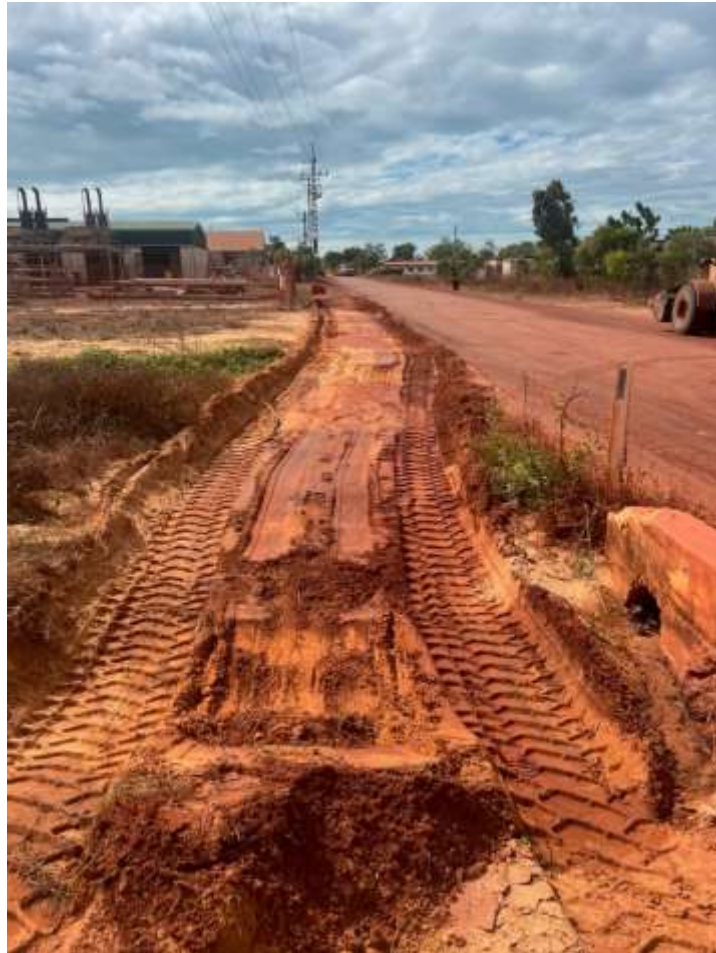
Pic 3: During clean-up along roadside

| <b>(e) the attempts made to prevent, reduce, control, rectify or clean up the pollution or resultant environmental harm caused or threatening to be caused by the incident</b> | <p><i>i. Confirmation signage and fencing has been erected, as appropriate.</i></p> <p>All visible contamination has been removed and site returned to safe condition.</p> <p><i>ii. Decontamination of the site as appropriate.</i></p> <p>As soon as ESO returned he was instructed to, isolate the pumps, close all the valves, and start removing the visually contaminated soil. All visually contaminated soil was removed that afternoon and stored on site on plastic sheeting (see attached photos). Further works are being undertaken to ensure the excavated contaminated material is contained, such as ensuring plastic sheeting is applied over the soil to protect from rain, and bulka bags will be sent to site which will be used for containing the soils once available.</p> <p>Environmental consultants (Ecoz) have also been engaged to undertake a site investigation and assist with remediation of the site as required.</p> |

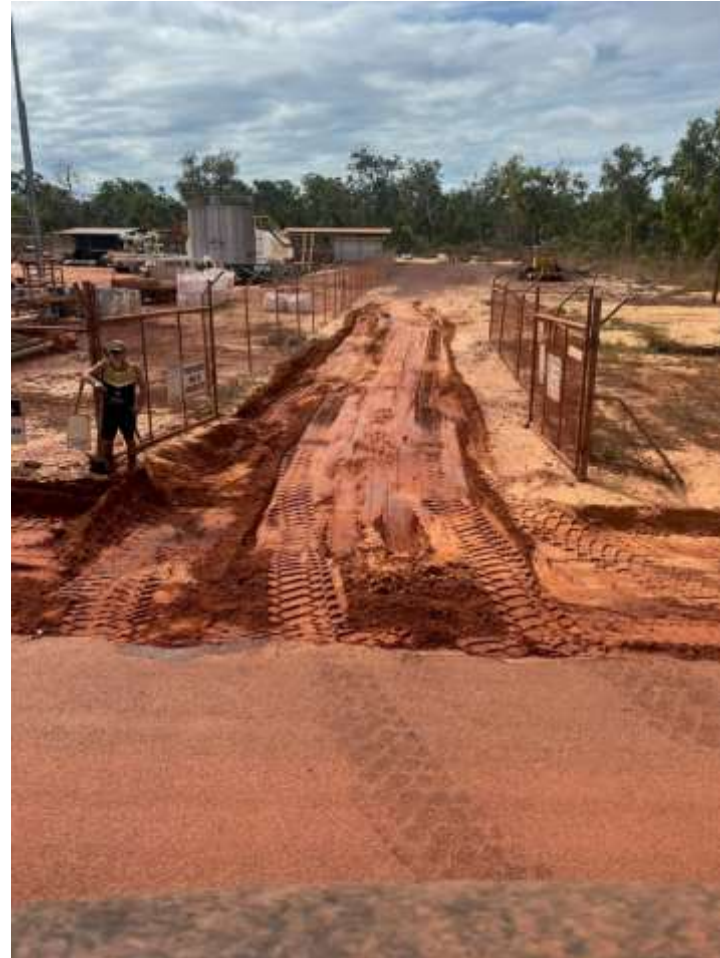
Pic 4: During clean-up from Power-station to roadside

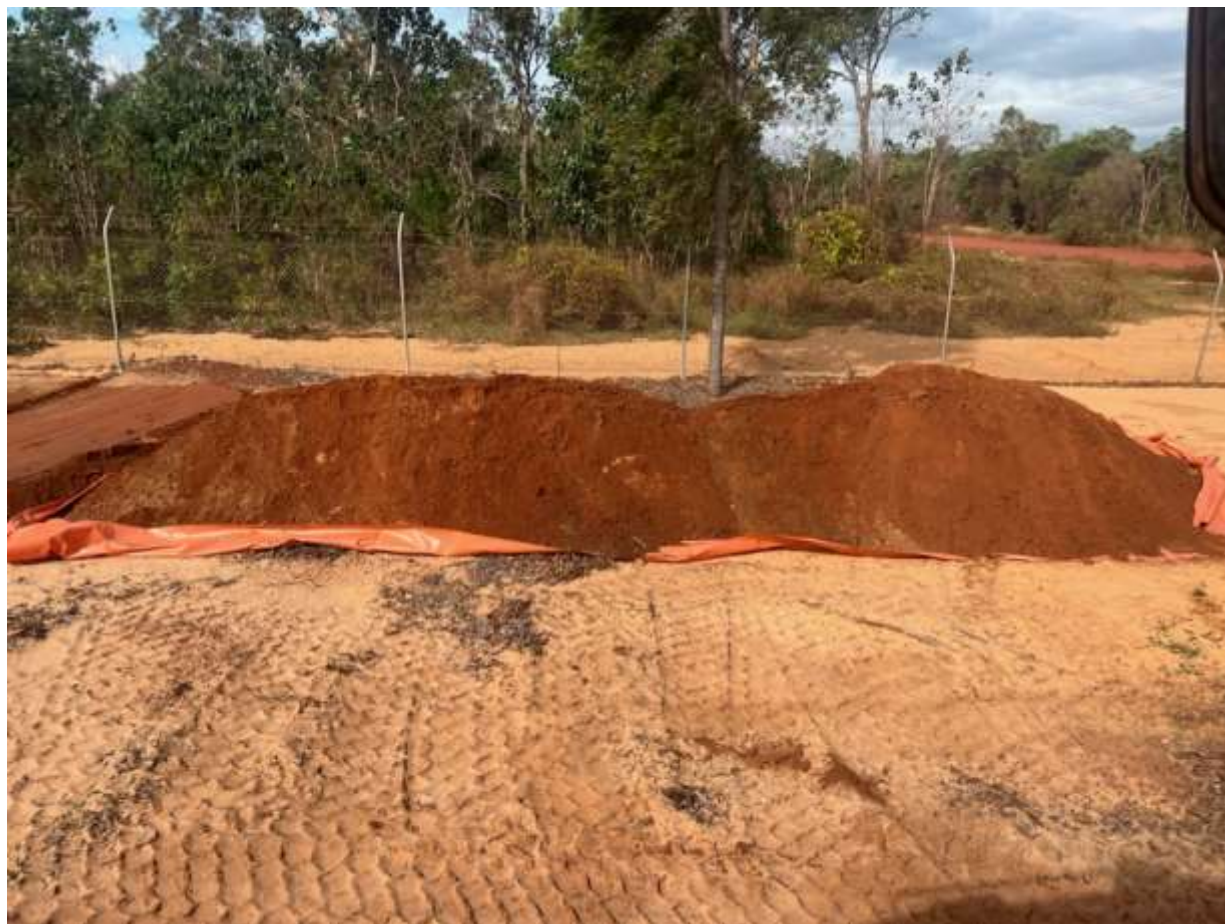
Pic 5: Immediate storage on plastic sheeting during clean-up works.
