## SECTION 14 INCIDENT REPORT (*Waste Management and Pollution Control Act*)

| <b>Incident:</b> | Discharge of diluted sewage from sewerage network, Sewage Pumping Station |

### Appendix A – Location Map (Bullocky Point SPS)

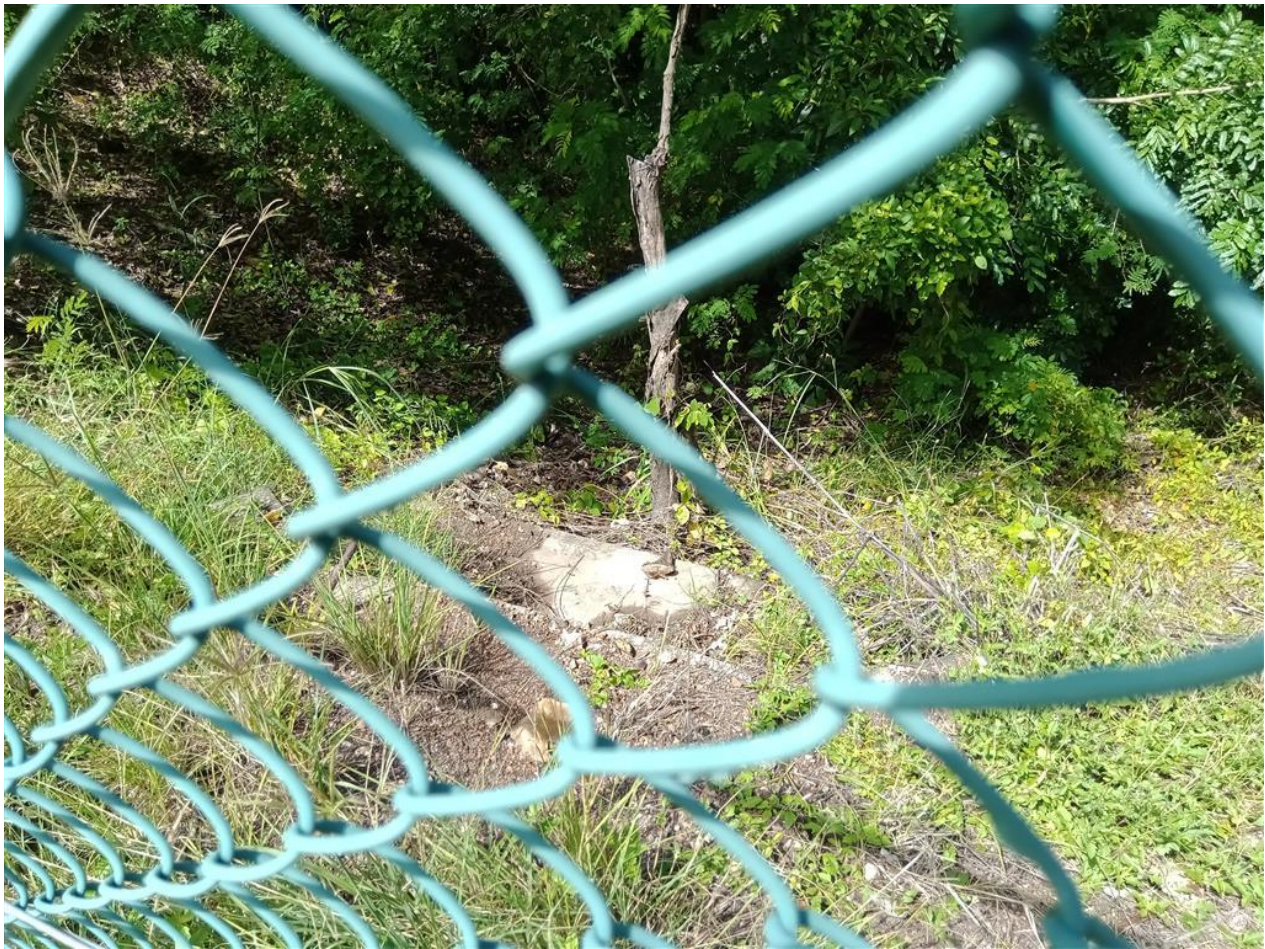
*Figure 1. Photo of the stormwater drain headwall, looking from within the compound, which is also the emergency overflow point.*

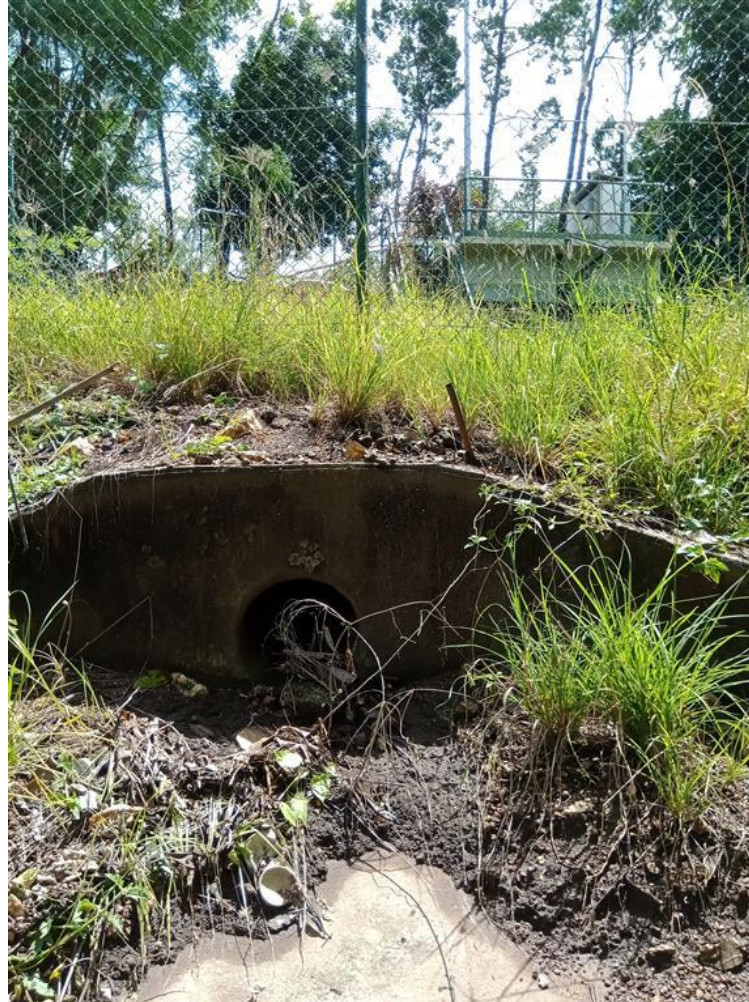
*Figure 2. Photo of the stormwater and emergency overflow point headwall, with the sewage pumping station in the background.*

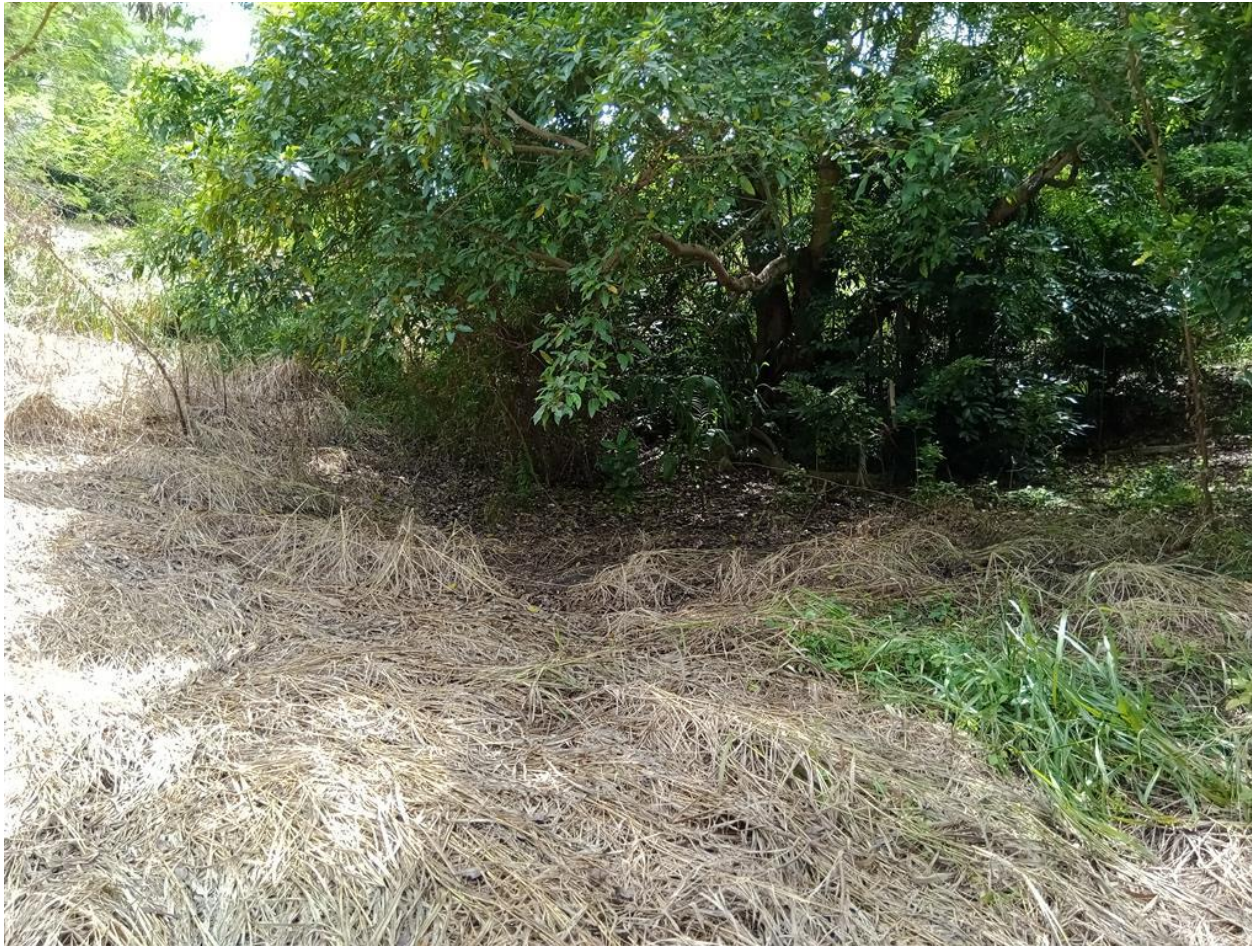
*Figure 3. Photo of the spill's flow path, looking up towards the SPS (behind the tree).*

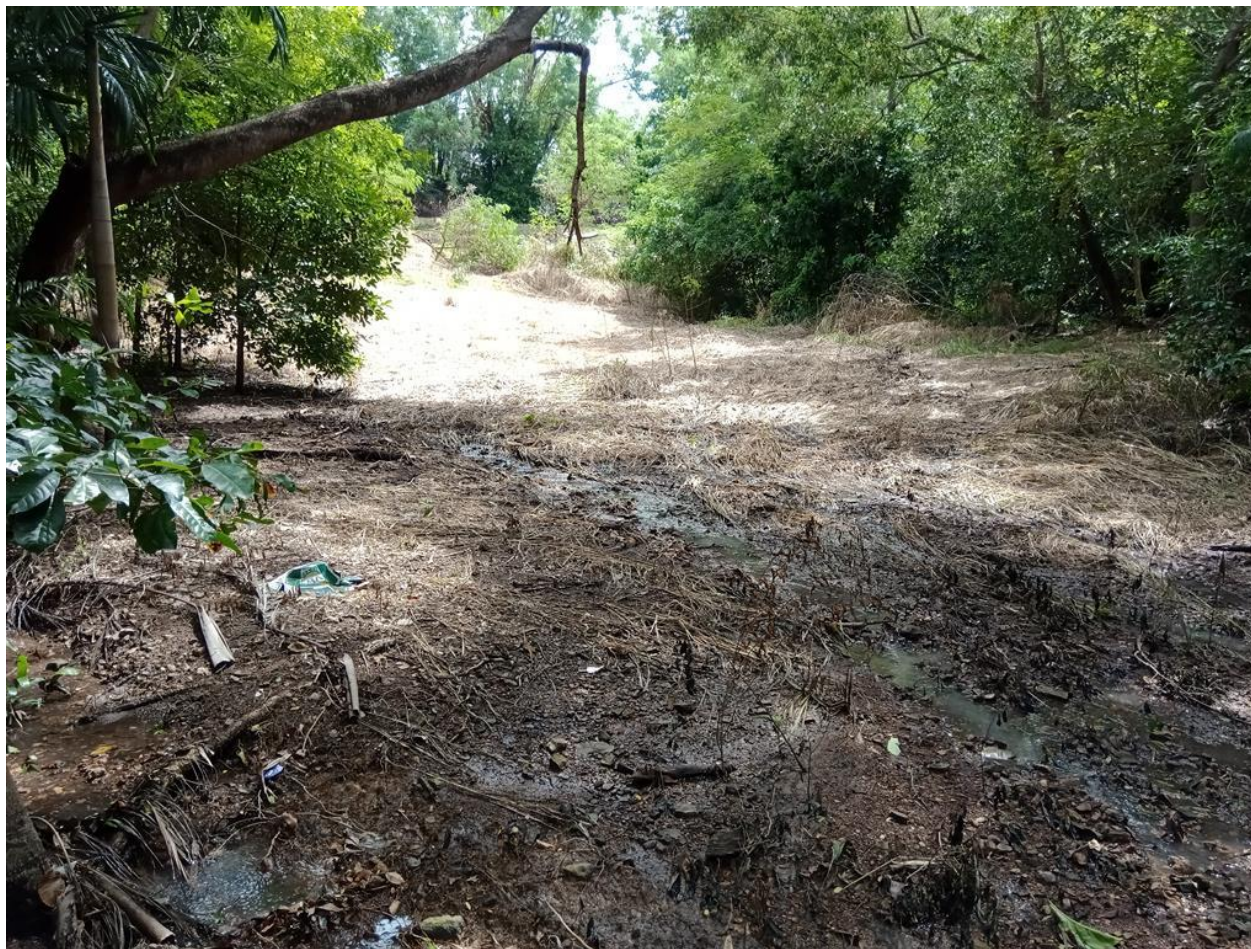
*Figure 4. Photo of the spill's flow path, looking downstream.*
