## SECTION 14 INCIDENT REPORT (*Waste Management and Pollution Control Act*)

| <b>Person / Company:</b> | GEMCO Mining Pty Ltd. |
| <b>Incident:</b> | <p>The Eastern Leases Project Area experienced a rain event on the afternoon of the 19<sup>th</sup> of October. As a result, the Emerald River Tributary Crossing (also known as CP1C2) had sediment-laden water flowing from the site down the ephemeral tributary. The sediment laden water extended off lease before stopping.</p> <p>By the time this issue was identified the water had started to recede with no follow up rainfall.</p> <p>The water did not connect to the perennial flows of the Emerald River.</p> <p>Refer Figure 1-4.</p> |

## NTEPA RFI 21/10/2022 | Incident: PRL11215 | Response: 24/10/2022

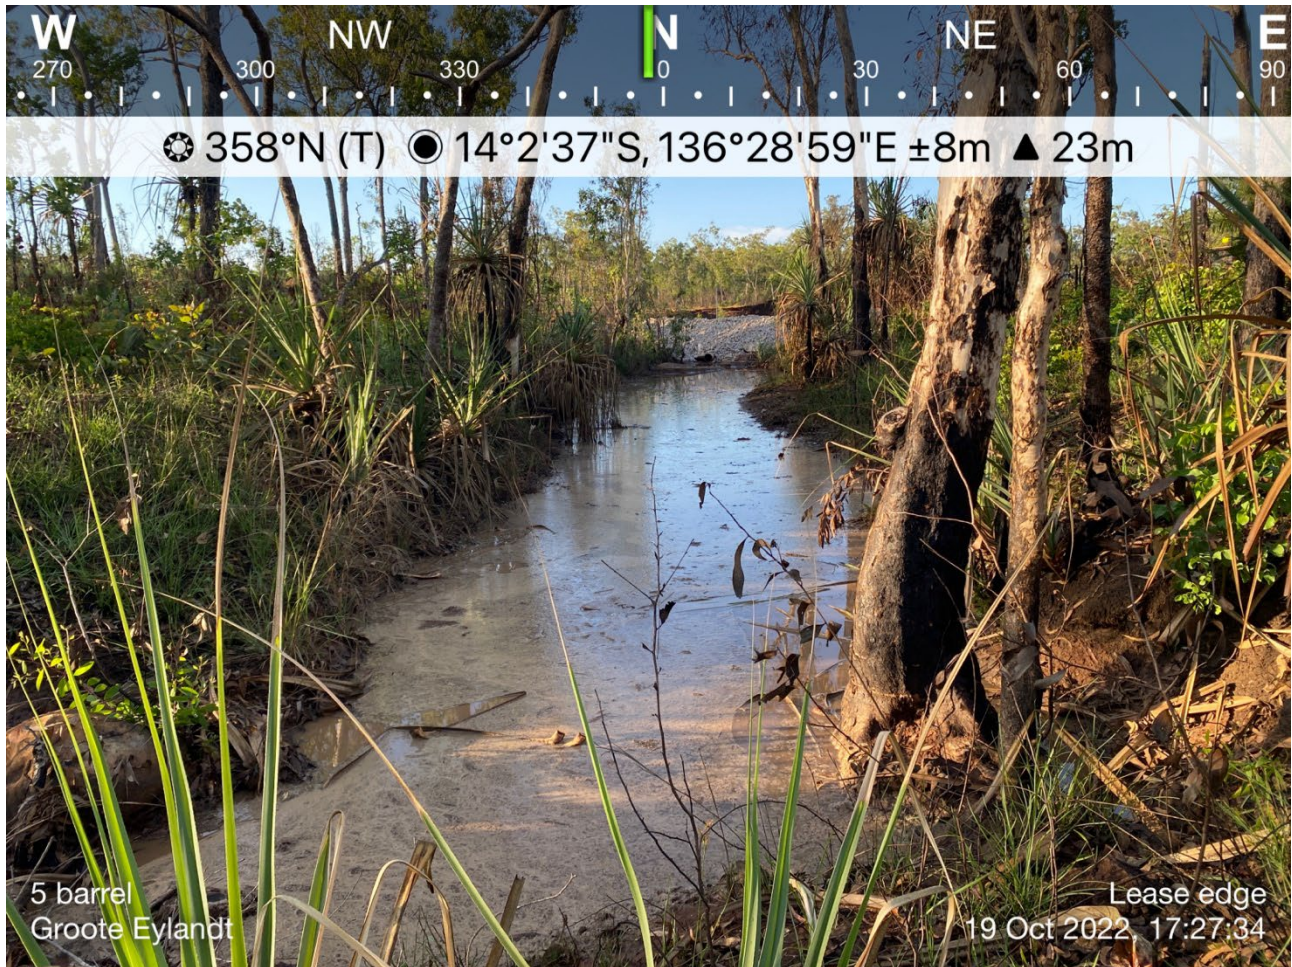
**Figure 2:** Sediment event in Emerald River Tributary 19 October 2022. Photograph taken from the approximate location of the lease boundary facing towards the construction area. The white rock visible in the tributary is a temporary crossing/culvert.

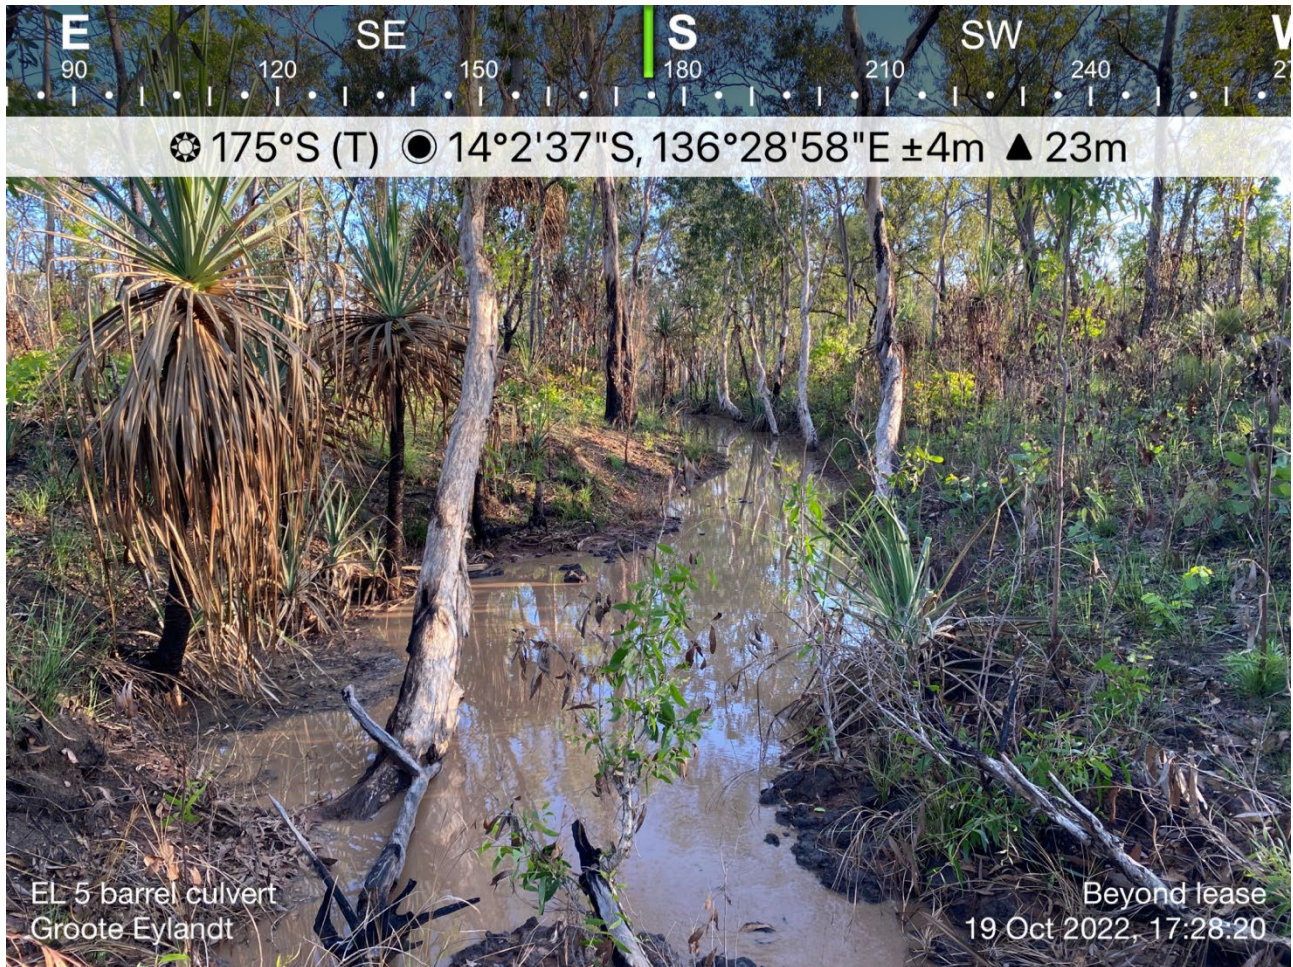
**Figure 3:** Sediment event in Emerald River Tributary 19 October 2022. Photograph taken from the approximate location of the lease boundary facing away from the construction

area.

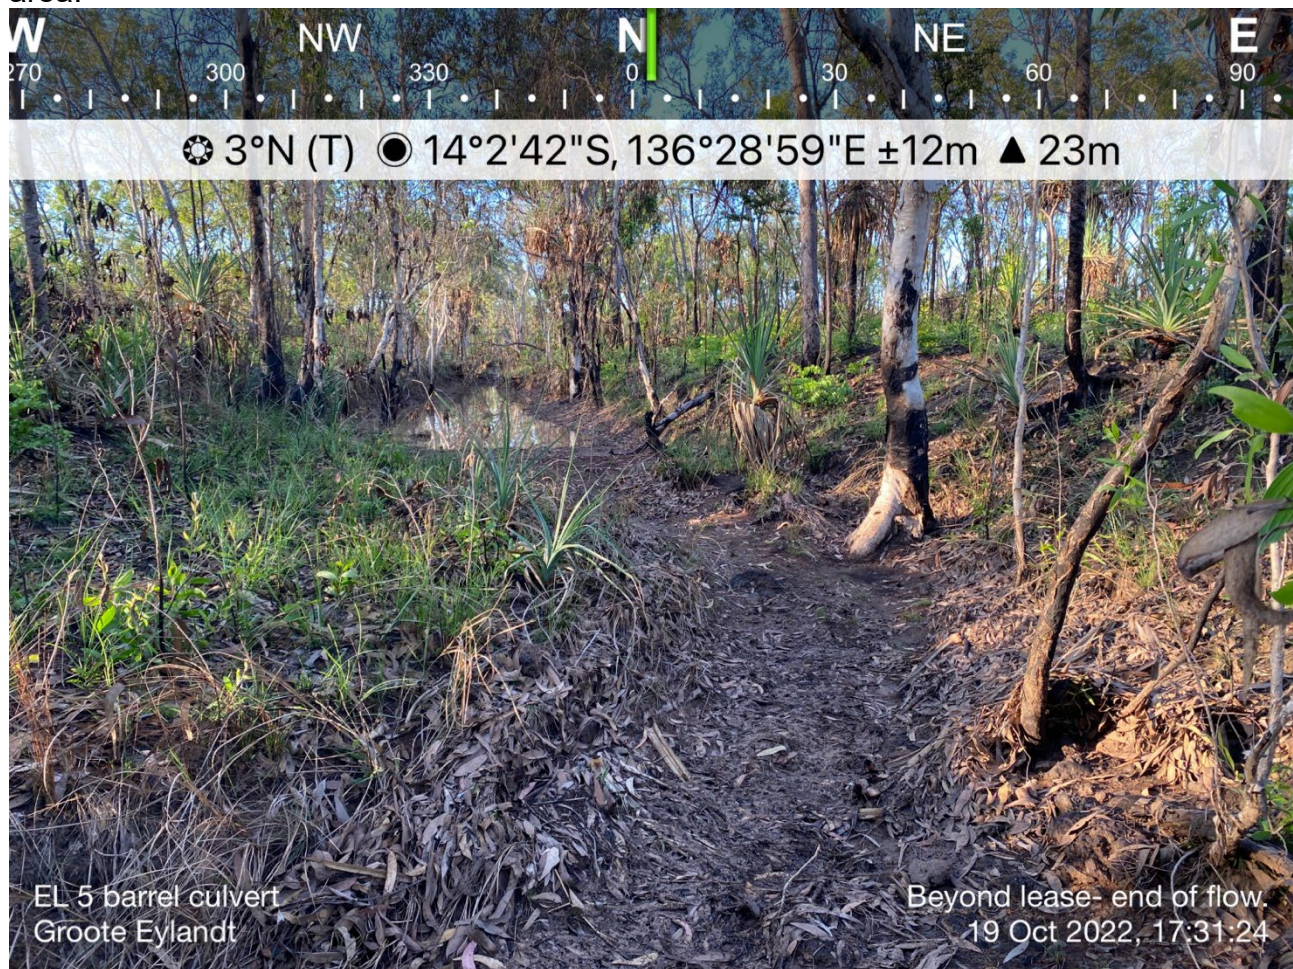
**Figure 4:** Sediment event in Emerald River Tributary 19 October 2022. Photograph taken from the end of flow. Approximately 150m from the edge of lease.

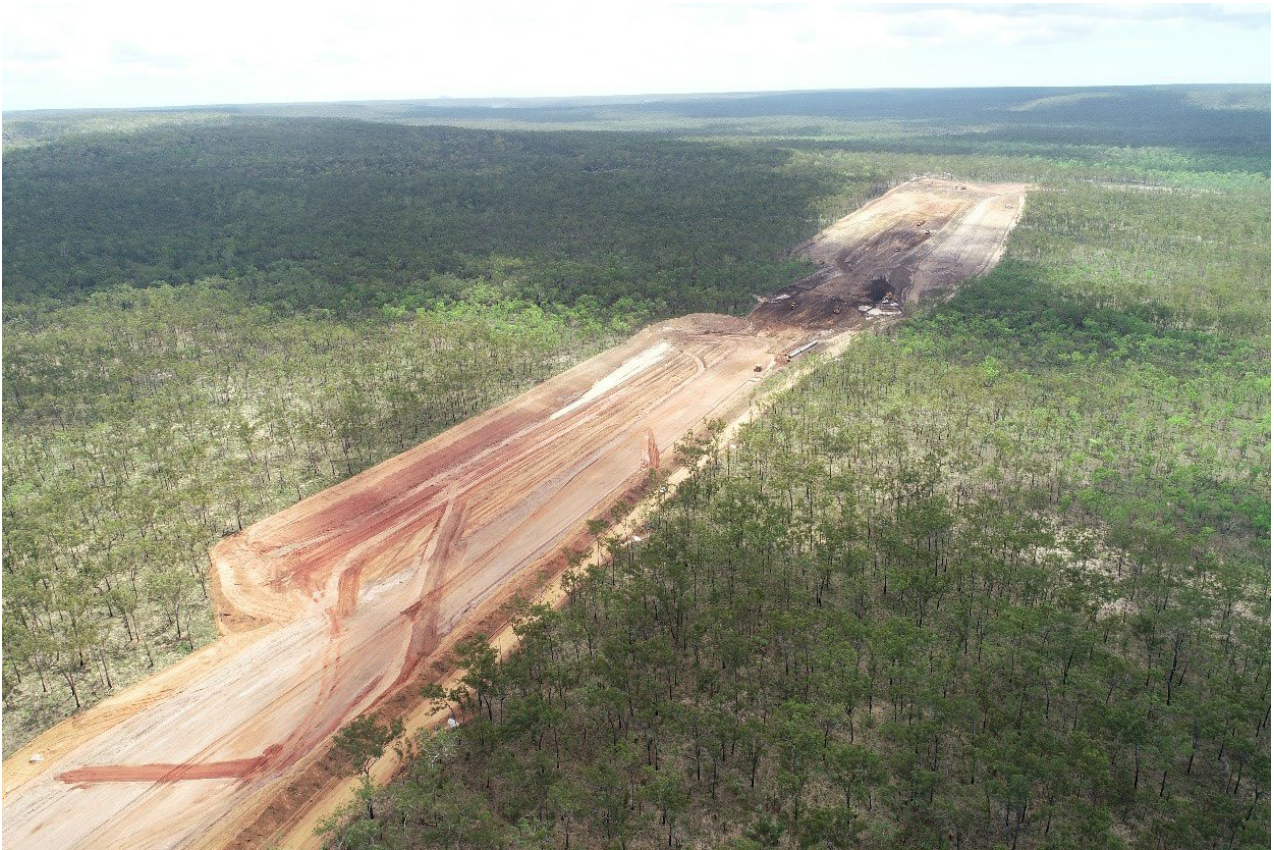
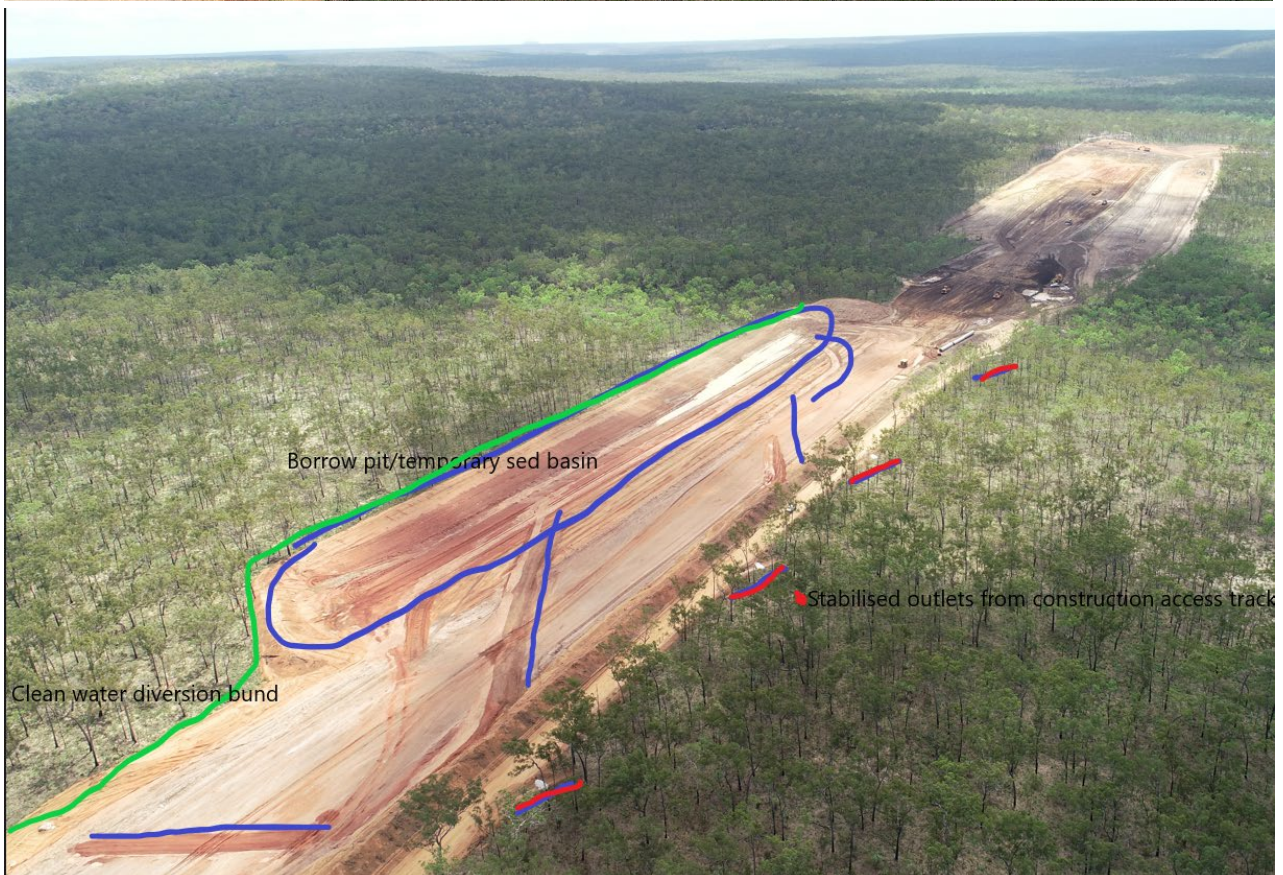
| NTEPA RFI | GEMCO RESPONSE |
|---|---|
| What were the ESC measures that failed in this instance?<br>Do you have any photos of the ESC measures that failed and what they were replaced with? If so please send through an amended s14 report with these additional photos attached. | The following temporary erosion and sediment controls were in place on the 19/10/22. <ul style="list-style-type: none"> <li>• All clean water diversion bunds were in place. Noting that they require final shaping.</li> <li>• Diversion bunds were installed on the westerly side of the catchment to divert all haul road stormwater into a borrow pit (Fig 5).</li> <li>• Stabilised outlets had been installed from the construction access track into the bush (Fig 5, Fig 6)</li> <li>• The temporary crossing is geofab-lined and clean filled to support filtration of stormwater captured by the haul road.</li> </ul> The catchment for CP1C2 is currently under construction and as such: <ul style="list-style-type: none"> <li>• There was an active scraper circuit on the eastern side of the catchment which prevented the installation of diversion bunds in this part of the catchment.</li> <li>• Both sides of the culvert are currently being built up to enable the construction of sediment ponds. Consequently, the area immediately adjacent to the waterway is open.</li> </ul> |

**Figure 5:** Temporary ESC at time of the event (facing east)

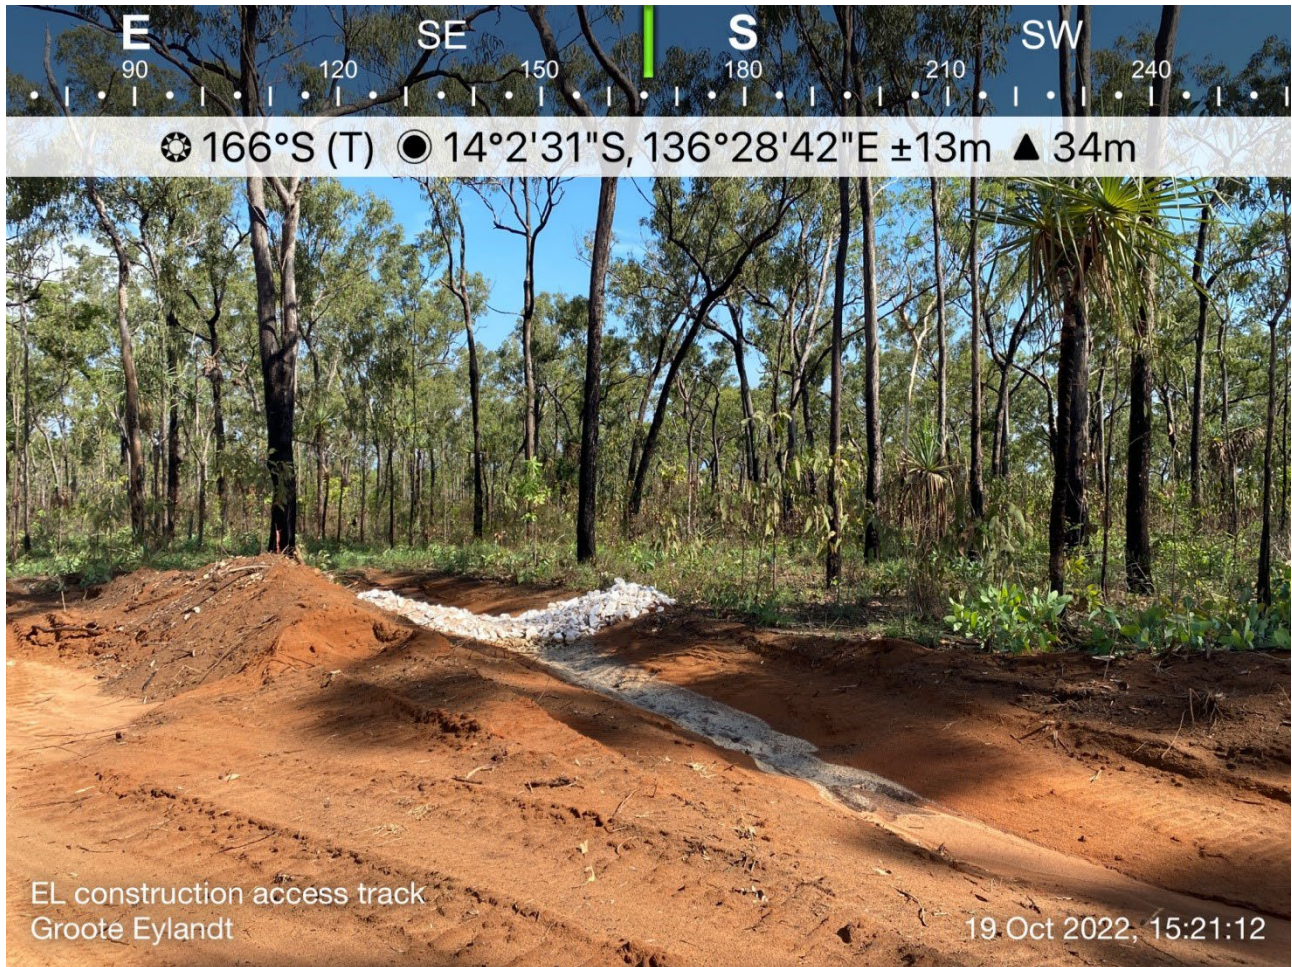
**Figure 6:** Temporary ESC at the time of the event: Stabilised outlets from the construction access track.
