## SECTION 14 INCIDENT REPORT (*Waste Management and Pollution Control Act*)

| <b>Incident:</b> | Spill of fully treated effluent |

| <b>(b) the place where the incident occurred</b> | <p><i>i. Description of the PWC asset from which the discharge occurred.</i></p> <p>Areyonga wastewater stabilisation ponds, irrigation field, Areyonga.</p> <p><i>ii. GPS coordinates of the discharge point from the PWC asset, and the final coordinates of the final discharge point.</i></p> <p>Discharge Point: 132.2648071 E, -24.0838911 S (irrigation field sprinkler)<br/>Final discharge point: 132.2644820 E, -24.0848079 S</p> <p><i>iii. Indicate any locations nearby to the discharge point where public can gain ready-access, such as public open spaces through which the discharge moves.</i></p> <p>Overflow is from the irrigation field, after the four treatment ponds, so the effluent is “fully” treated. The spill predominantly pooled within the irrigation field, with some effluent having run across the airstrip access road and into the adjacent bushland.</p> |

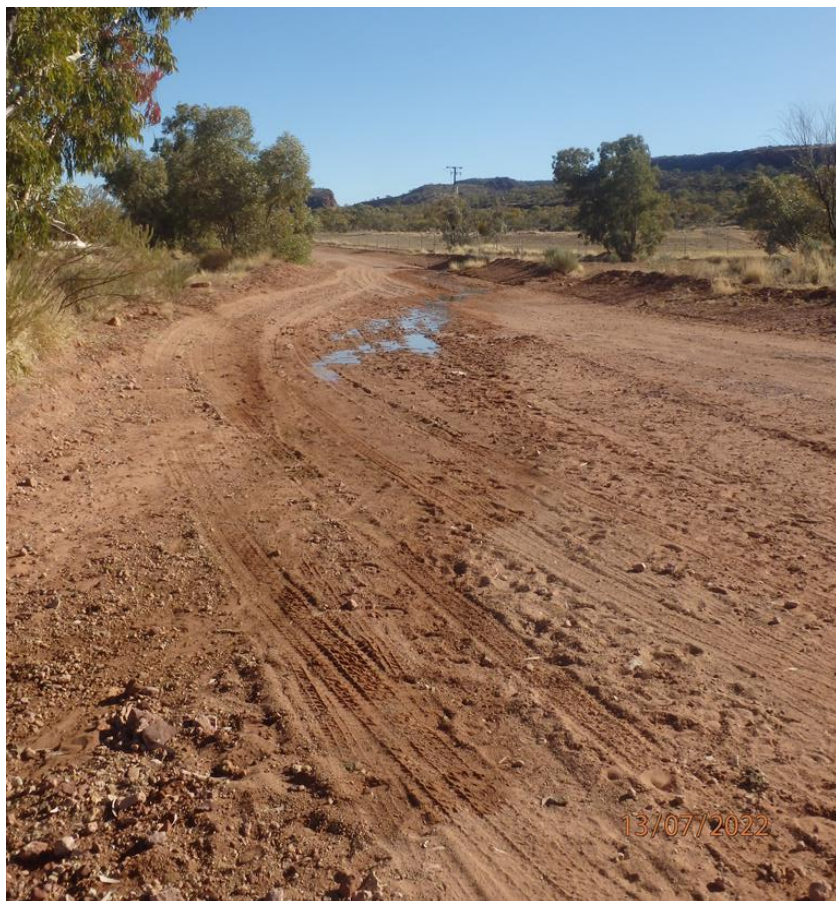
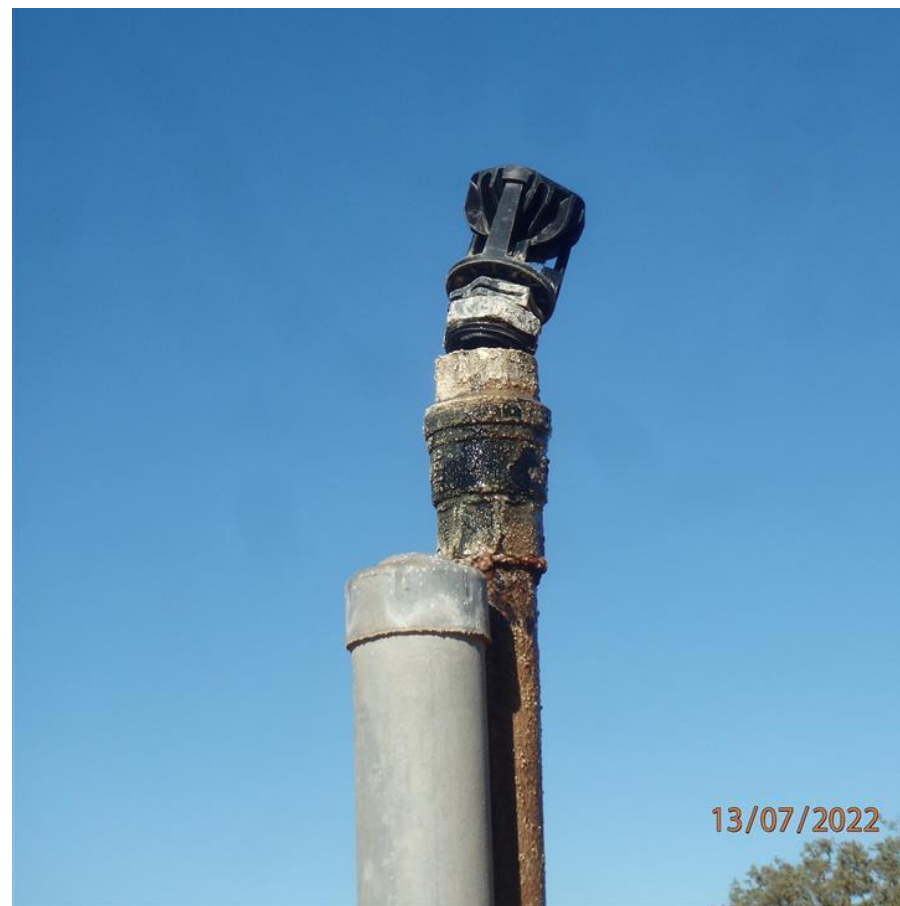
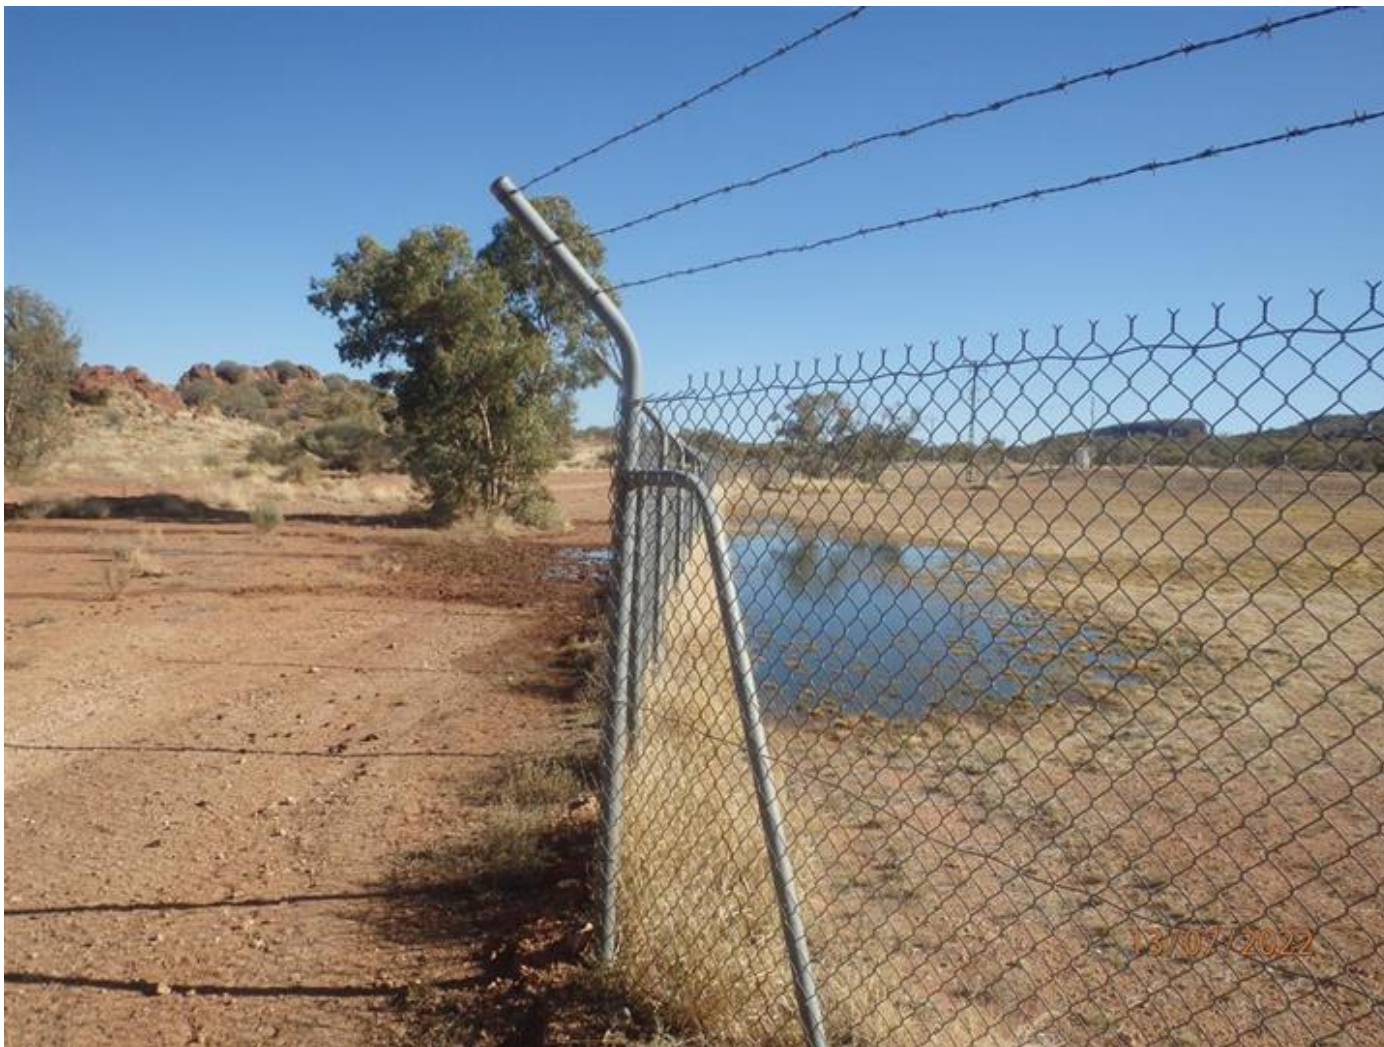
| | <p><i>ii. How PWC were notified, or became aware of the discharge.</i></p> <p>The Essential Services Operator (ESO) looking after the facility notified the Water and Sewage Technical Coordinator. Environmental Services became aware of the event from the Remote Services Acting Service Coordinator.</p> <p><i>iii. The process by which the discharge occurred.</i></p> <p>A polyethylene plastic threaded connector underneath the sprinkler head had broken allowing effluent to come directly out of the 20mm sprinkler riser pipe, without resistance from the sprinkler head. Because of this the effluent was not dispersed evenly across the irrigation field, but rather focused in one area.</p> <p><i>iv. The reason why the discharge occurred.</i></p> <p>The plastic threaded connector failed under pressure due to becoming brittle from age, and potentially deterioration from sun exposure.</p> |

Appendix B – Photograph of the spill area and damaged sprinkler.

| <b>(c) the date and time of the incident</b> | <p><i>i. The time and date of commencement and cessation of the discharge.</i></p> <p>The exact start time is unknown but it was sometime on the morning of the 12<sup>th</sup> July 2022. The sprinkler was repaired by mid-morning of the 13<sup>th</sup> July 2022. The sprinkler was only operational during the pre-set irrigation times.</p> |

| <b>(e) the attempts made to prevent, reduce, control, rectify or clean up the pollution or resultant environmental harm caused or threatening to be caused by the incident</b> | <p><i>i. Confirmation signage and fencing has been erected, as appropriate.</i></p> <p>Fencing not appropriate in this instance, as the only place where direct contact is possible is on a roadway. As the road is a considerable distance from the community, it is not envisaged for pedestrians to be in this location, only minimal vehicle traffic. The effluent is expected to dry up imminently, given that the sprinkler has been repaired and effluent is now evenly dispersed over a greater area. As such, no signage has been erected.</p> <p><i>ii. Decontamination of the site as appropriate.</i></p> <p>Overflow is fully treated effluent that has passed through 3 treatment ponds, sewage debris is not present. Natural processes (UV disinfection) will provide disinfection of the discharge.</p> |
