## SECTION 14 INCIDENT REPORT (*Waste Management and Pollution Control Act*)

| Person / Company: | GEMCO Mining Pty Ltd. |
| Incident: | The Eastern Leases Project Area experienced rain events on Thursday 24 <sup>th</sup> November through to and including Monday the 28 <sup>th</sup> of November. This resulted in water containing suspended sediment to run into the tributary of the Emerald River and the main Emerald River channel (Refer Figure 1,2,4). |

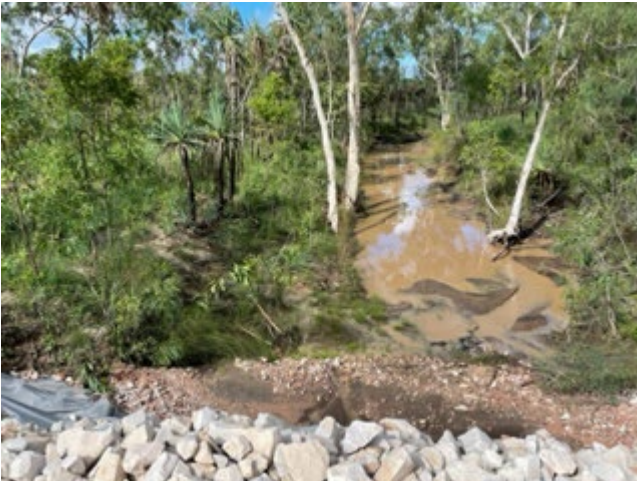
**Figure 2A:** Arch Bridge over Emerald River.

Sediment event in Emerald River main channel. 9AM Saturday 26th November 2022 after a 46mm rain event on the 25th of November. Photograph taken facing west (downstream) from the temporary crossing.

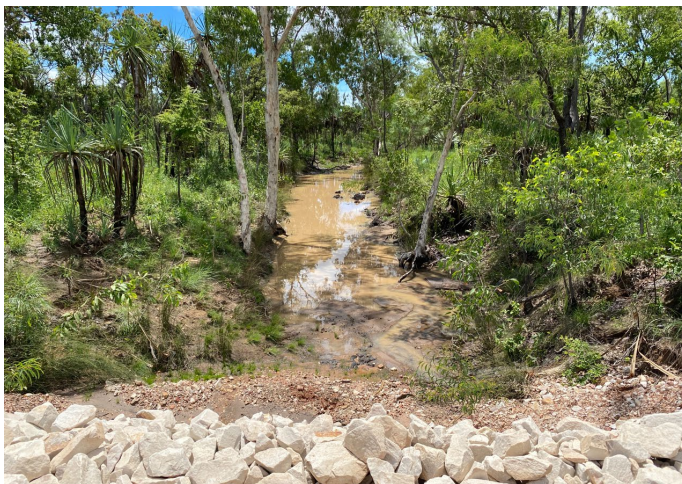
**Figure 3B:** Arch Bridge over Emerald River.

Sediment event in Emerald River main channel. 29th November 2022 after 65mm on the 28<sup>th</sup> of November. Photograph taken facing west (downstream) from the temporary crossing.

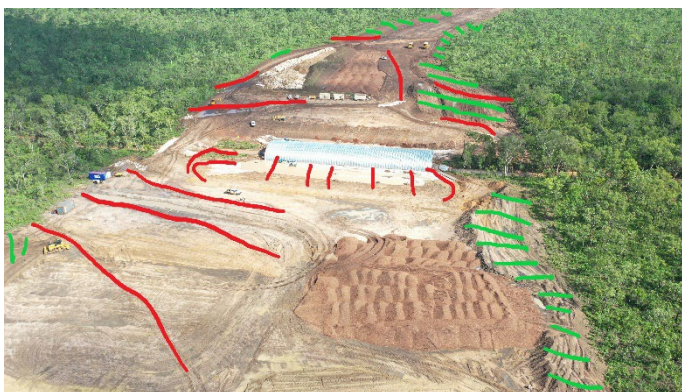
**Figure 3:** Arch Bridge over Emerald River.

Selected temporary controls in place at the time of all rainfall events.

Photograph taken facing north. Flow runs right to left across frame.

Also visible are: clean water diversion bunds (to final design), coir rolls, rock checks, contours on roads to slow velocity and reduce catchment size.

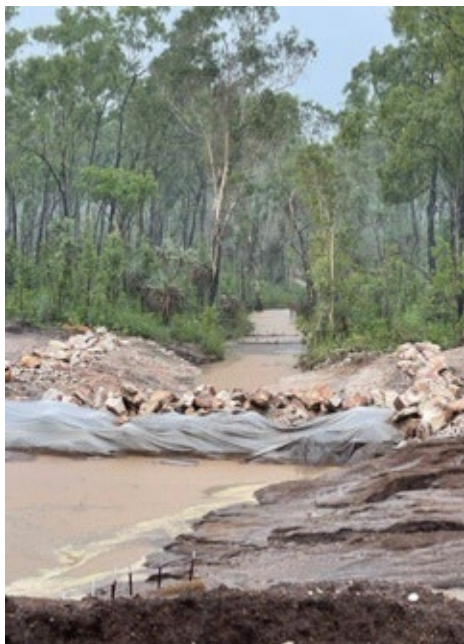
**Figure 4A:** 6 Barrell Culvert (CP1C2)

Sediment event in Emerald River Tributary (CP1C2). 25th November 2022, 1PM (46mm). Photograph taken facing south (downstream) from the culvert crossing. Visible in the photo is a geofab rock check.

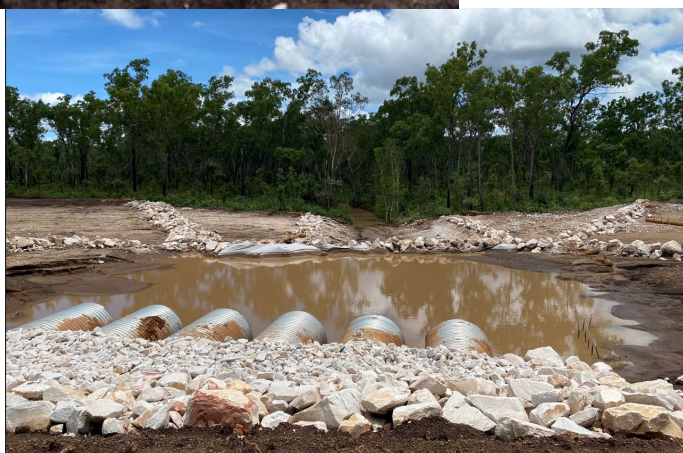
**Figure 4B:** 6 Barrell Culvert (CP1C2)

Sediment event in Emerald River Tributary (CP1C2). 29th November 2022 (65mm). Photograph taken facing south (downstream) from the culvert crossing. Visible in the photo is a geofab rock check.

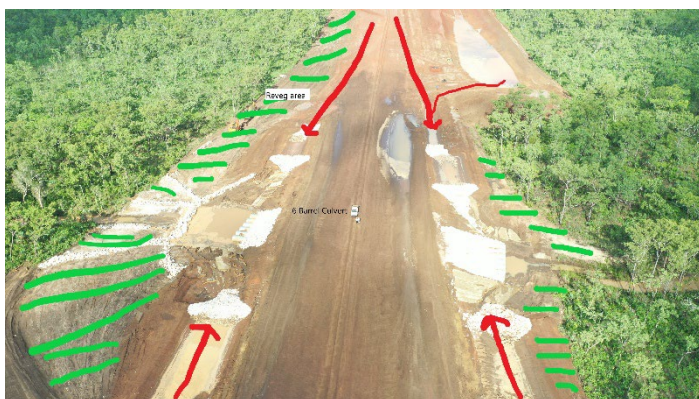
**Figure 5:** 6 Barrell Culvert (CP1C2)

Selected final and temporary controls in place at the time of all rainfall events. Photograph is taken facing west. Flow runs right to left across the photo.

Also visible are: clean water diversion bunds (to final design), coir rolls, floc block, jute matting to stabilise sediment basin outflow, sediment basins (to final design), contours on roads to slow velocity and reduce catchment size.
