## SECTION 14 INCIDENT REPORT (*Waste Management and Pollution Control Act*)

| <b>Person / Company:</b> | Power and Water Corporation ( <b>PWC</b> ) |
| <b>Incident:</b> | Discharge of sewage from sewerage network, Yuelamu Sewage Pumping Station No. 1 |

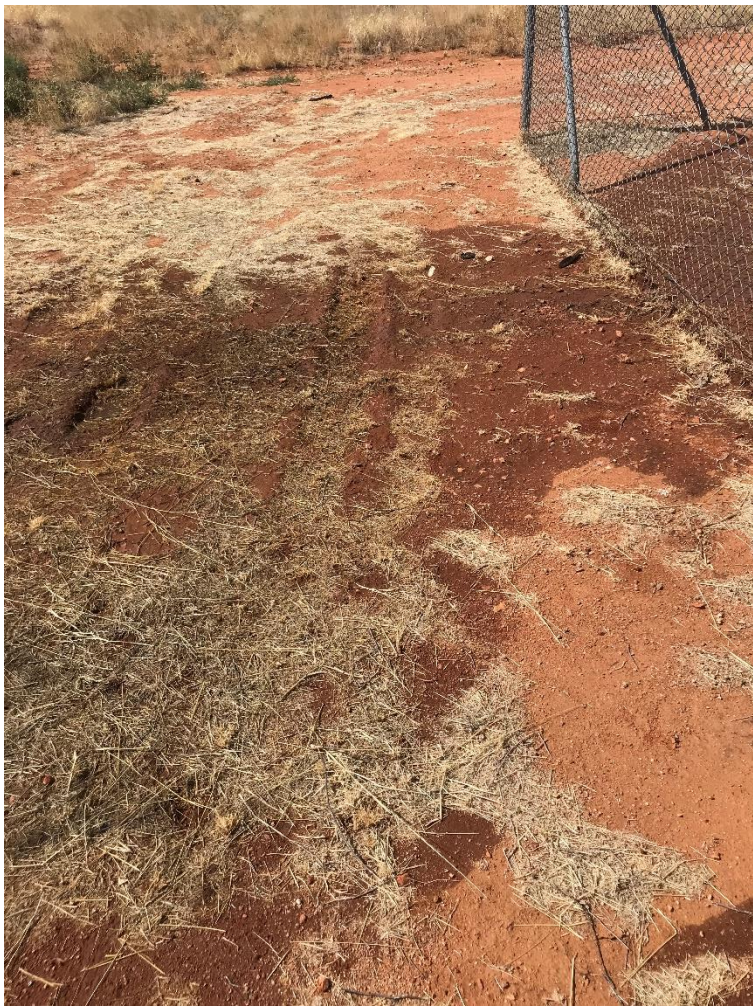
Appendix B – Photograph of the spill

| <b>(a) the incident causing or threatening to cause pollution</b> | <p><i>i. Description of the waste that was discharged.</i></p> <p>Raw sewage (no gross pollutants)</p> <p><i>ii. Indicative wastewater quality for the discharge.</i></p> <p>No representative wastewater quality data available for this community.</p> <p><i>iii. Volume of the waste that was discharged.</i></p> <p>The volume of wastewater discharged is unknown. No telemetric monitoring occurs at the site of discharge. It was estimated though to have been around 500 litres.</p> |
| <b>(c) the date and time of the incident</b> | <p><i>i. The time and date of commencement and cessation of the discharge.</i></p> <p>The sewage pumping station overflow began at an unknown time before 09:30hrs on 31/07/2022 when the spill was first noticed, and ceased at 10:30hrs 31/07/2022.</p> |

| <b>(e) the attempts made to prevent, reduce, control, rectify or clean up the pollution or resultant environmental harm caused or threatening to be caused by the incident</b> | <p><i>i. Confirmation signage and fencing has been erected, as appropriate.</i></p> <p>No signage or fencing was erected in this instance, as the spill occurred in an area not typically accessed by members of the public.</p> <p><i>ii. Decontamination of the site as appropriate.</i></p> <p>Clean up consistent with Sewage Spills/Overflow Response Work Instruction as appropriate to the location, and to minimise risk to the Environment. Site was inspected for any wastewater gross pollutants, of which none were observed. In the absence of lime, sodium hypochlorite was applied to the spill area as a means of disinfection.</p> |
