## SECTION 14 INCIDENT REPORT (*Waste Management and Pollution Control Act*)

| <b>Date and Time of Notification:</b> | Monday 3 <sup>rd</sup> October 2022, 15:30hrs |
| <b>Person / Company:</b> | Power and Water Corporation ( <b>PWC</b> ) |
| <b>Incident:</b> | Discharge of sewage from sewerage network (no gross pollutants) |

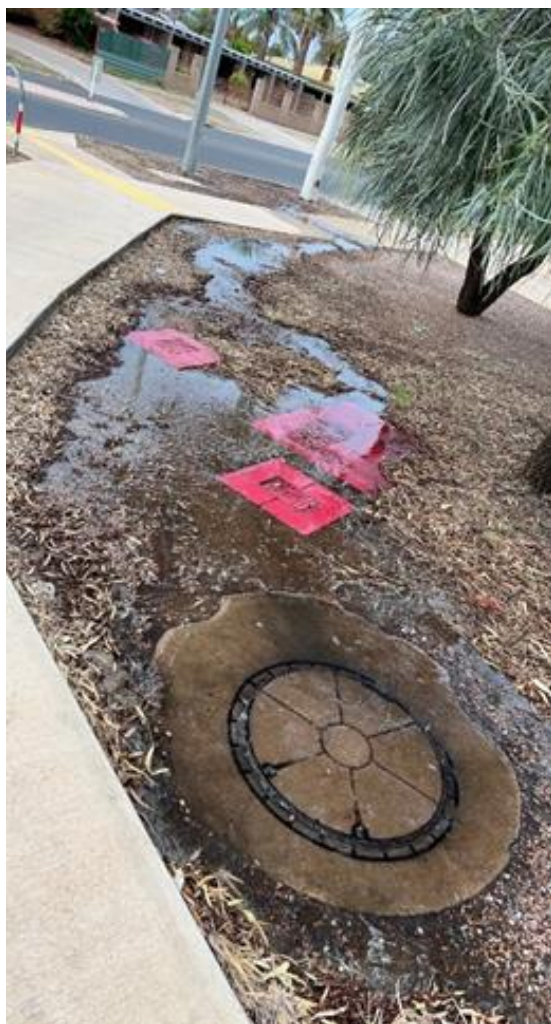
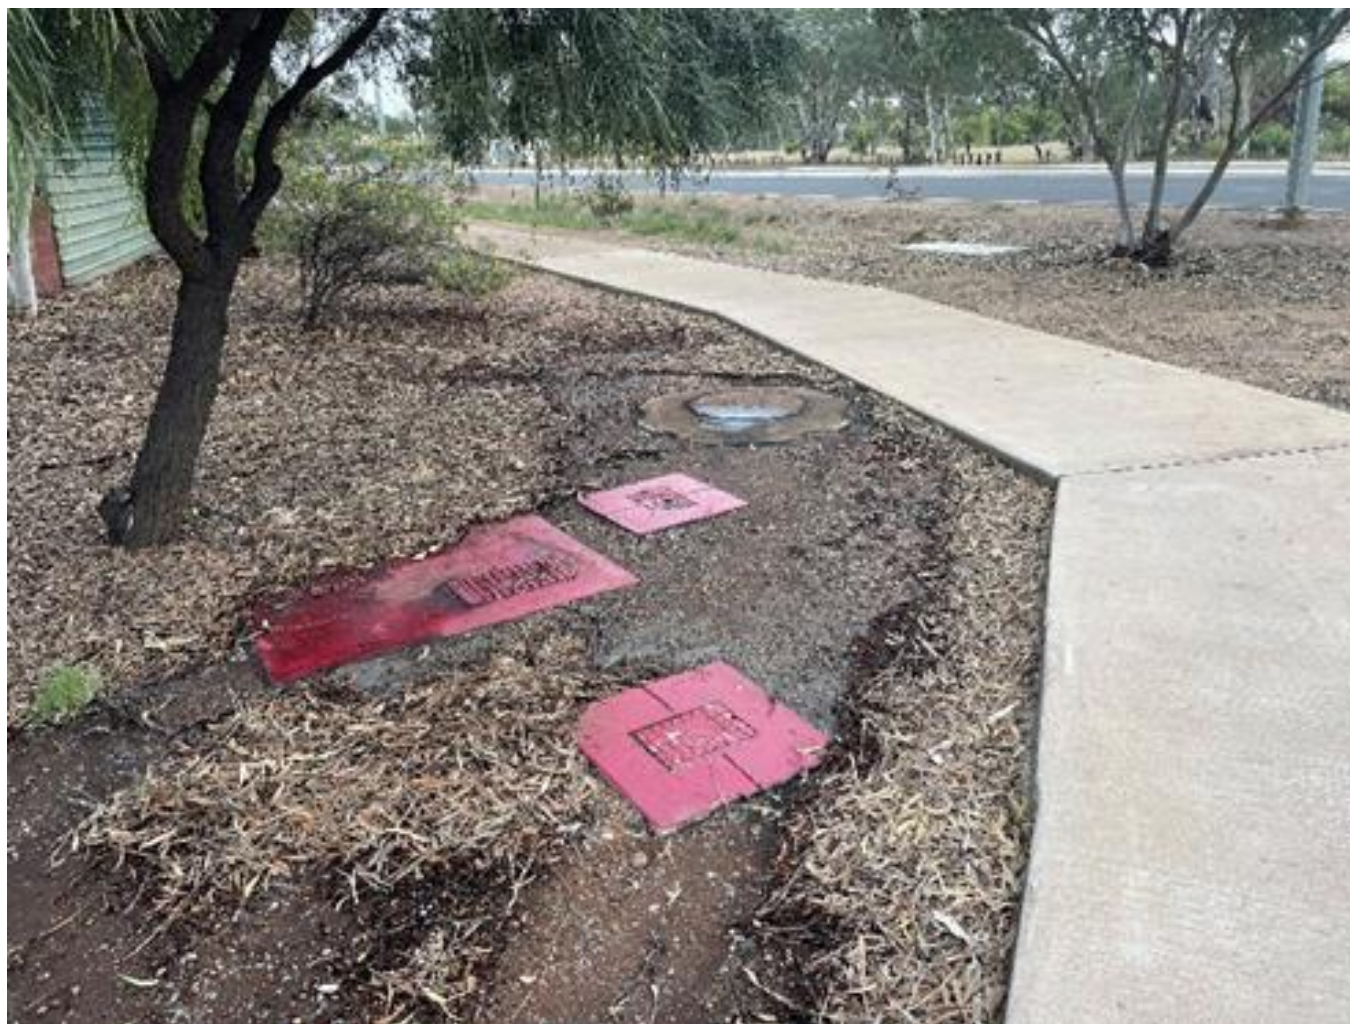
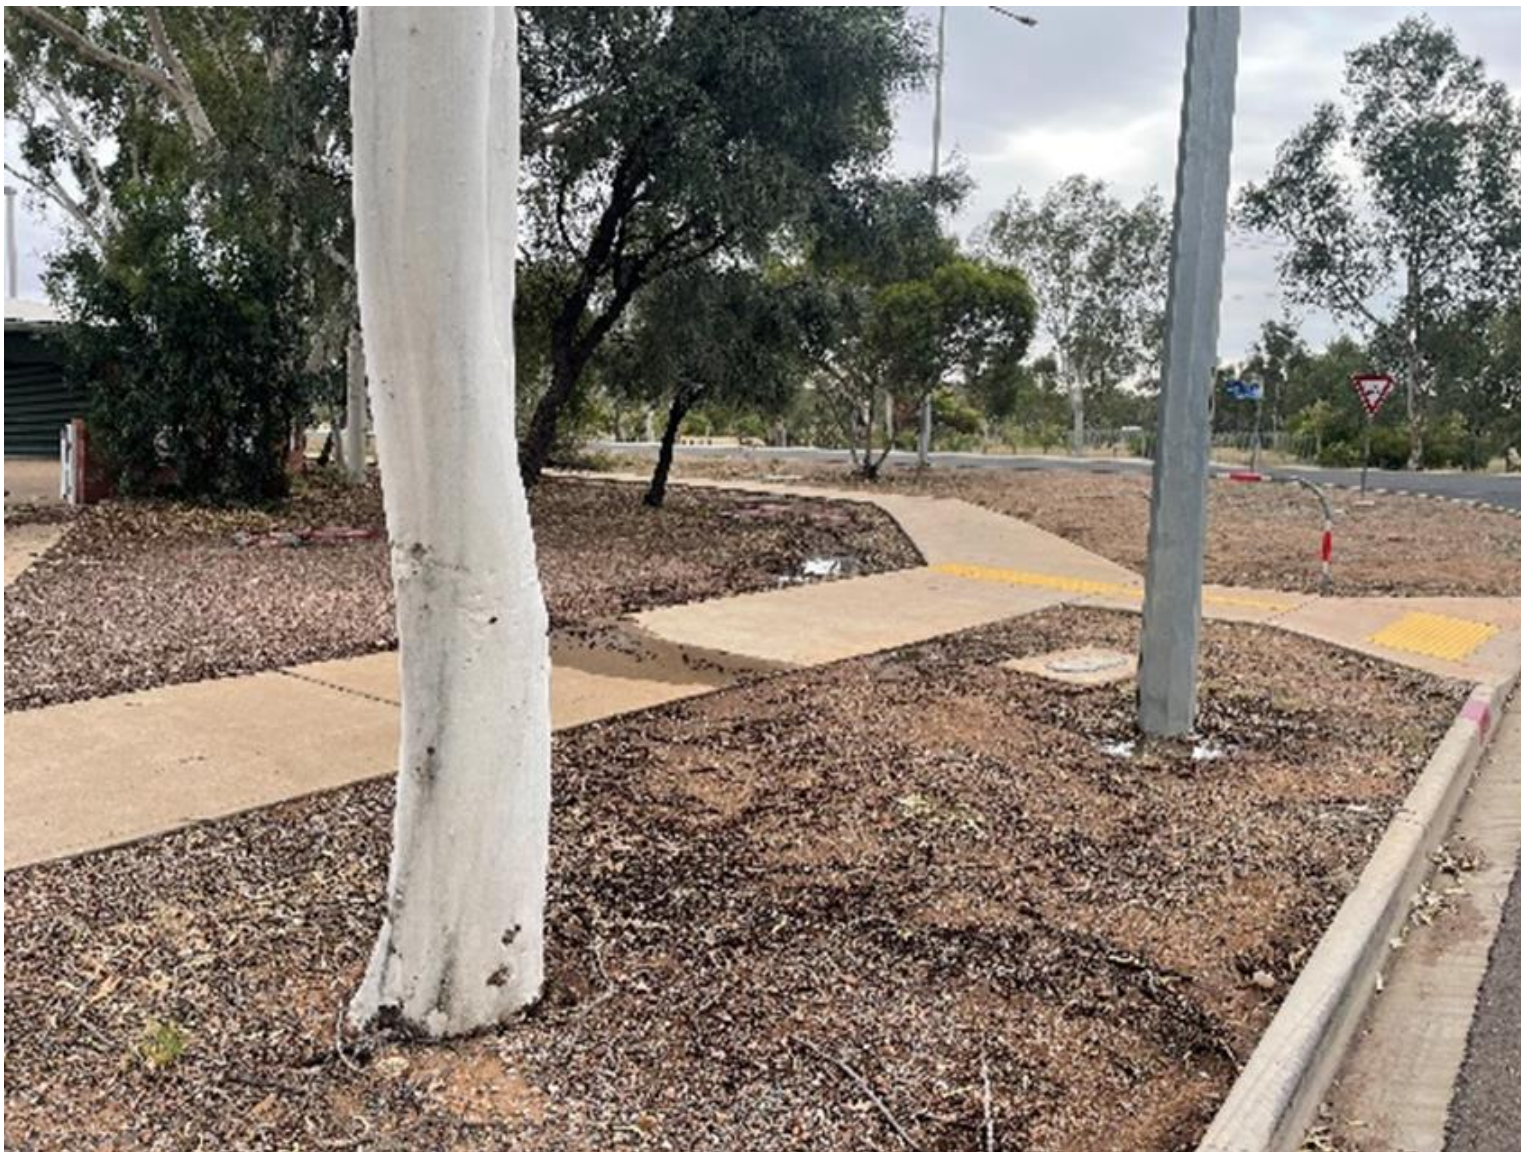
| <b>(c) the date and time of the incident</b> | <p><i>i. The time and date of commencement and cessation of the discharge.</i></p> <p>The commencement time of the spill is approximately 06:50hrs 03/10/2022. A PWC sewer reticulation field crew attended the site at 07:01hrs and the blockage was resolved by 08:44hrs 03/10/2022.</p> <p><i>ii. How PWC were notified, or became aware of the discharge.</i></p> <p>The spill was initially reported by a local resident who advised PWC of the spill.</p> <p><i>iii. The process by which the discharge occurred.</i></p> <p>A blockage of the DN150 sewer main, which was as a result of foreign objects being discarded into the sewer system impeded the flow, resulted in raw sewage overflowing from the manhole.</p> <p><i>iv. The reason why the discharge occurred.</i></p> <p>As per (c) iii. A combination of foreign objects being incorrectly disposed of into the sewer system and tree roots penetrating the sewage pipework impeding normal flows resulted in a blockage of the sewer main.</p> |

Appendix B – Photographs of the discharge point (manhole) and immediate surrounds.

| <b>(e) the attempts made to prevent, reduce, control, rectify or clean up the pollution or resultant environmental harm caused or threatening to be caused by the incident</b> | <p>The clean-up was undertaken as per Sewage Spills/Overflow Response Work Instruction. Affected areas such as the footpath was disinfected and pressure washed.</p> <p><i>i. Confirmation signage and fencing has been erected, as appropriate.</i></p> <p>During the entire time of the repair and clean up, PWC and/or contractors were on site to warn passers-by of the sewage spill, until such time that the area was safe.</p> <p>Upon resolution of the blockage, the area was cleaned comprehensively to ensure the area was safe for the public to access immediately.</p> <p><i>ii. Decontamination of the site as appropriate.</i></p> <p>Clean up consistent with Sewage Spills/Overflow Response Work Instruction as appropriate to the location, and to minimise risk to the environment.</p> |
