## SECTION 14 INCIDENT REPORT (*Waste Management and Pollution Control Act*)

| Incident: | Discharge of sewage from sewerage network (manhole cover) |

## Appendix A – Location map

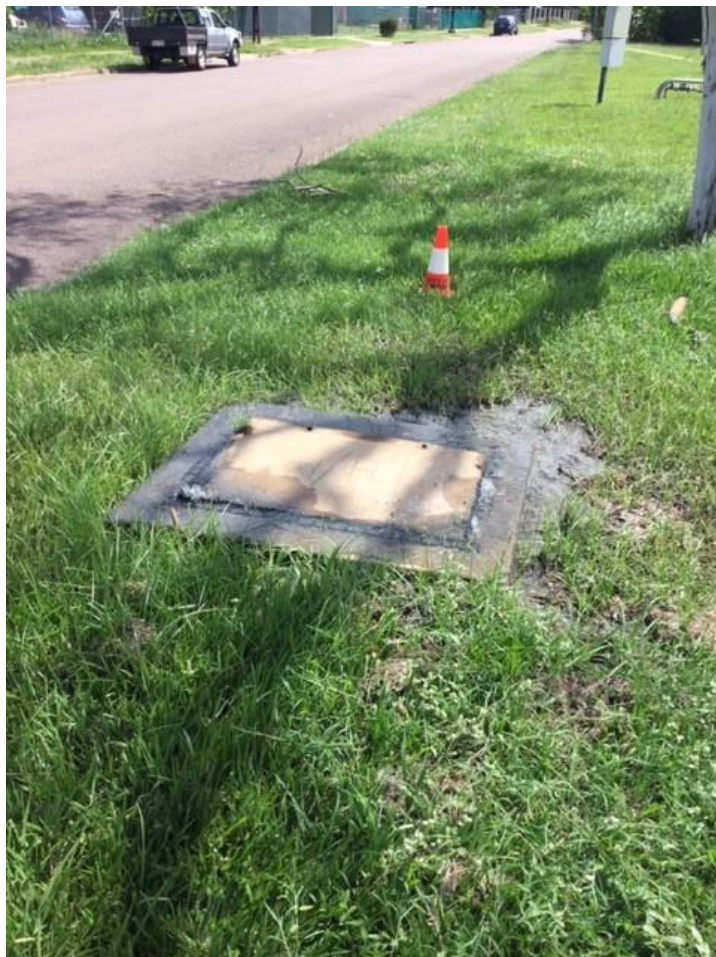
Historical image

Appendix B – Photograph of the spill site, clean-up crew in action and erected fencing and signage post clean up.

| <b>rectify or clean up the pollution or resultant environmental harm caused or threatening to be caused by the incident</b> | <p>Fencing and signage was erected once the blockage in the sewer main was cleared, and the area was cleaned up by vacuum truck.</p> <p><i>ii. Decontamination of the site as appropriate.</i></p> <p>Clean up consistent with Sewage Spills/Overflow Response Work Instruction as appropriate to the location, and to minimise risk to the Environment. Blockage was cleared and upon resolution of the blockage, the site was left in a clean state, free from any gross pollutants and the surrounding surface was cleaned and disinfected.</p> |
