## SECTION 14 INCIDENT REPORT (*Waste Management and Pollution Control Act*)

| Incident: | Discharge of diluted sewage from sewerage network via Overflow Relief Gully (ORG) during monsoon event. |

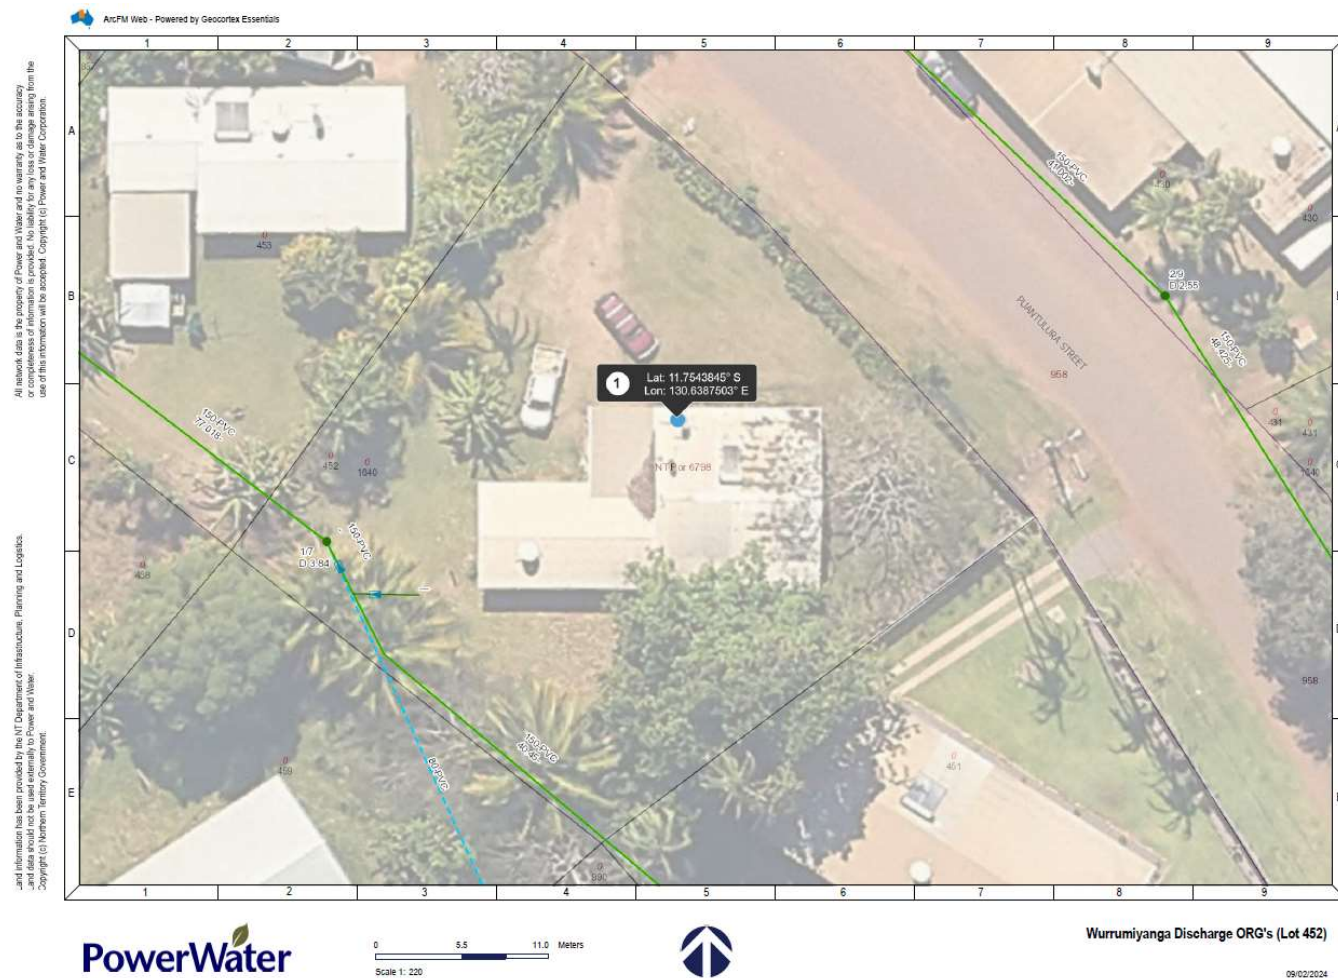
Wurrumiyanga ORG discharge - lot 452

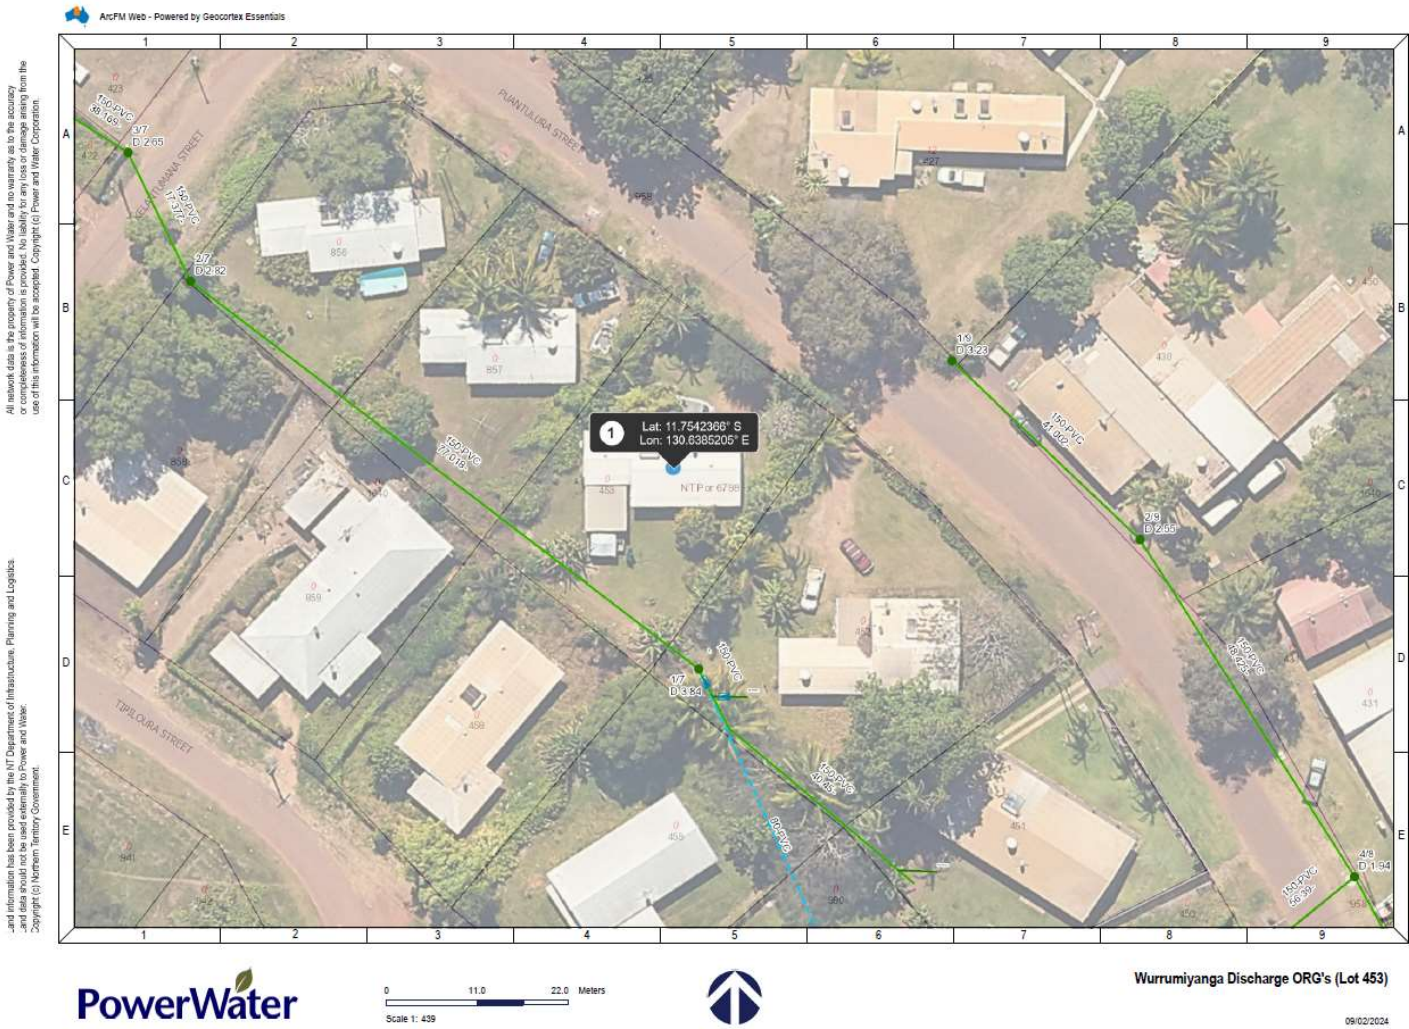
Wurrumiyanga ORG discharge - lot 453

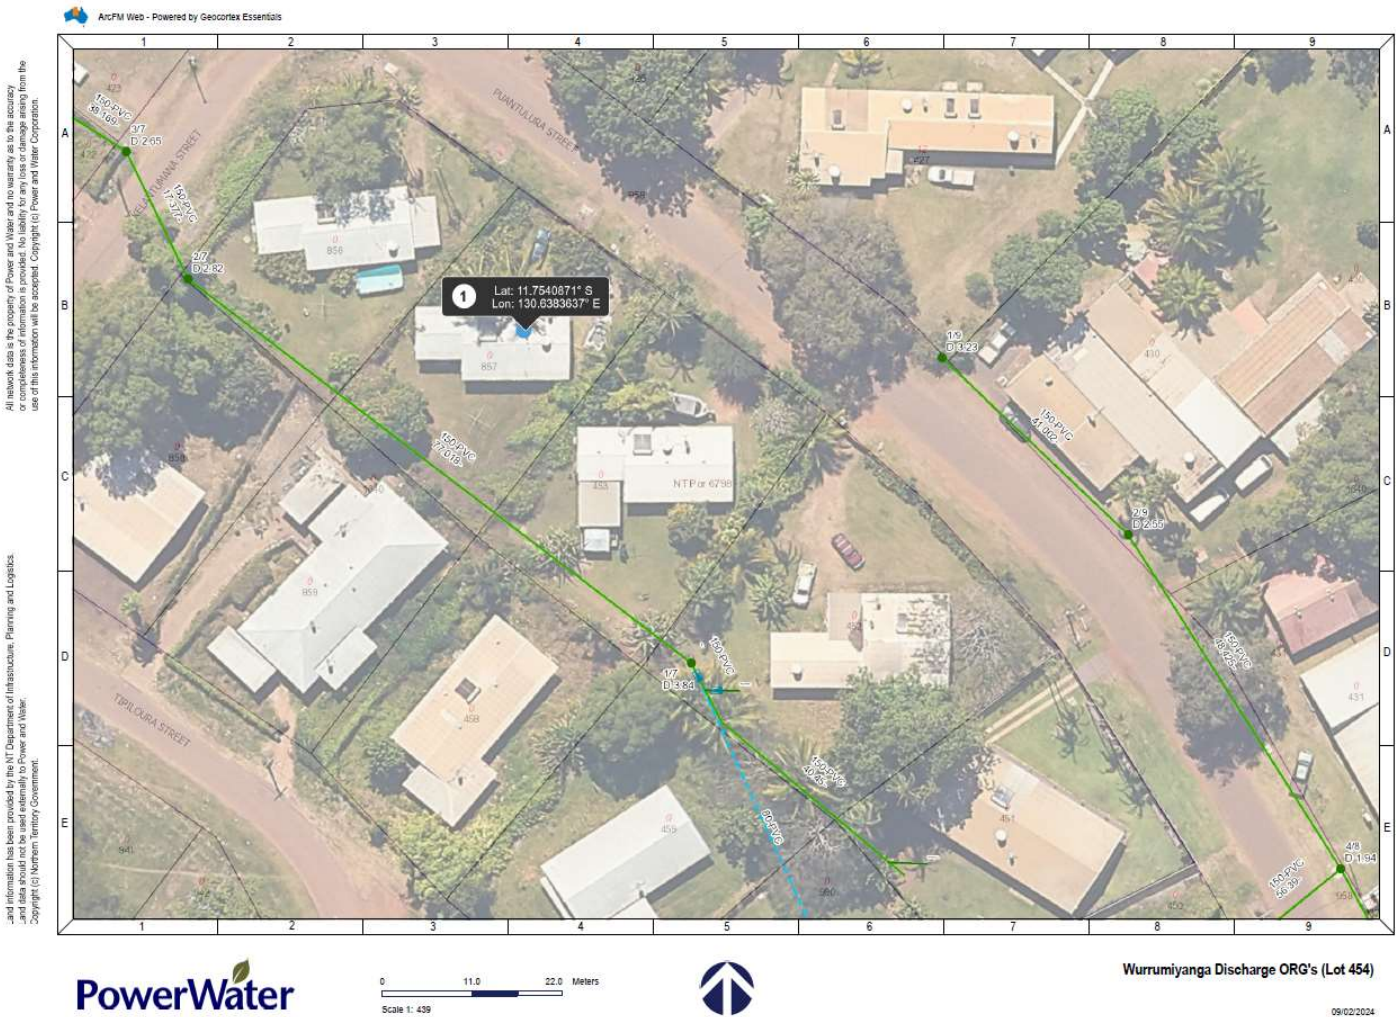
Wurrumiyanga ORG discharge - lot 454 (listed as 857)

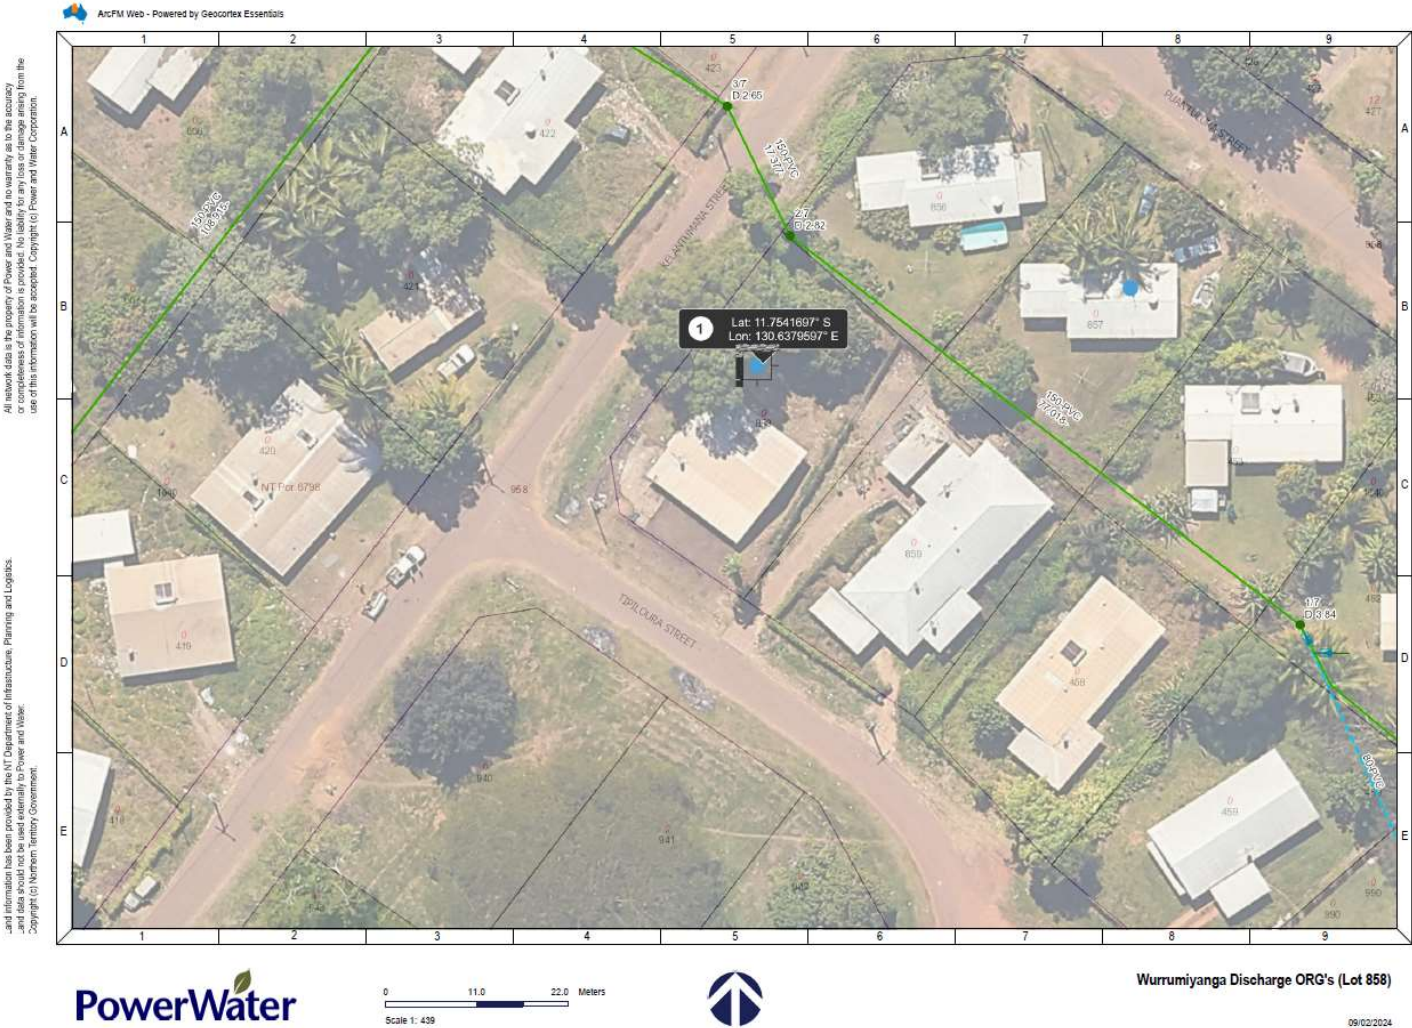
Wurrumiyanga ORG discharge - lot 858

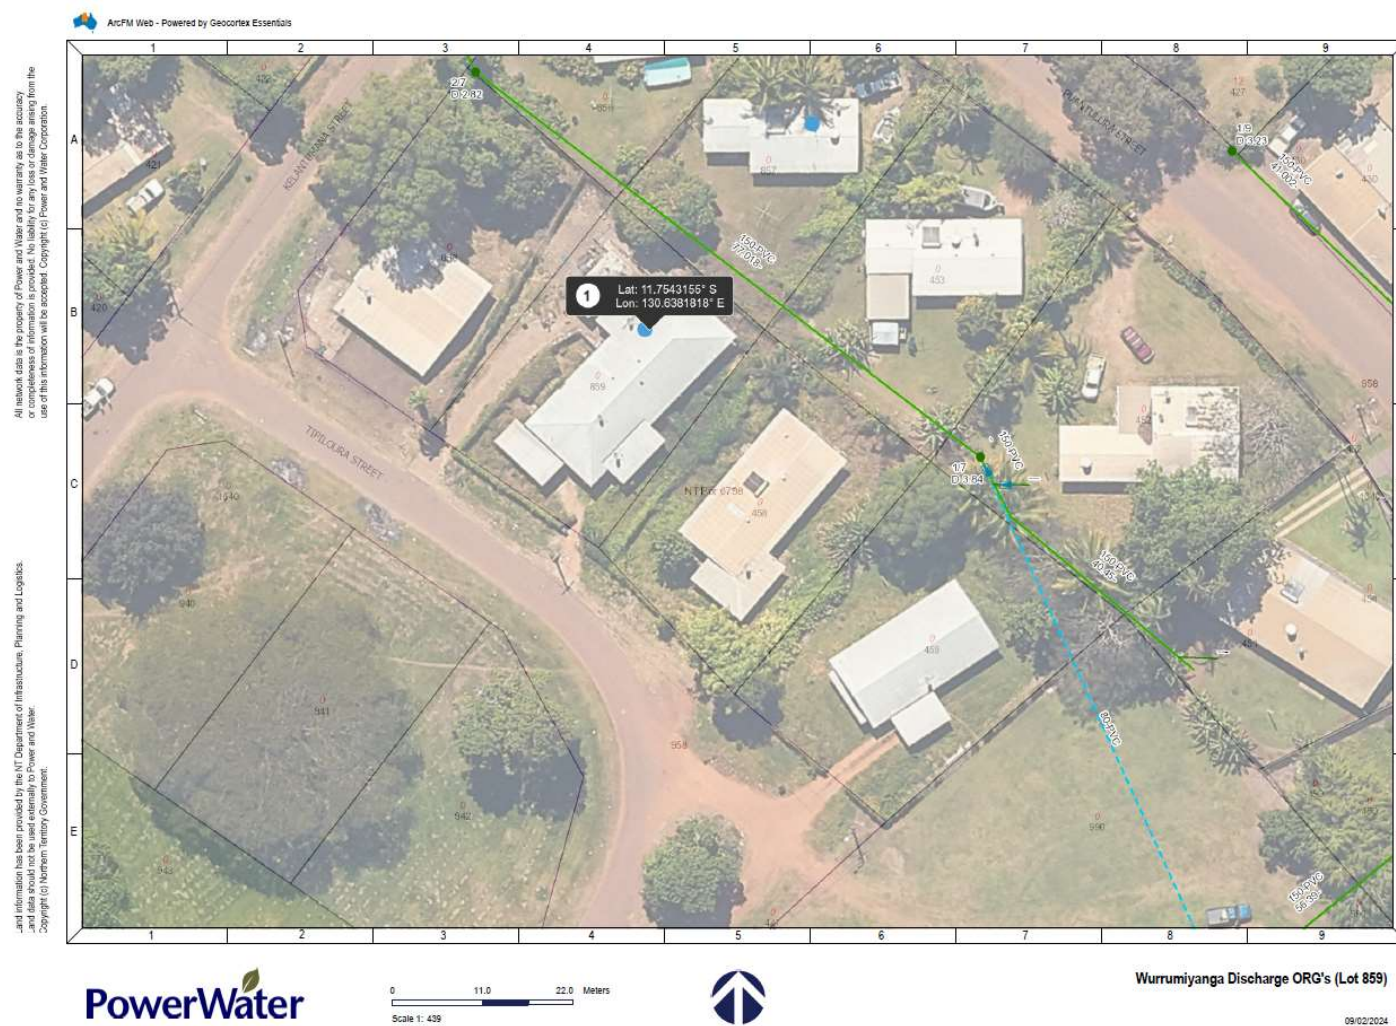
Wurrumiyanga ORG discharge - lot 859

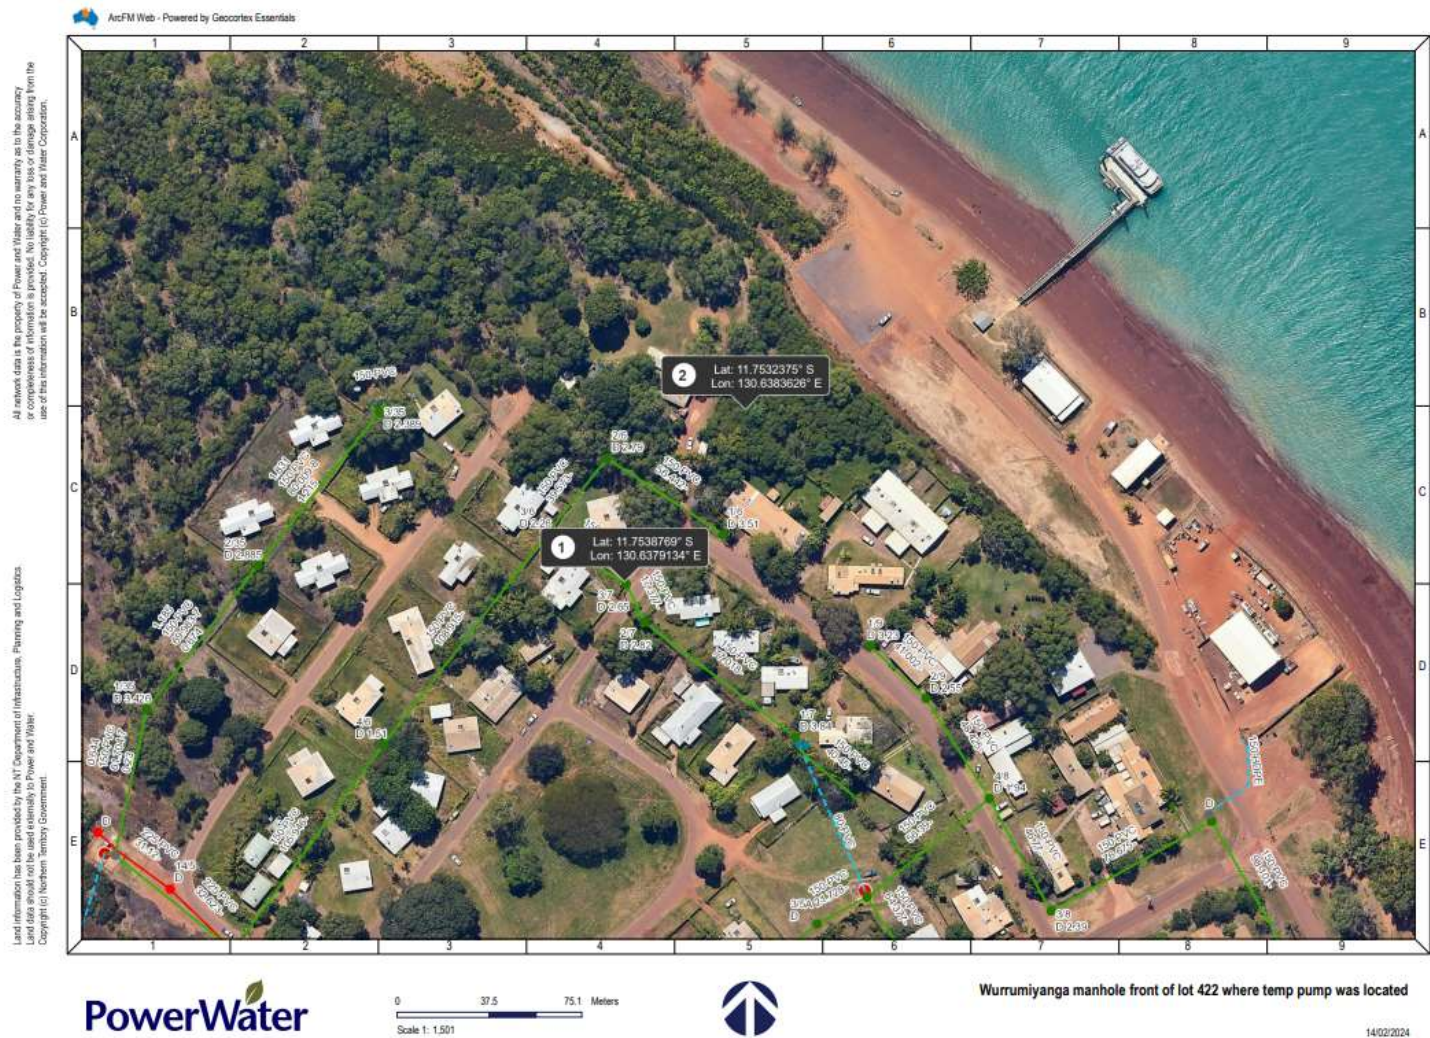
Pump location temporarily placed in manhole - front of lot 422
