## SECTION 14 INCIDENT REPORT (*Waste Management and Pollution Control Act*)

| Incident: | Discharge of highly diluted sewage effluent from Multiple locations of the sewerage network, due to monsoonal weather event. |

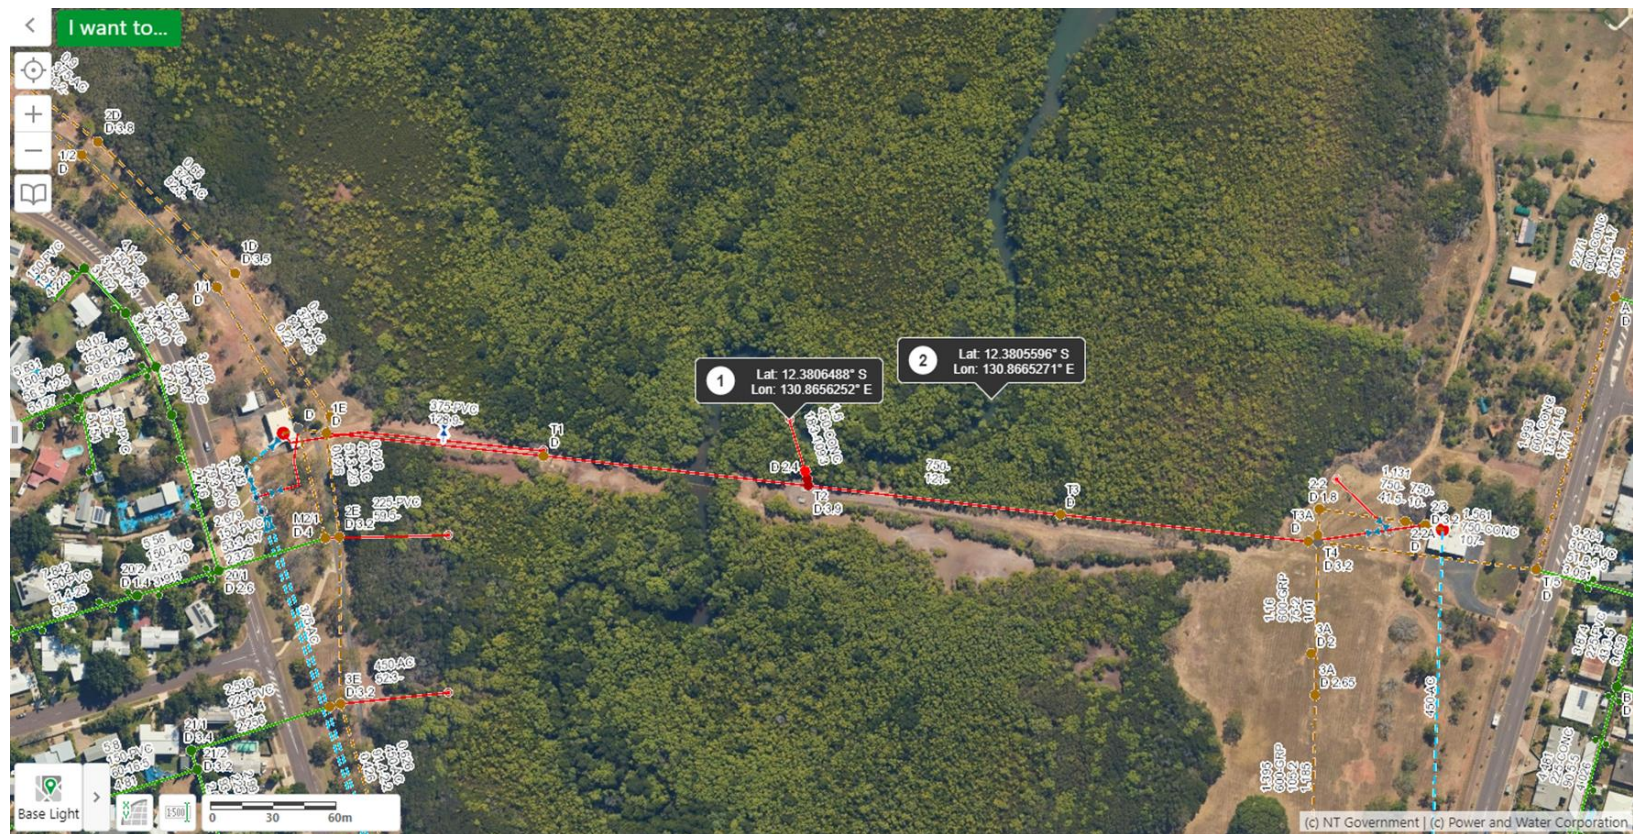
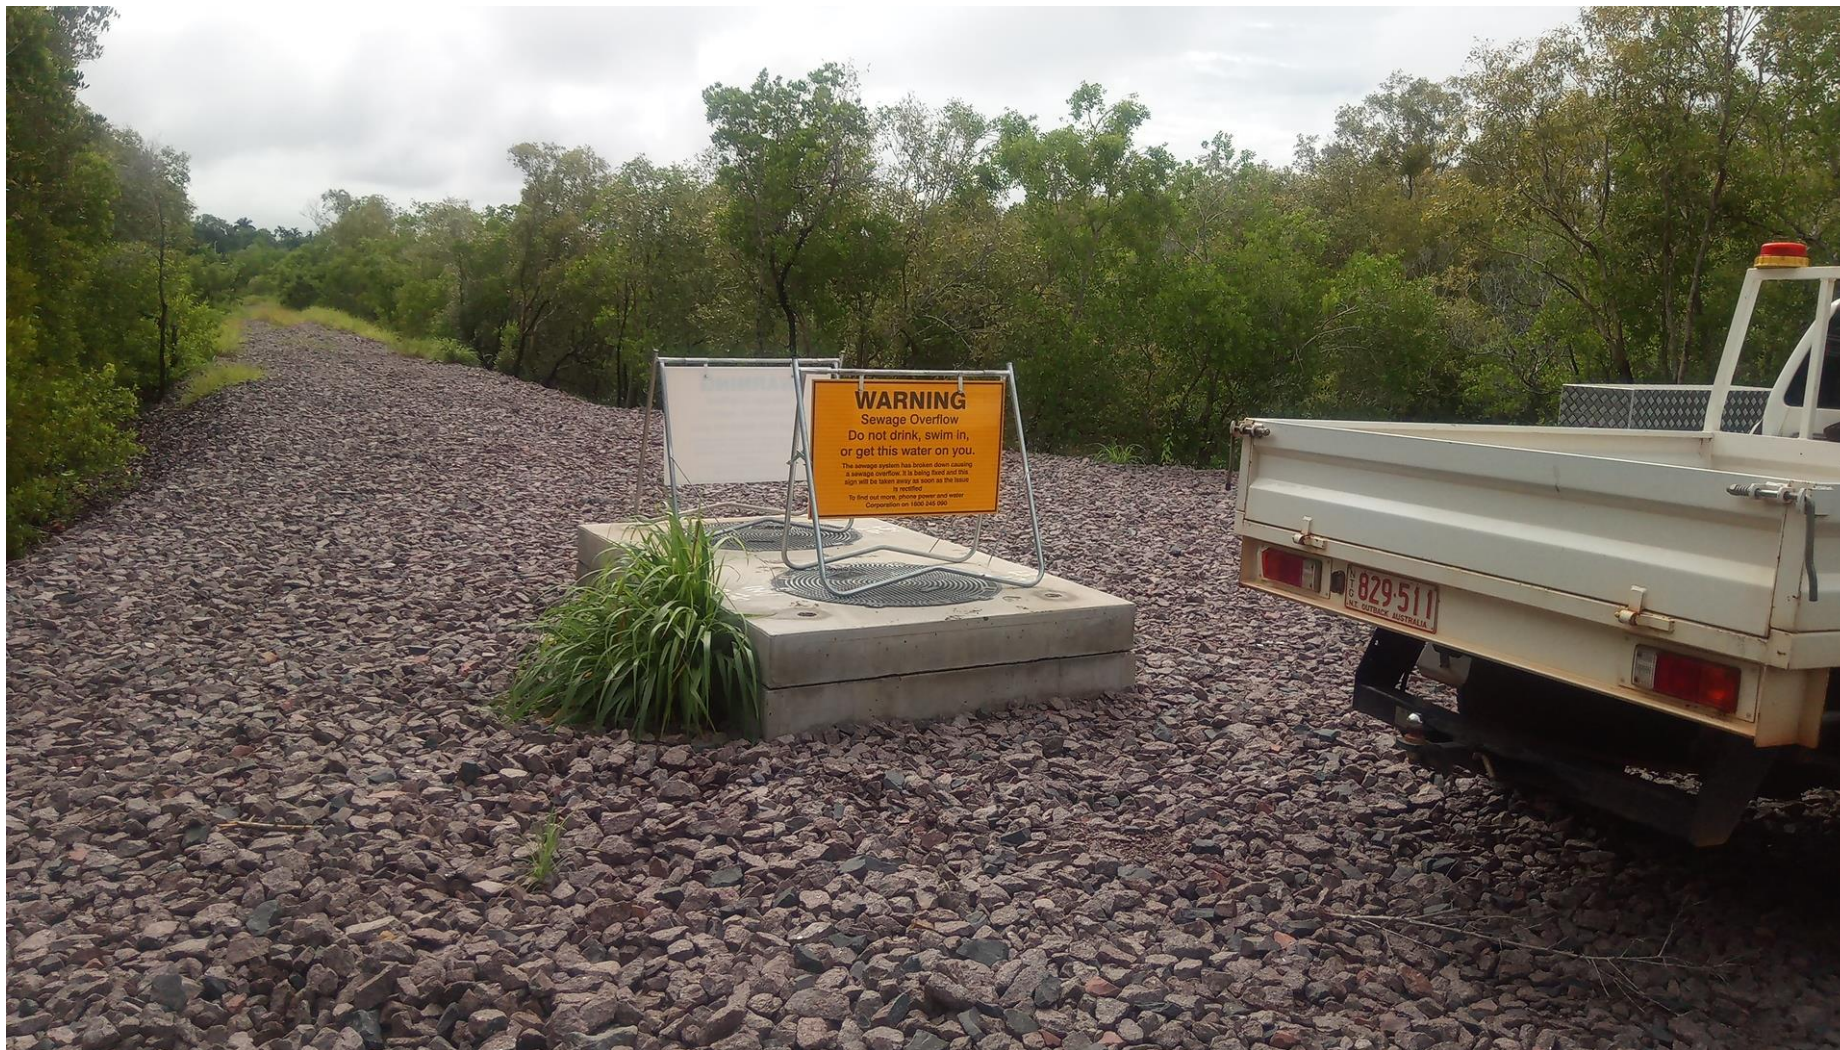
### Lakeside Drive and Rapid Creek SPS Discharge Point

*Lakeside Drive and Rapid Creek SPS Discharge Point Historical Photo dated 15/2/2021.*
