## SECTION 14 INCIDENT REPORT (*Waste Management and Pollution Control Act*)

| Person / Company: | Power and Water Corporation |
| Incident: | Discharge of highly diluted effluent from sewerage network, due to severe wet weather events. |

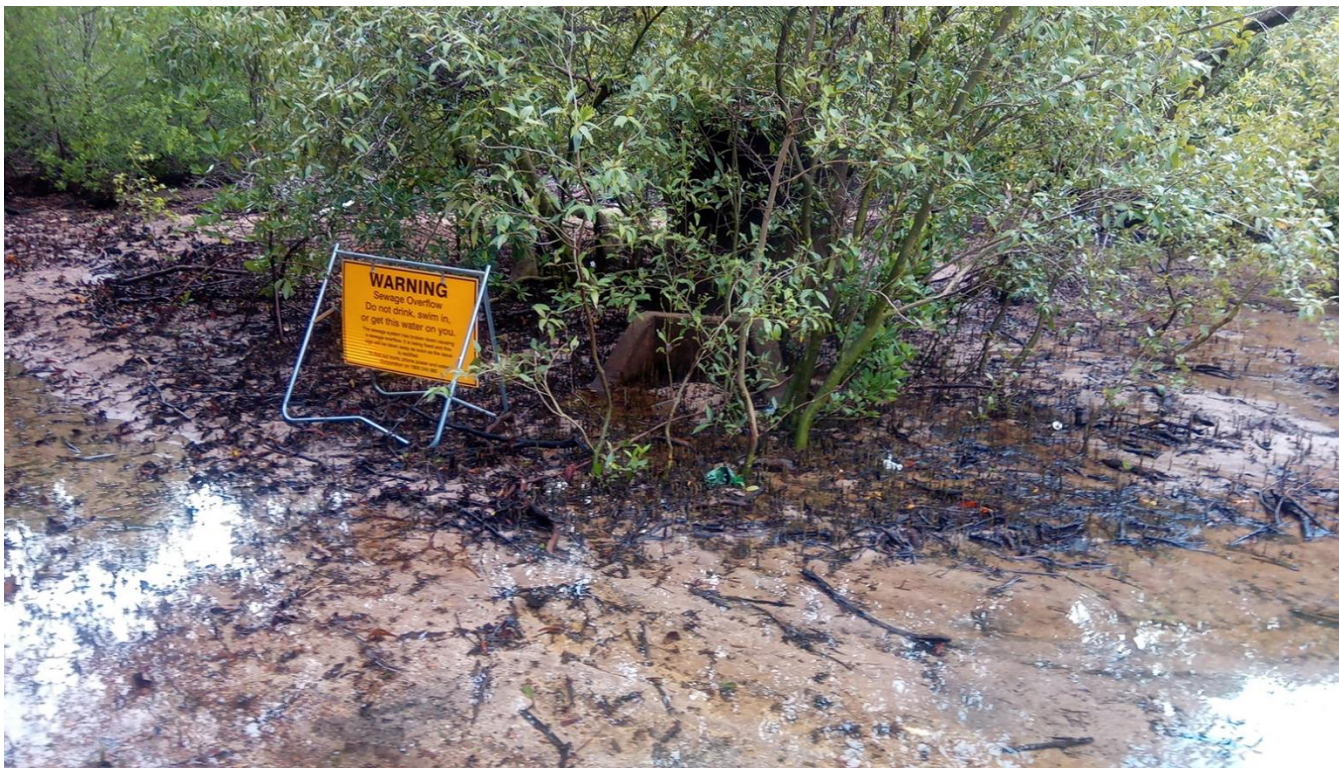
### Coconut Grove SPS

*Coconut Grove SPS Discharge Point Historical Photo dated 15/1/2021.*

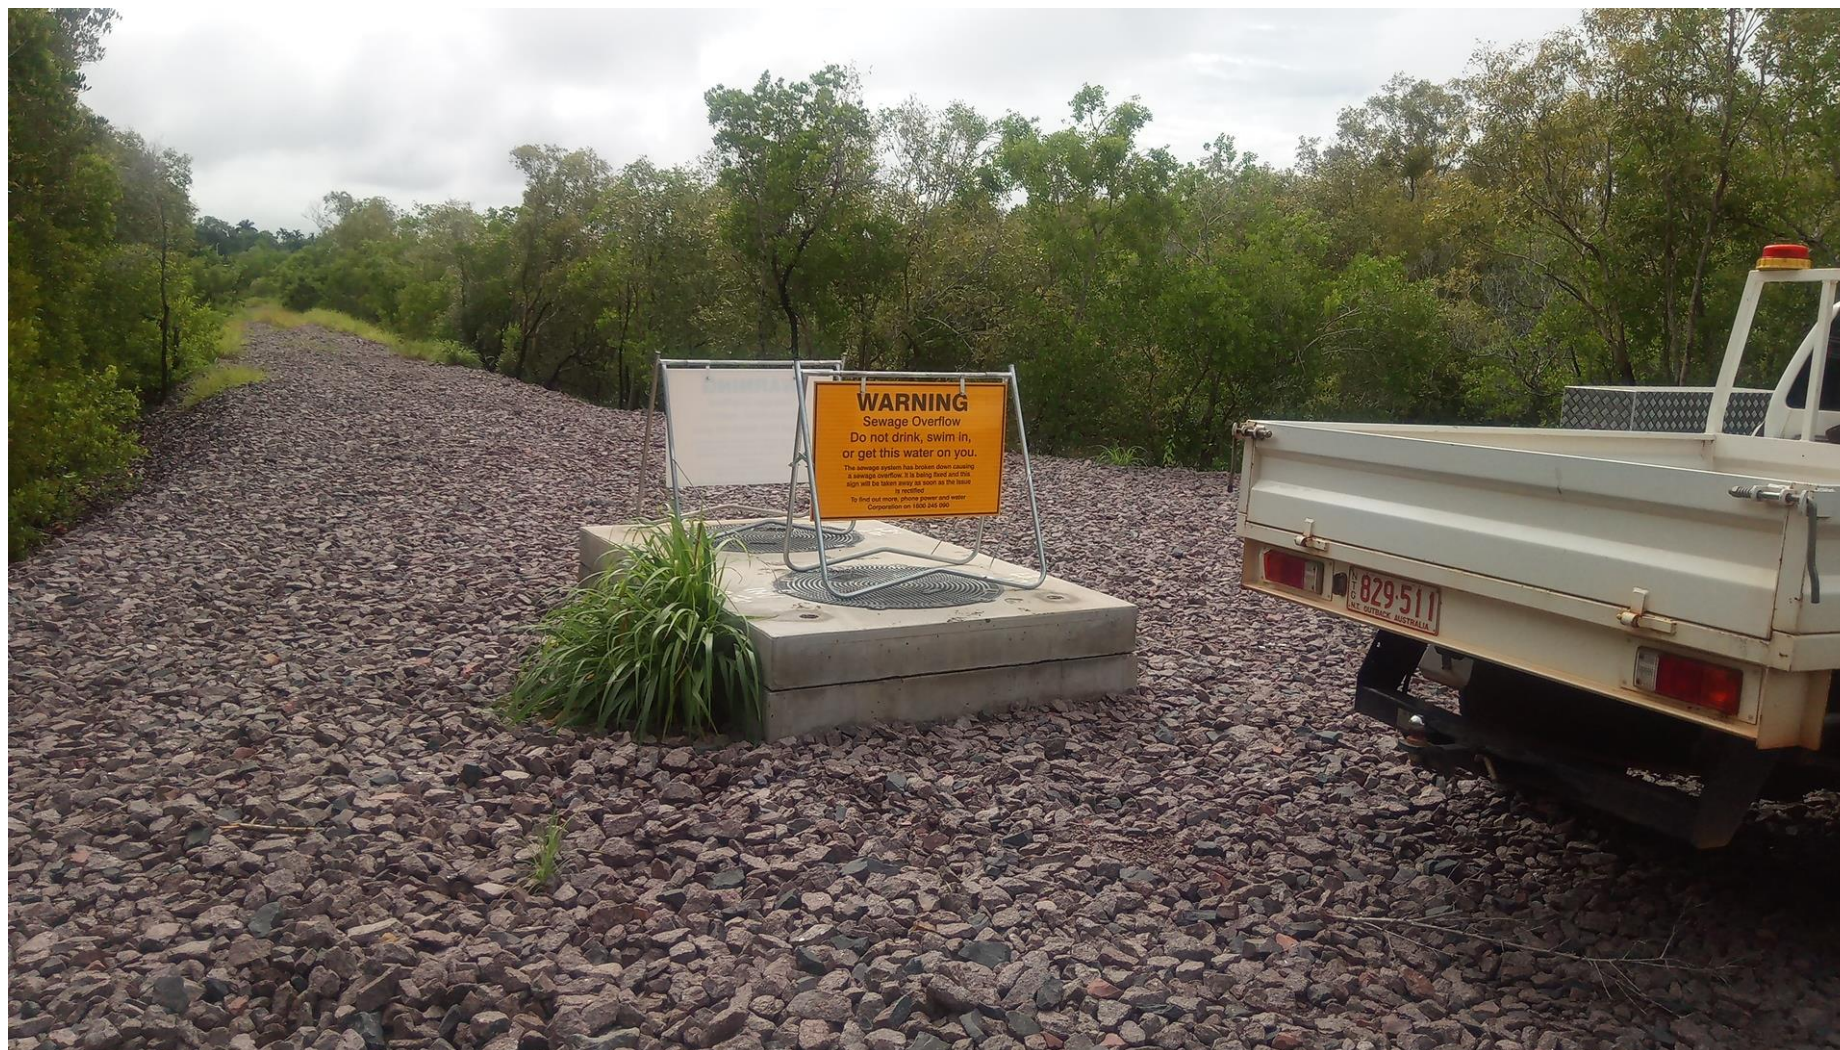
Lakeside Drive and Rapid Creek SPS Discharge Point

*Lakeside Drive and Rapid Creek SPS Discharge Point Historical Photo dated 15/2/2021.*

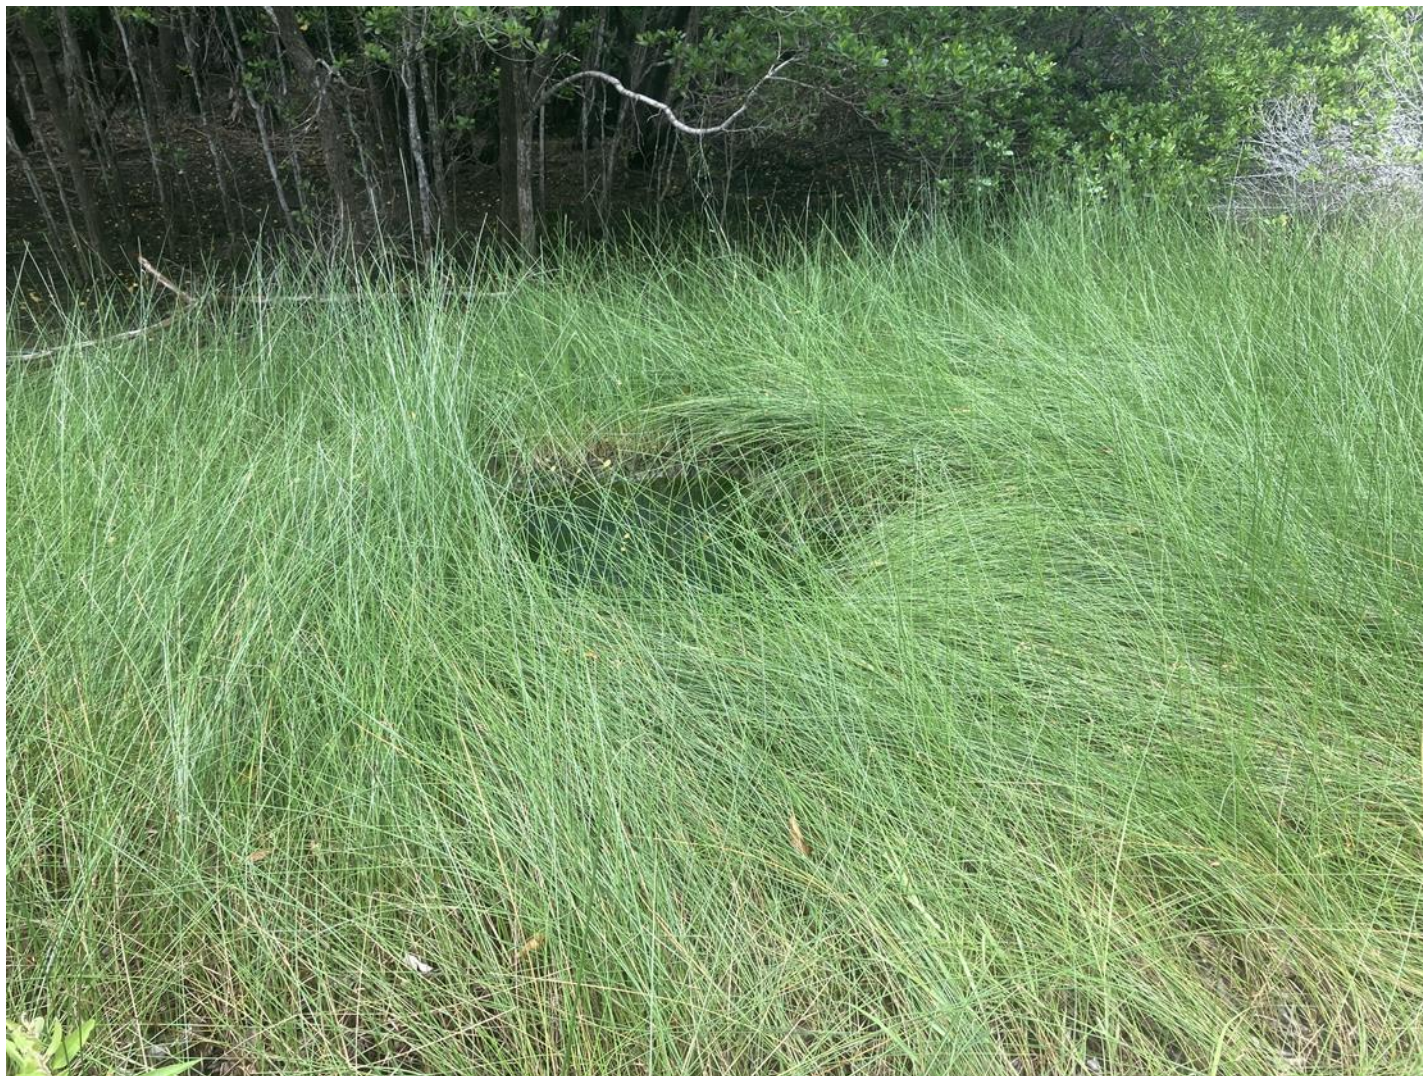
Ludmilla SPS

*Ludmilla SPS Emergency Discharge Point, Historical Photo dated 21 January 2021*
