SECTION 14 INCIDENT REPORT (*Waste Management and Pollution Control Act*)

Date and Time of Notification:	Initial notification (Call) – 30 January 2025 at 18:06						
Person / Company:	Lana Treasure on behalf of McArthur River Mining Pty Ltd (MRM)						
Incident:	Spillage of bulk concentrate on the Carpentaria Highway. The source of the spill originated from a road train travelling from McArthur River Mine (the Mine) to the Bing Bong Loading Facility (BBLF).						
(a) the incident causing or threatening to cause pollution	A road train travelling from the Mine to the BBLF spilled approximately 1 kilogram (kg) of concentrate on the roadside of the Carpentaria Highway. All concentrate was confined to the road and roadside.						
(b) the place where the incident occurred	The Global Positioning System (GPS) points for the incident location are provided in Table 1 below and shown in Figure 1. <i>Table 1 – GPS Coordinates of spill</i> <table border="1"> <thead> <tr> <th>Incident Location</th> <th>Easting*</th> <th>Northing*</th> </tr> </thead> <tbody> <tr> <td>Carpentaria Highway</td> <td>644025.20</td> <td>8257280.83</td> </tr> </tbody> </table> <p><i>*All coordinates were taken using th

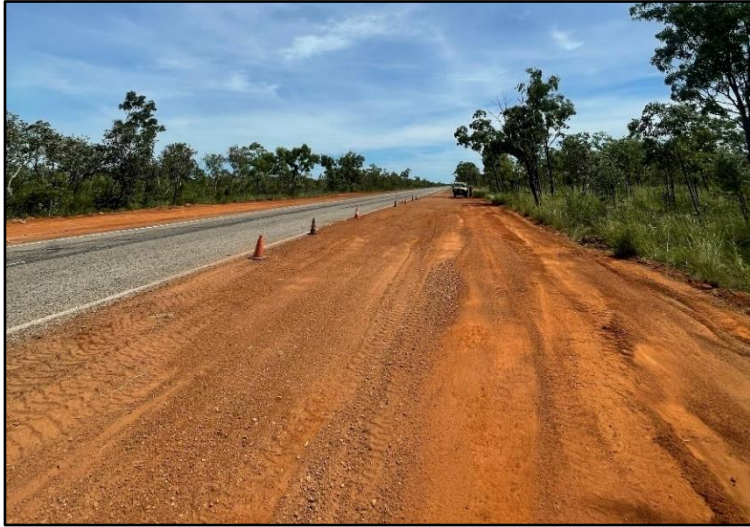
<p>Figure 4. Post remediation heading North towards Bing Bong</p> <p>Potential for Environmental Harm</p> <p>The risk of environmental harm from this incident is considered low, because:</p> <ul style="list-style-type: none"> • The extent of concentrate loss was limited to the bitumen road and immediate roadside and did not enter any waterways. • No sensitive receptors were impacted as a result of the incident or subsequent remediation works. • Remediation works were completed within 24 hours of the incident being reported to the MRM Environment team, minimising the potential risk of migration beyond the incident location. <p>Validation of Clean-up</p> <p>On 30 January and 1 February 2025, four soil samples were collected at the incident location in accordance with the <i>Australian Standard 4482.1-2005: Guide to the investigation and sampling of sites with potentially contaminated soil</i>. A further four control samples were collected from reference sites > 50 metres (m) from the incident location.</p> <p>Sample results and details of further remediation works will be provided to the Northern Territory Environmental Protection Authority (NT EPA) in due course once laboratory results have been received.</p>

<p>(e) the attempts made to prevent, reduce, control, rectify or clean up the pollution or resultant environmental harm caused or threatening to be caused by the incident</p>	<p>Clean-up Works</p> <p>A pressure hose and bobcat was used to collect the concentrate from the road and roadside at the incident location. A small excavator was then used to collect all potentially contaminated material on the immediate roadside.</p> <p>All potentially contaminated material will be sent to the Tailings Storage Facility for appropriate disposal at MRM.</p>
