SECTION 14 INCIDENT REPORT (*Waste Management and Pollution Control Act*)

Date and Time of Notification:	Friday 16th May 2025, 11:15hrs
Person / Company:	Power and Water Corporation
Incident:	Diesel spill at Snake Bay barge landing Milikapiti – Melville Island

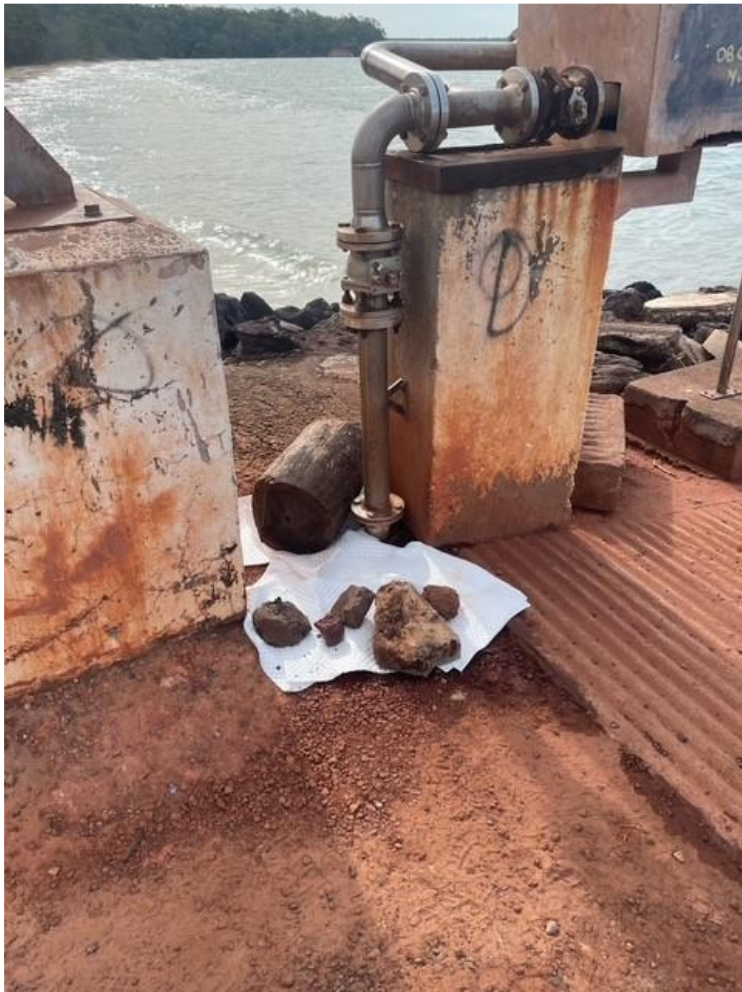
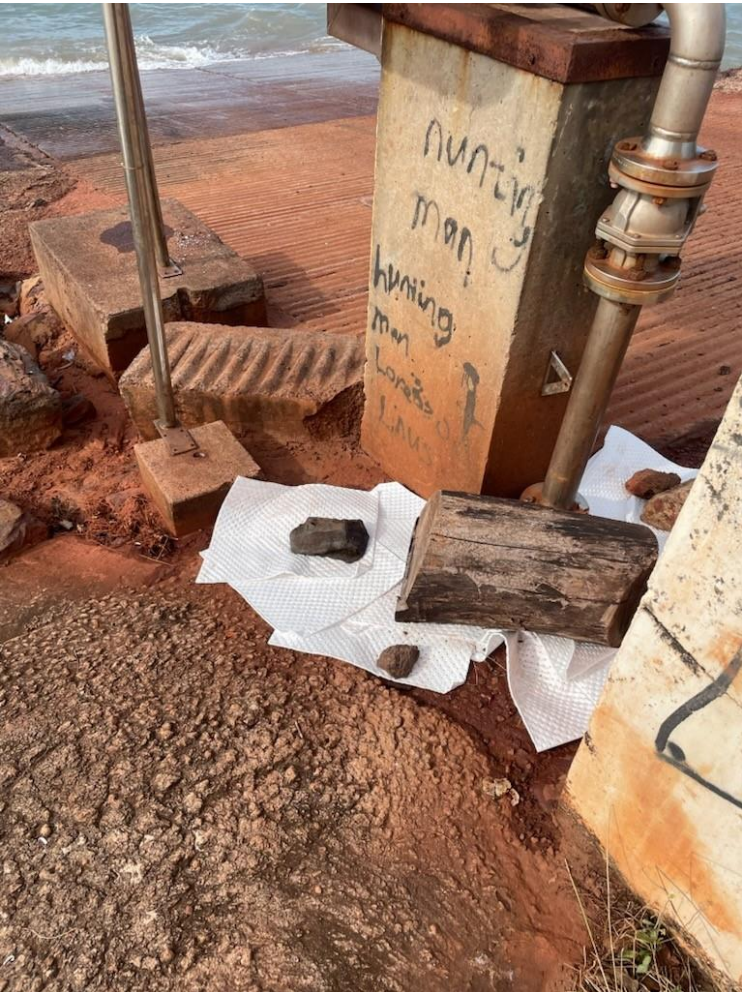
Figures 1 & 2. Milikapiti (Snake Bay) barge landing diesel fuel fill point, where the spill has come to the surface

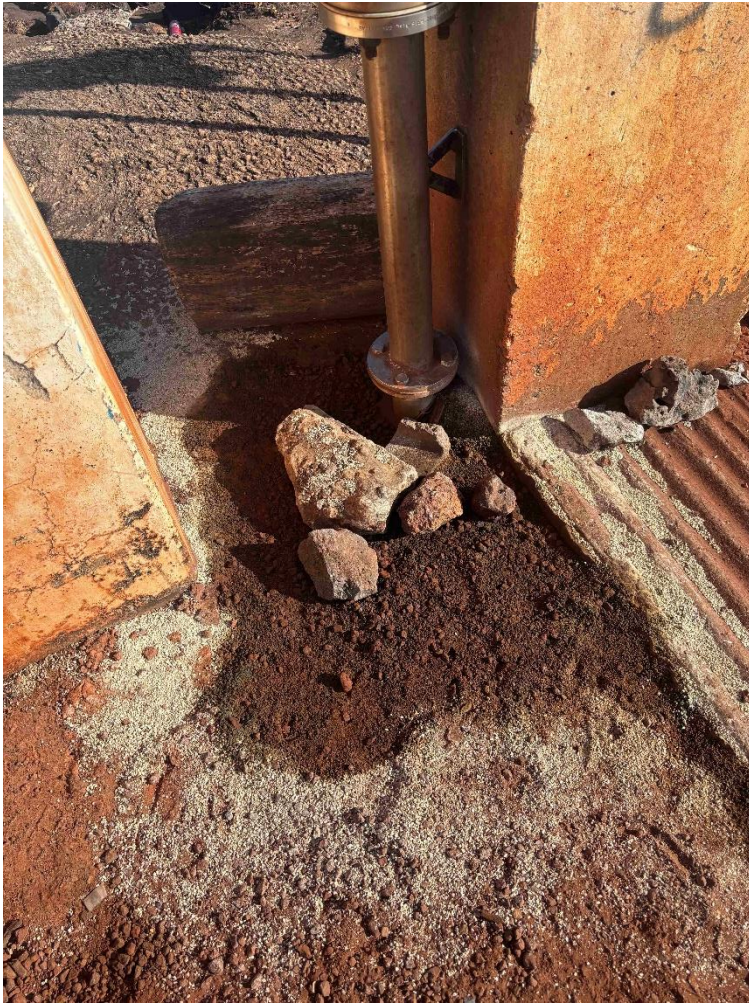
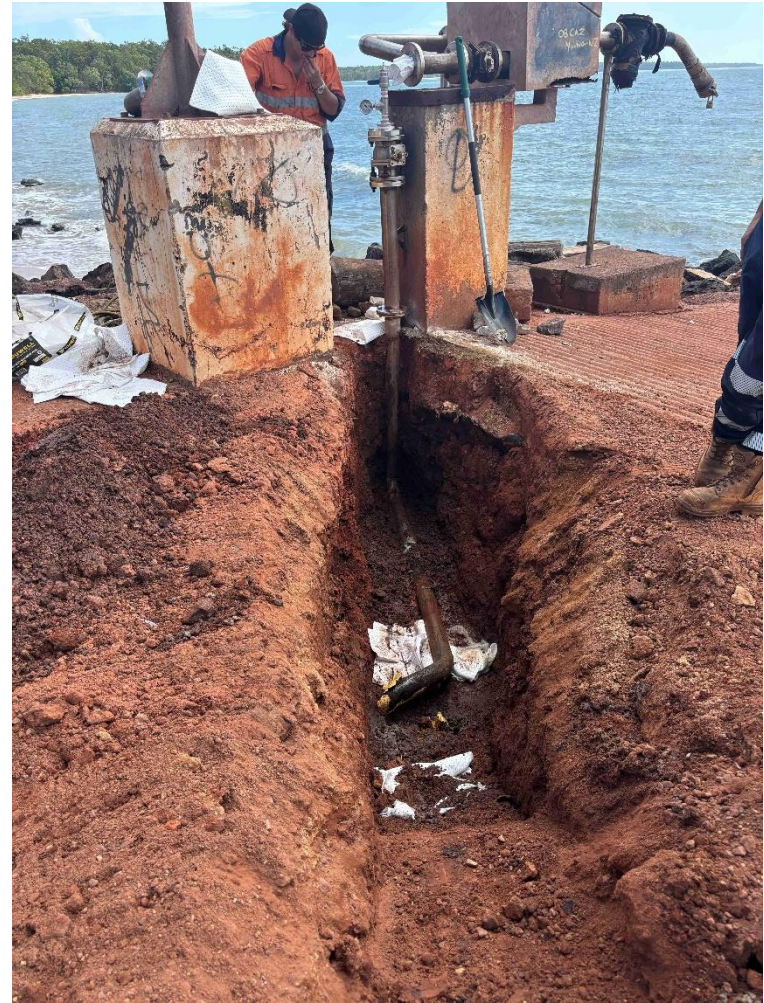
Figures 3 & 4., Where the spill has come to the surface and the excavation to expose the pipe.
