SECTION 14 INCIDENT REPORT (*Waste Management and Pollution Control Act*)

Date and Time of Notification:	Initial notification: Wednesday 26 March 2025, 15:45 hrs Final notification: Friday 28 March 2025, 14:00 hrs
Person / Company:	Power and Water Corporation
Incident:	Discharge of highly diluted sewage effluent at multiple locations from sewerage network

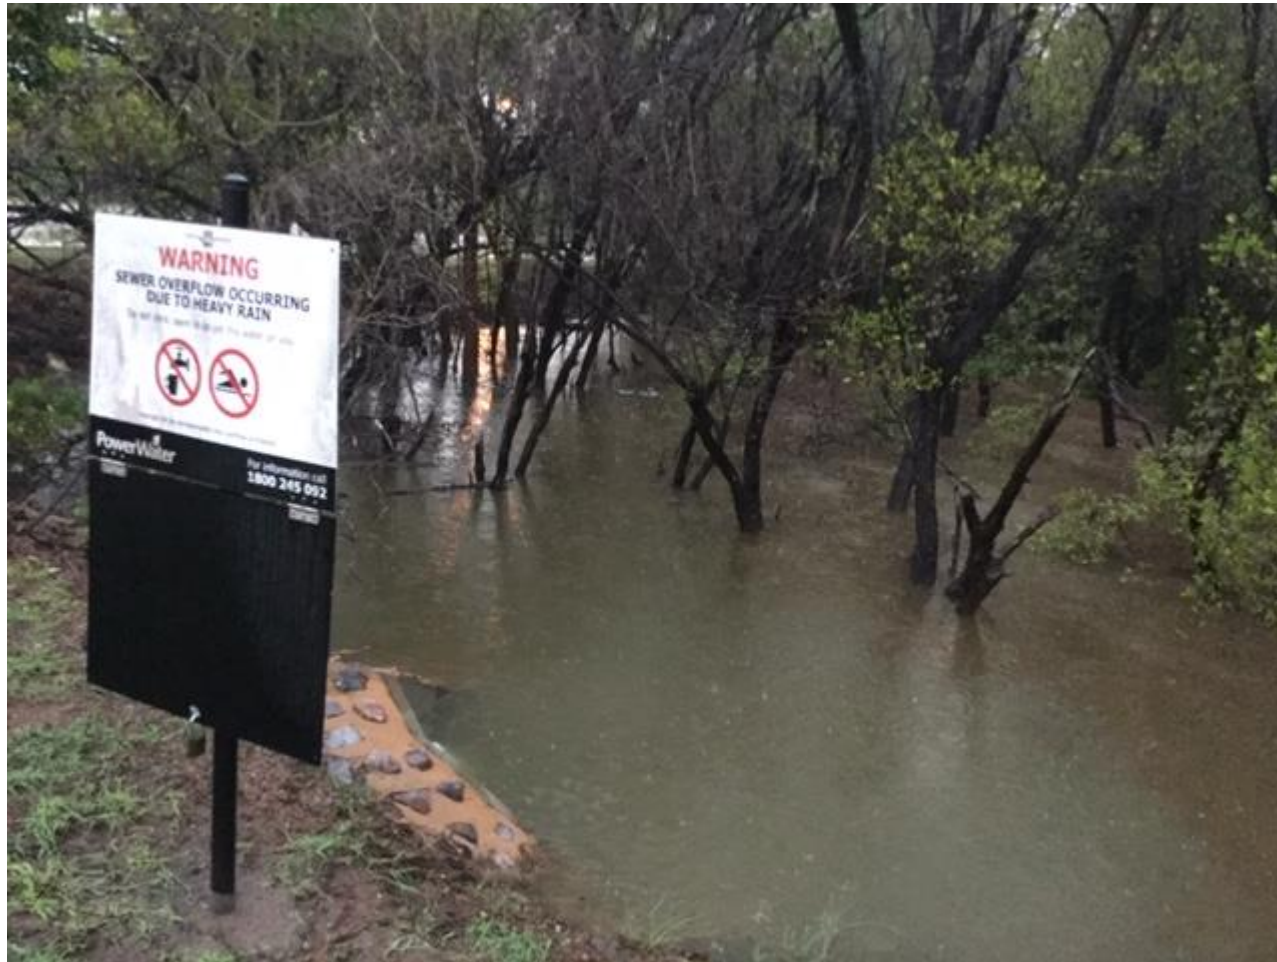
Indicative photo of the sewer overflow relief point on the corner of Rapid Creek Road and Trower Road. Historical photo from 2020.

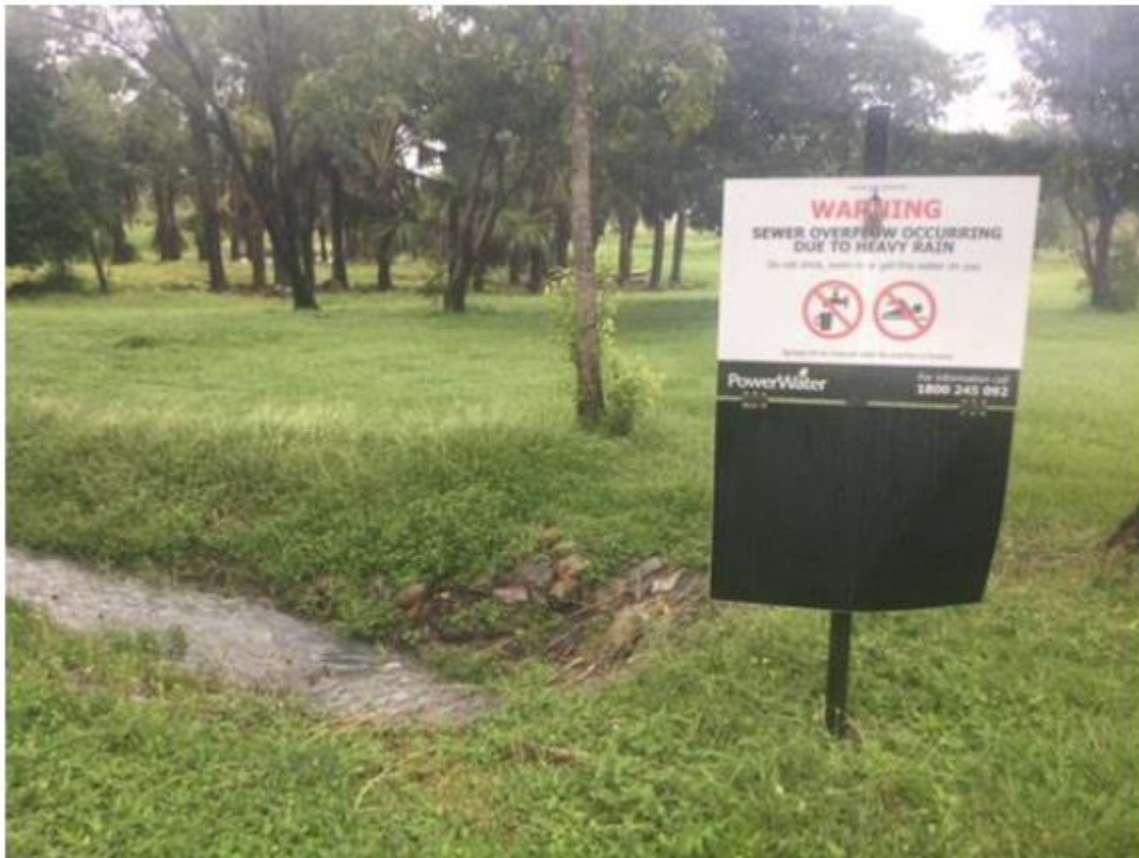
Indicative photo of the sewer overflow relief point at 24 East Point Road. Historical photo from 2021.

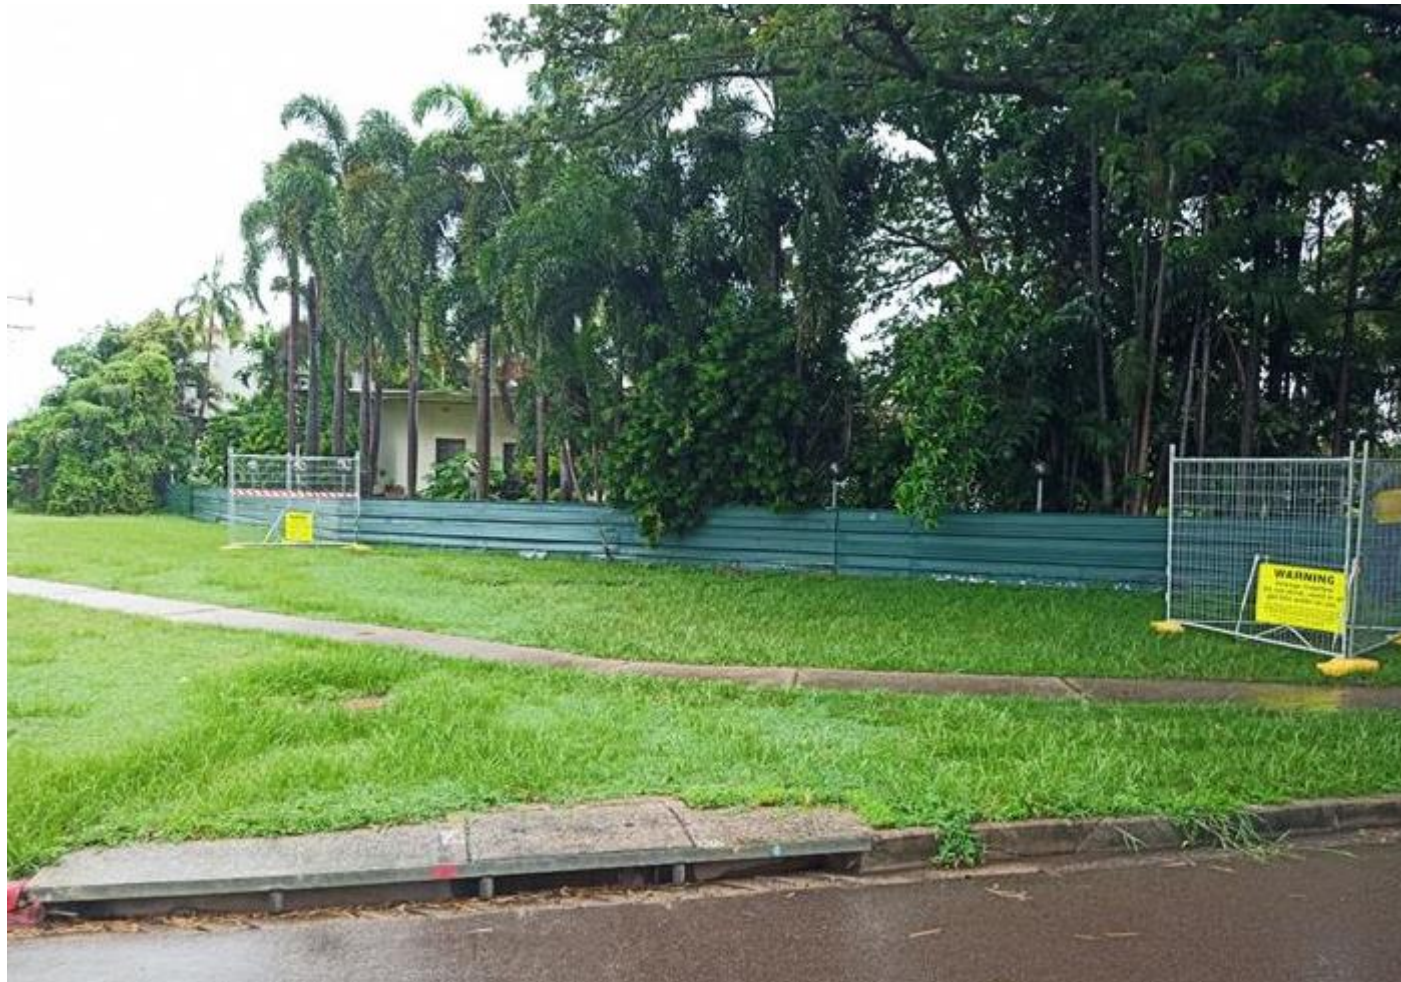
Indicative photo of the fenced access chambers on the corner of Gregory Street and East Point Road. Historical photo from 2021.
