## SECTION 14 INCIDENT REPORT (*Waste Management and Pollution Control Act*)

<b>Date and Time of Notification:</b>	Monday 14 <sup>th</sup> July 2025, 13:30hrs
<b>Person / Company:</b>	Power and Water Corporation
<b>Incident:</b>	Diesel fuel spill from fuel transfer pipeline struck by front end loader - Elcho Island / Galiwinku

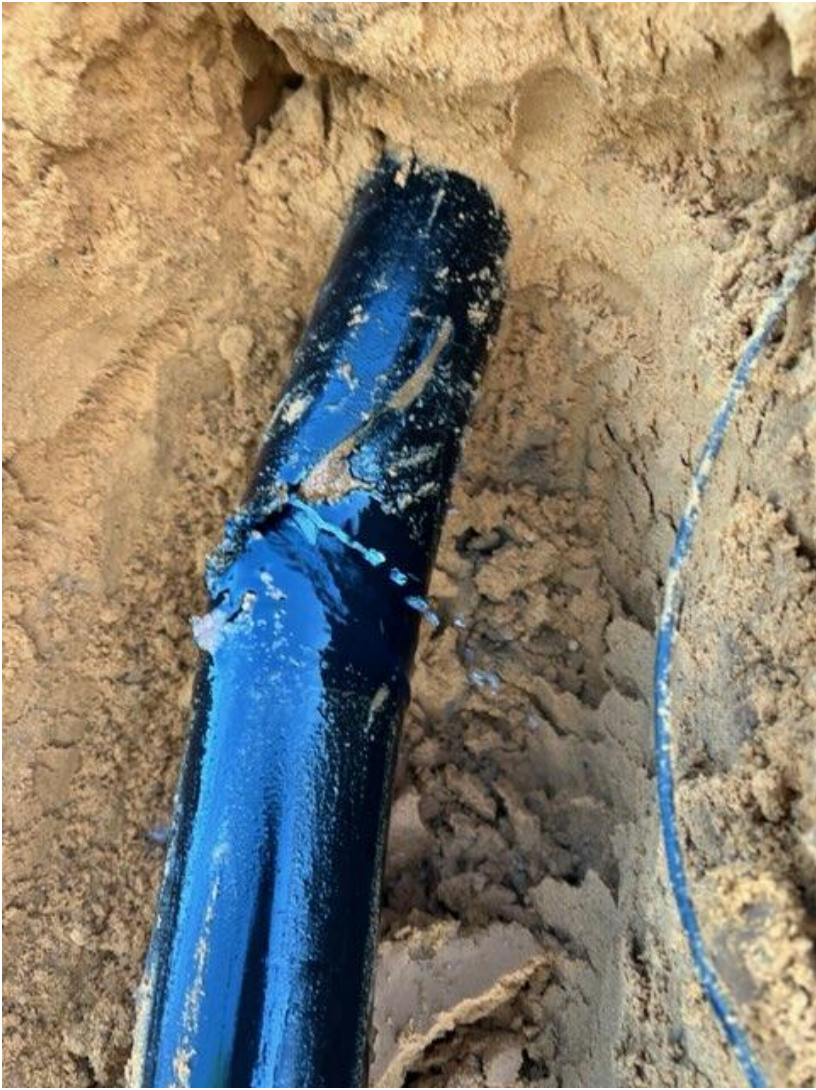
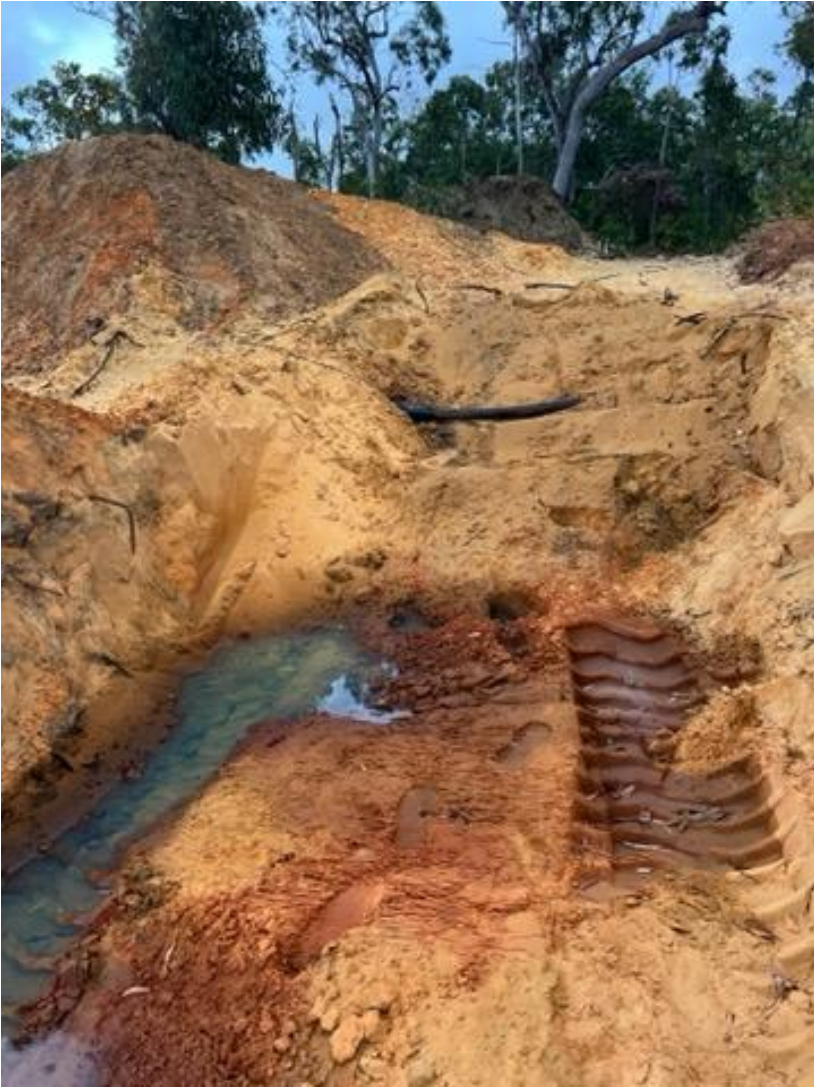
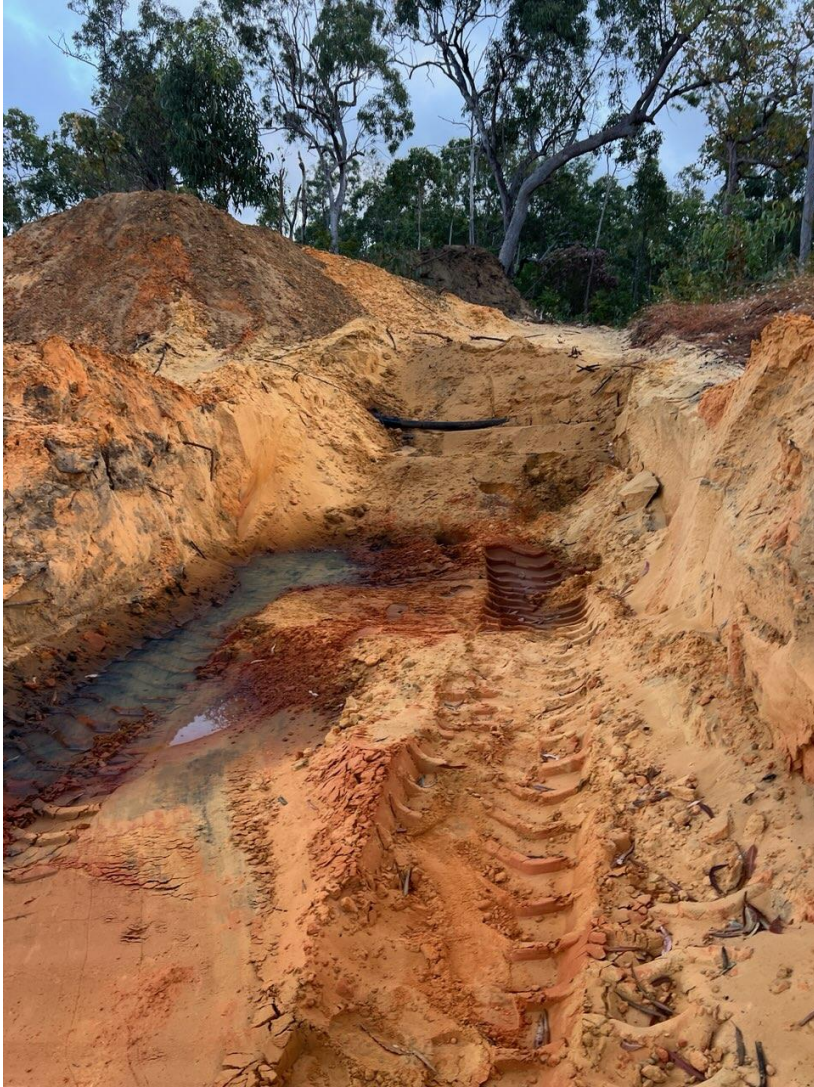
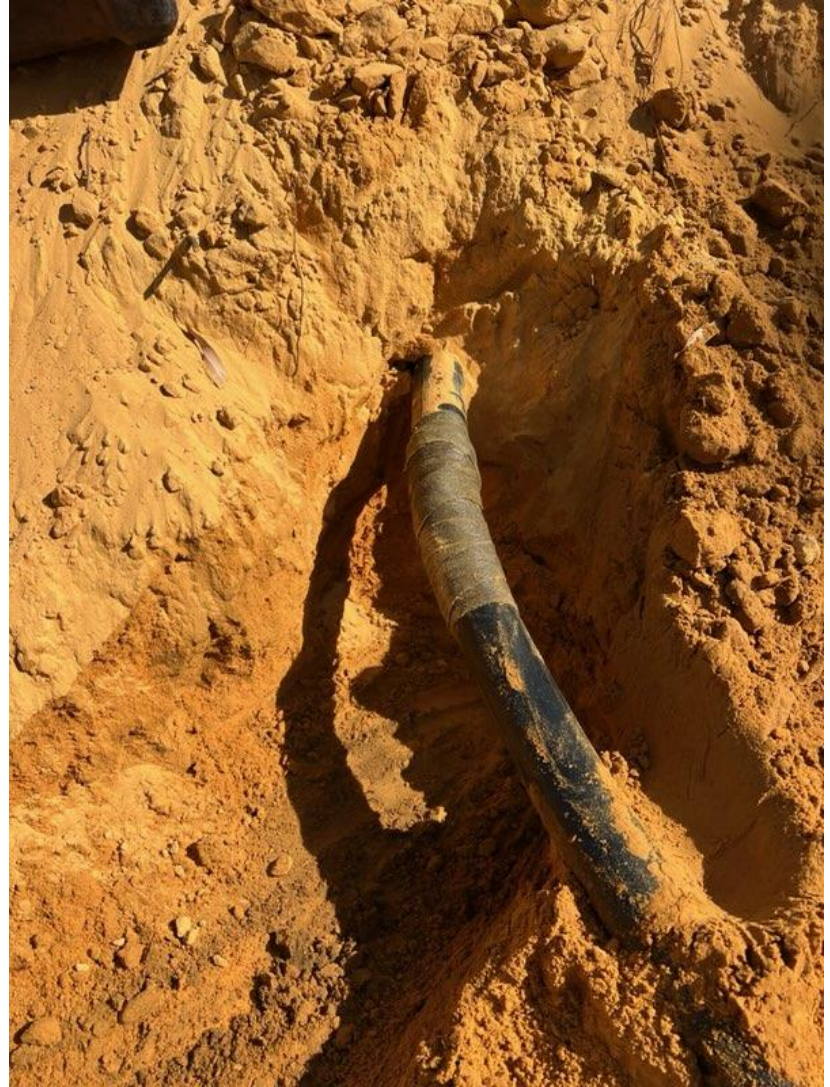
Appendix B – Location Photographs

<p>USCW was advised of the spill by a local indigenous contractor on the Island. Power &amp; Water however did not become aware of the spill until Monday 14/07/2025 07:00hrs.</p> <p><i>iii. The process by which the discharge occurred.</i></p> <p>Evidence points to a front-end loader having struck the fuel transfer pipeline.</p> <p><i>iv. The reason why the discharge occurred.</i></p> <p>One of 3 front-end loaders on the Island were operating in the area where the transfer pipeline was struck. Vicinity markers for the pipeline were previously in place but kept getting stolen.</p>
<b>(d) how the pollution has occurred, is occurring or may occur</b>	As per (c) iii & (c) iv.
<b>(e) the attempts made to prevent, reduce, control, rectify or clean up the pollution or resultant environmental harm caused or threatening to be caused by the incident</b>	<p><i>i. Attempts made to prevent, reduce, control, rectify or clean up the pollution.</i></p> <p>No fuel transfers occurred since the spill was detected.</p> <p>The fuel transfer pipeline was isolated at both ends.</p> <p>A temporary patched by wrapping the damaged section with Denso tape has been done to prevent any further spill to ground, see attached photograph.</p> <p>A contractor has been engaged to fly to the Island to undertake permanent repairs of the poly pipe as well as remediate the affected area, by digging up any contaminated soils for transfer back to Darwin and ultimately disposed of by a licenced waste management service provider.</p> <p><i>ii. Decontamination of the site as appropriate.</i></p> <p>All contaminated soil will be removed and transferred back to Darwin by a suitably licenced barge service and disposed of by a licenced waste management service provider.</p>
