## SECTION 14 INCIDENT REPORT (*Waste Management and Pollution Control Act*)

<b>Date and Time of Notification:</b>	Tuesday 21 <sup>st</sup> January 2025, 14:30hrs
<b>Person / Company:</b>	Power and Water Corporation
<b>Incident:</b>	Discharge of sewage from sewerage network – Manhole Cover

Sewage Spill from manhole at Umbakumba

21/01/2025

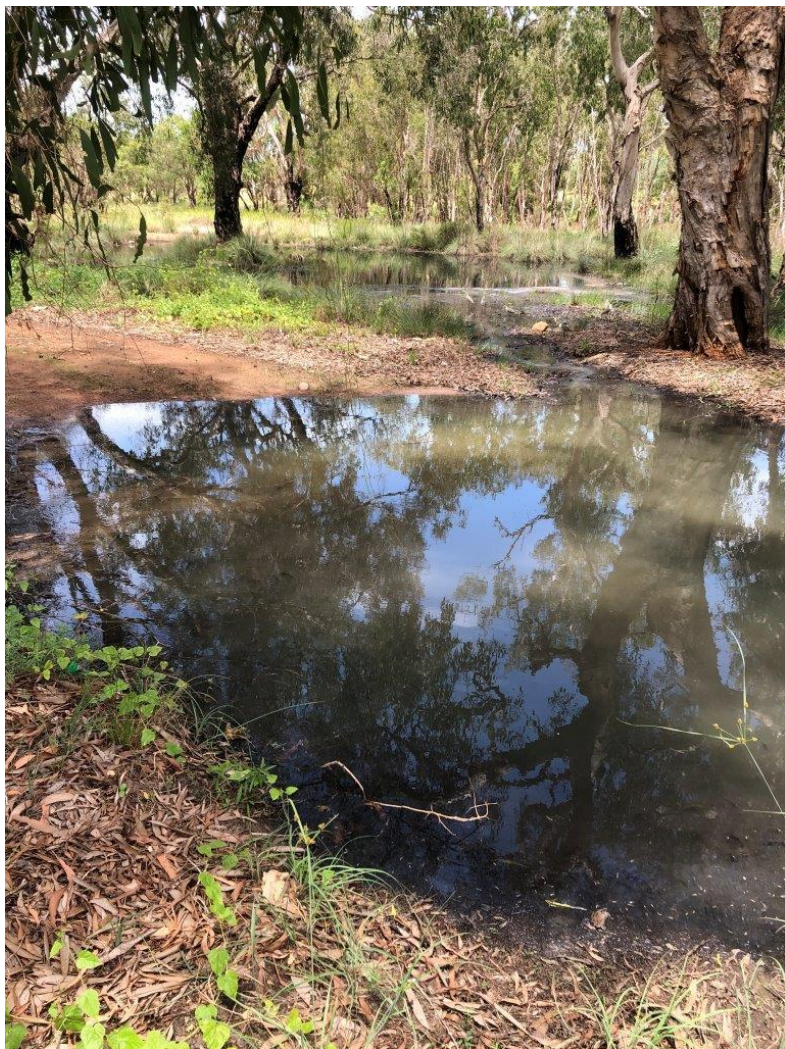
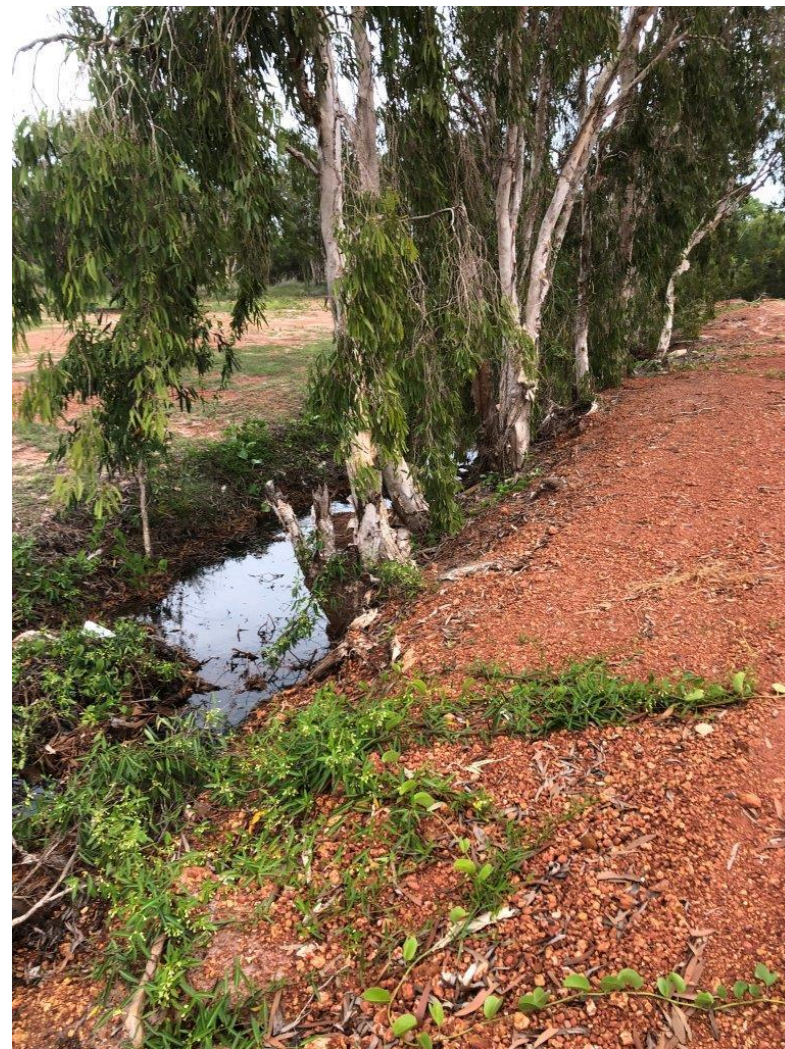
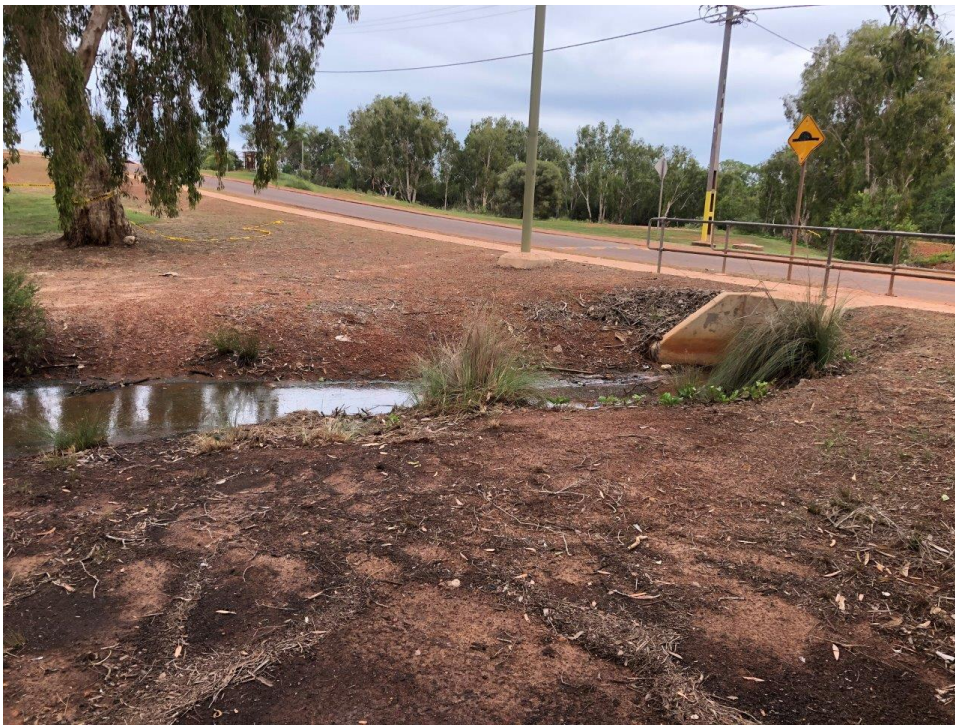
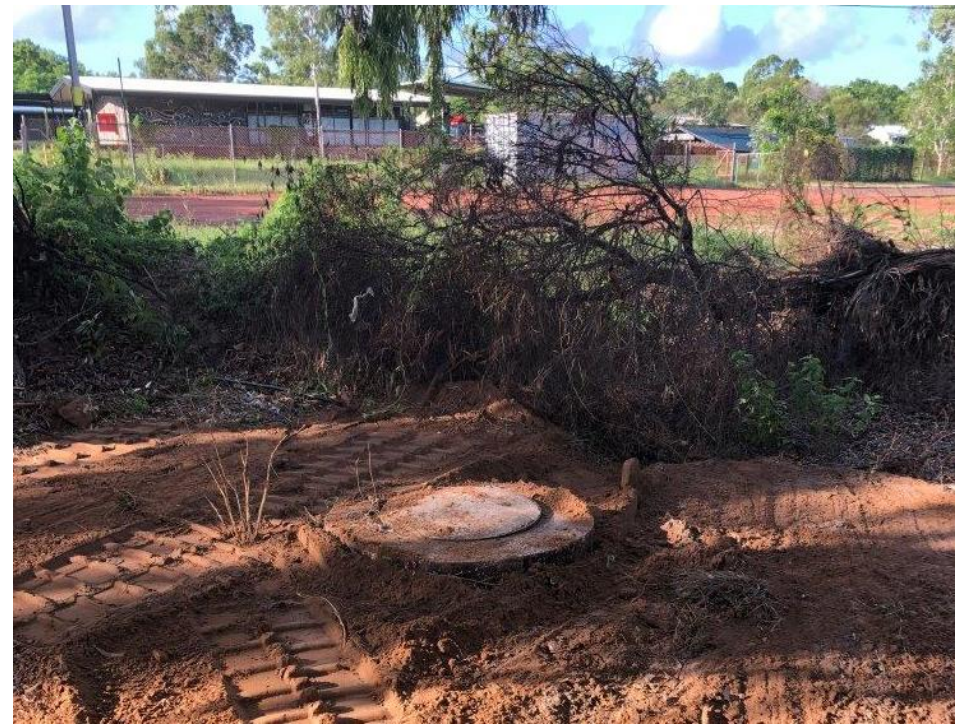
Appendix B – Location Photographs

<b>(d) how the pollution has occurred, is occurring or may occur</b>	<p>As per (c) iii &amp; (c) iv.</p> <p>A large portion of the spill that could not be recovered by vacuum truck did end up flowing through a small swamp area and then to a small tidal creek nearby. There were no obvious signs of any adverse effects caused by the spill. There was a high tide of 1.9m and a low of 0.8m on the day of the spill.</p>
<b>(e) the attempts made to prevent, reduce, control, rectify or clean up the pollution or resultant environmental harm caused or threatening to be caused by the incident</b>	<p><i>i. Confirmation signage and fencing has been erected, as appropriate.</i></p> <p>No signage or fencing was erected in this instance. The area that the spill flowed through was too great to fence.</p> <p><i>ii. Decontamination of the site as appropriate.</i></p> <p>Clean up consistent with Sewage Spills/Overflow Response Work Instruction as appropriate to the location, and to minimise risk to the environment.</p>
