SECTION 14 INCIDENT REPORT (*Waste Management and Pollution Control Act*)

Date and Time of Notification:	Sunday 4 May 2025 at 2:30pm
Person / Company:	Power and Water Corporation
Incident:	Sewage leak from Sewer Rising Main (SRM) Galiwinku – Close Out PRL13048

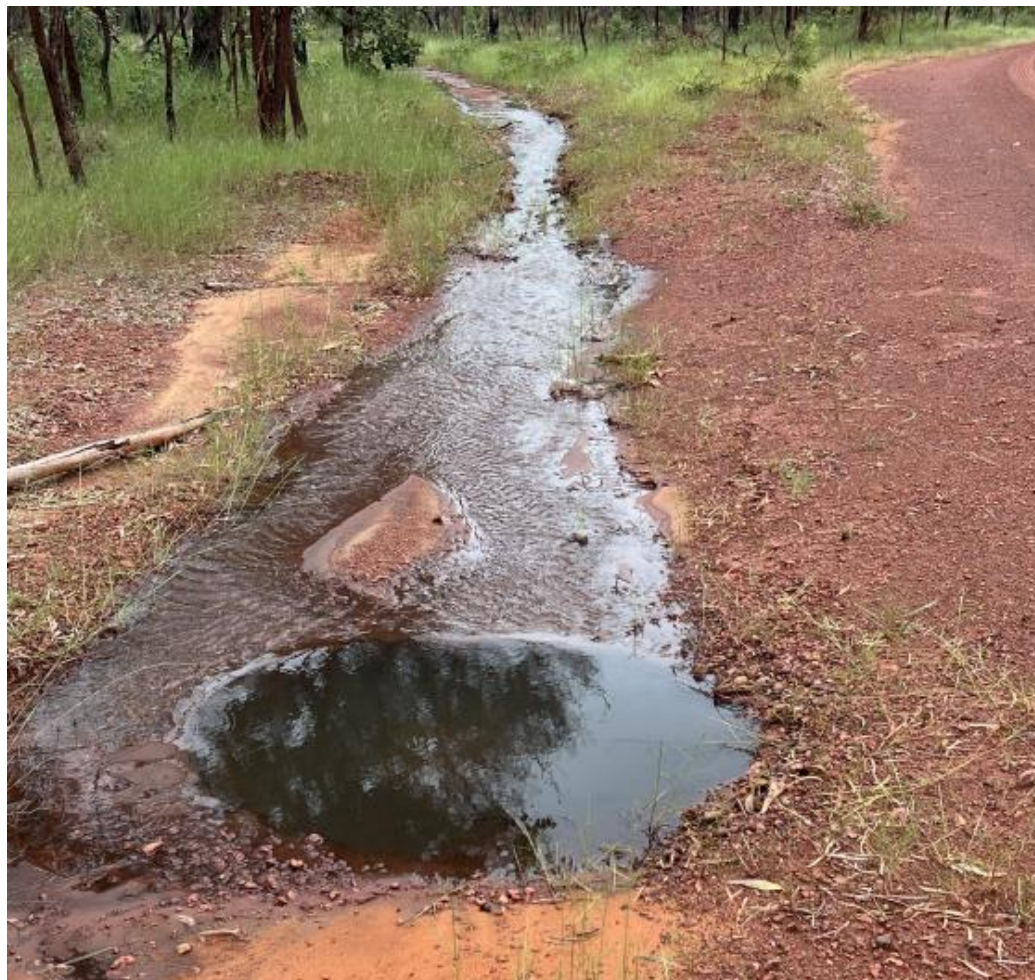
Appendix C – Picture of Overflow

<p><i>iii. Volume of the waste that was discharged.</i></p> <p>An estimated 10KL of diluted sewage was discharged that covered an area of approximately 10m².</p>	Date	Rainfall (mm)	03/05/2025	17.2	04/05/2025	1.8	05/05/2025	3.0	06/05/2025	27.8
Date	Rainfall (mm)										
03/05/2025	17.2										
04/05/2025	1.8										
05/05/2025	3.0										
06/05/2025	27.8										
<p>(b) the place where the incident occurred</p>	<p><i>i. Description of the PWC asset from which the discharge occurred.</i></p> <p>A leak has been detected in the SRM that runs between Sewer Pump Station 2 and the wastewater ponds servicing the community of Galiwinku (Appendix A and B). This SRM runs parallel to the access road for the ponds. The leak has been observed discharging into the adjacent bushland.</p> <p><i>ii. GPS coordinates of the discharge point from the PWC asset, and the final coordinates of the final discharge point.</i></p> <ol style="list-style-type: none"> 1. Discharge Point: 12 1.9976767 S, 135 35.0084293 E (SRM Leak) 2. Final discharge point: 12 2.0224382 S, 135 34.9694683 E (Bushland adjacent to SRM)

(c) the date and time of the incident	<p><i>i. The time and date of commencement and cessation of the discharge.</i></p> <p>The exact commencement time of the leak is unknown, but it is estimated that the leak occurred over a period of four days. As the leak has occurred underground it is assumed that the leak had been occurring for a number of days before the leak was detected on the surface</p> <p>The leak was first reported at approximately 12:00pm Sunday 4 May 2025.. The leak was repaired by 6/05/2025.</p> <p><i>ii. How PWC were notified, or became aware of the discharge.</i></p> <p>The leak was initially reported to the Power and Water Technical Co-ordinator responsible for this community.</p> <p><i>iii. The process by which the discharge occurred.</i></p> <p>The leak has occurred from an underground SRM. The cause of the break is unknown. Pressure testing will be undertaken on this SRM to check for further leaks.</p> <p><i>iv. The reason why the discharge occurred.</i></p> <p>As per (c) iii. PWC will investigate the fault and ensure that it is rectified as soon as practical.</p>

(d) how the pollution has occurred, is occurring or may occur	As per (c) iii & (c) iv.
(e) the attempts made to prevent, reduce, control, rectify or clean up the pollution or resultant environmental harm caused or threatening to be caused by the incident	<p><i>i. Confirmation signage and fencing has been erected, as appropriate.</i></p> <p>Temporary fencing will be installed to protect the public until repairs can occur.</p> <p><i>ii. Decontamination of the site as appropriate.</i></p> <p>Clean up consistent with Sewage Spills/Overflow Response Work Instruction as appropriate to the location, and to minimise risk to the environment.</p>
