PROJECT SEA DRAGON  
BYNOE HARBOUR  
BROODSTOCK BREEDING FACILITY

MONITORING REPORT – JUNE 2023 TO MAY 2024

### **Re: ESCP Compliance Inspection – Project Sea Dragon – Bynoe BMF**

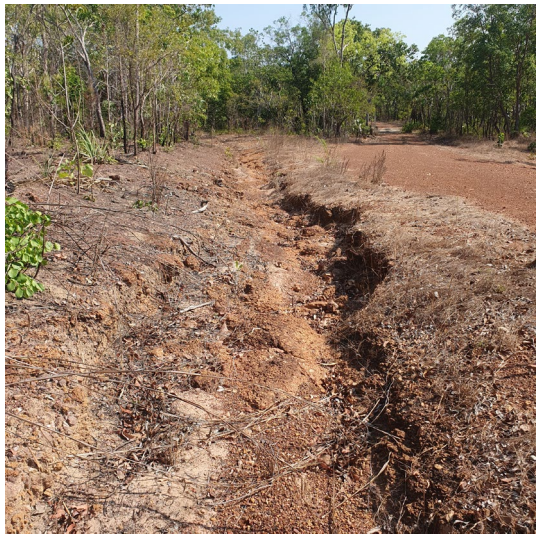
At irregular intervals, scour is commencing in road table drains where the gradient steepens. A watch should be maintained on these and if scour increases the drains require reshaping and installation check dams to reduce flow velocity deepening of the scour. An example is seen at site 1.

| Site No. | Comment<br>Latitude and Longitude | Photographs |
|---|---|---|
| <b>Site 1</b><br>Road access | Gully erosion: Gully in table drain toward creek west side. This drain displays active scour.<br><br>This, and other similar scoured areas should be repaired in accordance with IECA guidelines. See standard IECA Drawing RCD-1 attached.<br><br>-12.7792101<br>130.5545956 | |

1. Scour in table drains (see example site 1) should be checked regularly and repaired and stabilised if the width and depth continues to increase.
2. Culverts at Site 4 should be upgraded as traffic increases.
3. The gully at the downstream side of the causeway should be stabilised.
4. Maintain routine maintenance of mitre drains.
5. Repair rills at site 10 on the discharge ponds bund and stabilise with soil binder.

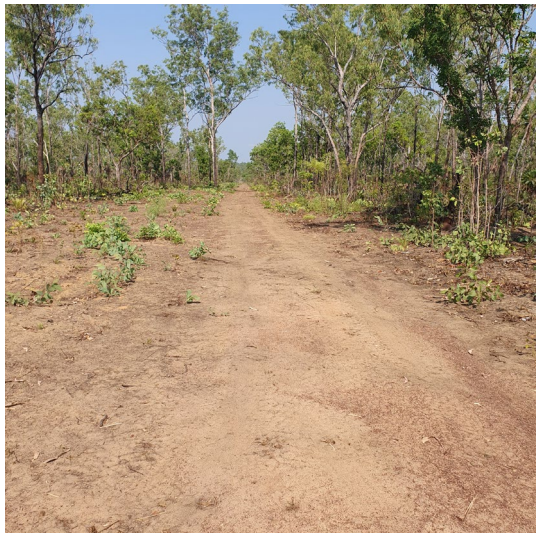
| Site No. | Comment<br>Latitude and Longitude | Photographs |
|---|---|---|
| <b>Site 2</b> | Fire break property boundary. Slashed and well maintained.<br>-12.7703034<br>130.554576 | |

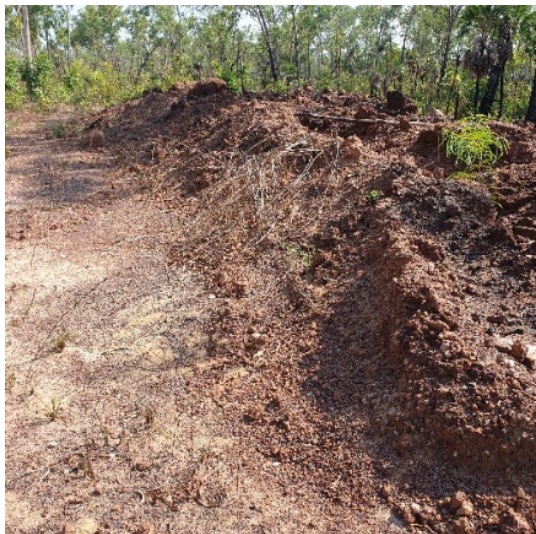
| Site No. | Comment<br>Latitude and Longitude | Photographs |
|---|---|---|
| <b>Site 3</b> | Soil unknown source. Gravelly soil. Little erosion.<br><br>-12.7701448<br>130.5546857 | |

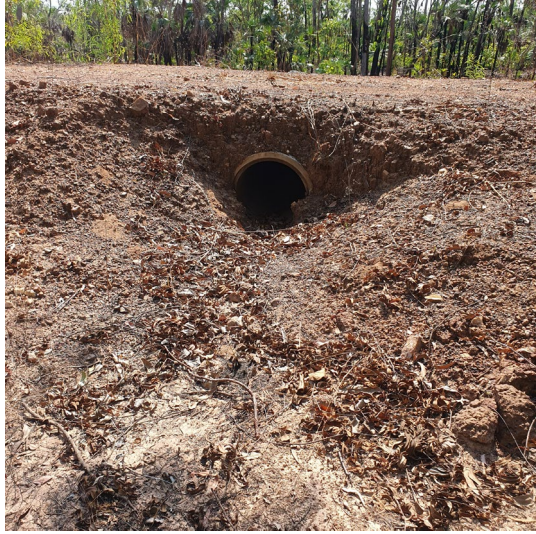
At site 4, a creek crossing was inspected. The culvert at this location needs to be properly designed and installed in accordance with the International Erosion Control Association (IECE) best practice methods. It is understood that a decision is yet to be made as to whether a causeway will be constructed, or the culverts upgraded. The soil at this is comprised large gravel and few fines so does not present a significant erosion risk.

| Site No. | Comment<br>Latitude and Longitude | Photographs |
|---|---|---|
| Site 4 | <p>Creek crossing.<br/>Determine peak discharge for pie or causeway design. If retaining pipe, wingwalls will be required to stabilise road batters.</p> <p>-12.7590654<br/>130.5545697</p> | <p><b>Photograph 1</b></p> |

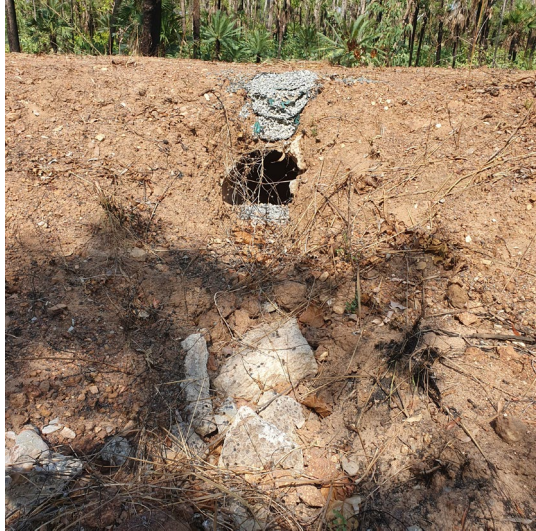
| Site No. | Comment<br>Latitude and Longitude | Photographs |
|---|---|---|
| | <p>Downstream damaged pipe concrete in swale to control erosion.<br/>May need riprap energy dissipater downstream.<br/>Road surface above outlet also eroding. This will need repair once operations begin</p> <p>-12.7590654<br/>130.5545697</p> | <p><b>Photograph 2</b></p> |

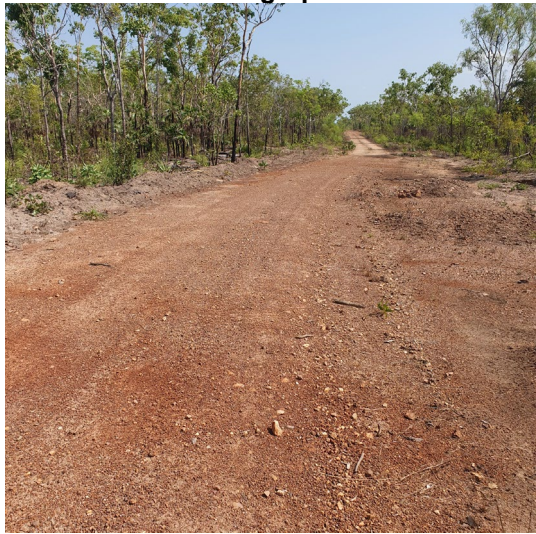
| <p><b>Site 5</b><br/>Road Access</p> | <p>Works completed.<br/>-12.7469427<br/><br/>130.5545366</p> | <p><b>Photograph 1</b></p> |

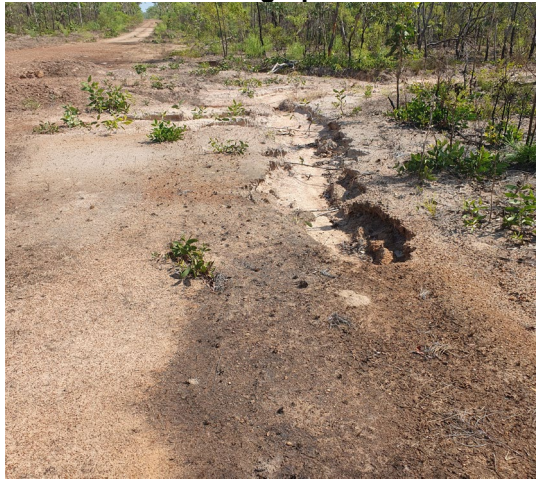
Site 5 shows erosion of fine material where a causeway was repaired. This should be stabilised.

| | <p>Gully east side causeway. To be repaired.</p> <p>Repair in accordance with IECA guidelines. See standard IECA Drawing RCD-1 attached.</p> <p>-12.7469427<br/>130.5545366</p> | <p><b>Photograph 2</b></p> |

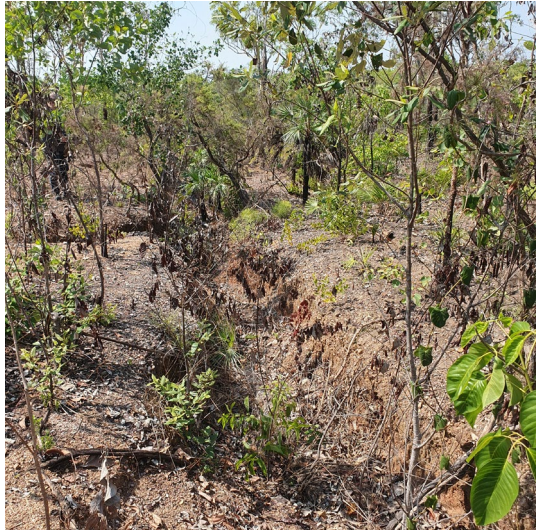
Sites 6 and 14 show what may be erosion incision into historic wheel ruts. These gullies appear to be stable as head cut is not observed at the top of the gullies. This would be best observed during the wet season to form a decision on how this should be managed.

| <p><b>Site 6</b><br/>Road access</p> | <p>Large gully west side of road. Trees growing in it. Needs repair. Although this may be an historic issue. Monitor during the wet season to determine if increasing in size and whether repair is required.</p> <p>-12.7347787<br/>130.5541025</p> | |

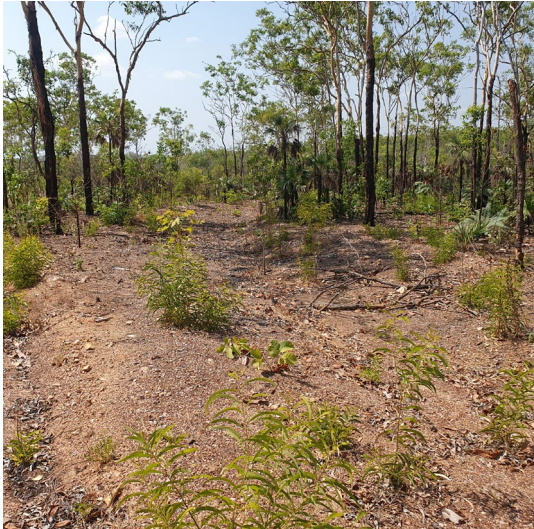
Site 7 shows a typical mitre drain installed as recommend and functioning correctly.

| <p><b>Site 7</b><br/>Mitre drain</p> | <p>Typical mitre drain functioning correctly.</p> <p>-12.7345347<br/>130.5538666</p> | |

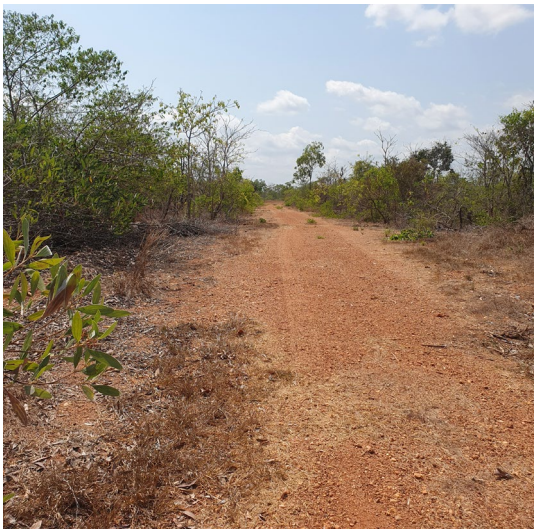
| <p><b>Site 8</b><br/>Intake Ponds</p> | <p>No erosion.<br/>Intake pond pipeline corridor.</p> <p>-12.7103162<br/>130.5492265</p> | |

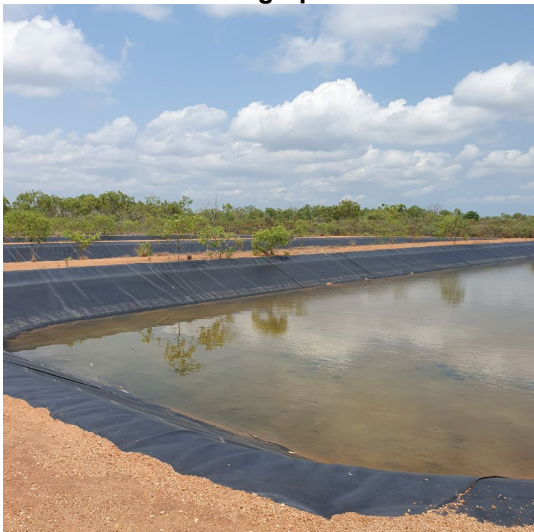
| <p><b>Site 9</b><br/>Intake Ponds</p> | <p>Good condition.<br/>Recommend removal trees from bunds. Mostly Acia sp. When trees die the holes left by roots may cause tunnelling in bunds.</p> <p>-12.7114752<br/>130.5510164</p> | <p><b>Photograph 1</b></p> |

It is recommended that trees are removed from bunds.

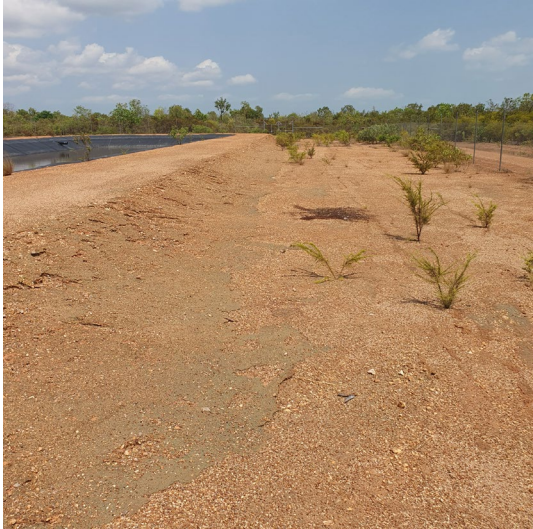
| <p><b>Site 9</b><br/>Intake<br/>Ponds</p> | <p>Soil binder may need reapplication. Inspect during wet season.</p> <p>-12.7114752<br/>130.5510164</p> | <p><b>Photograph 2</b></p> |

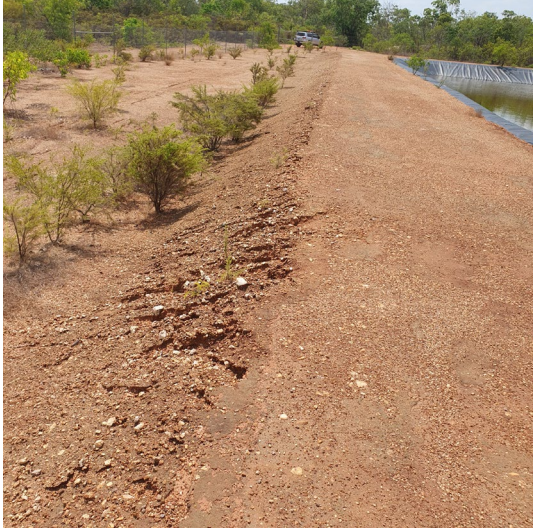
Site 10 shows rills developing in the crest of the discharge ponds bund. These should be monitored over the wet season and repaired once construction starts.

| <p><b>Site 10</b><br/>Discharge<br/>Ponds</p> | <p>Rill erosion. Rills on pond embankment. These should be repaired, and soil binder applied to maintain integrity of bund. Monitor during wet season. If increasing in size, repair.</p> <p>-12.7110629<br/>130.5505108</p> | |

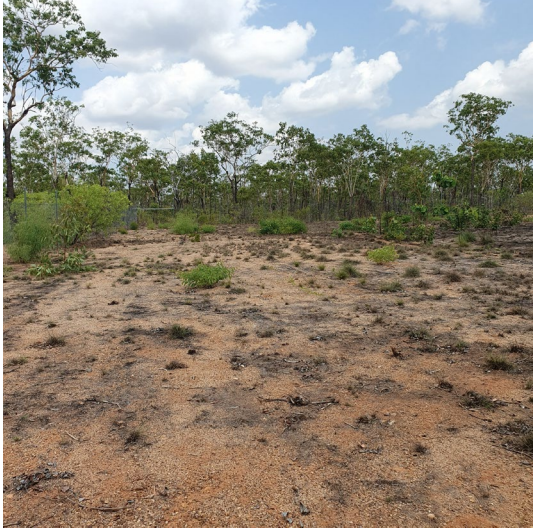
| <p><b>Site 11</b><br/>Residences</p> | <p>No erosion issues.</p> <p>-12.7313572<br/>130.5450745</p> | |

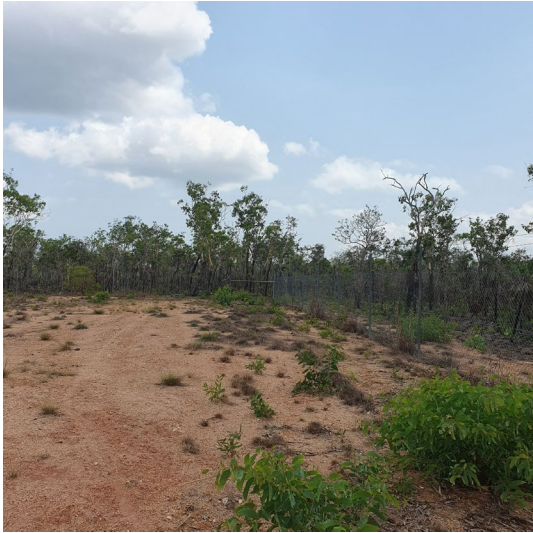
| <p><b>Site 12</b><br/>Residences</p> | <p>No erosion issues.</p> <p>-12.7321039<br/>130.5400147</p> | |

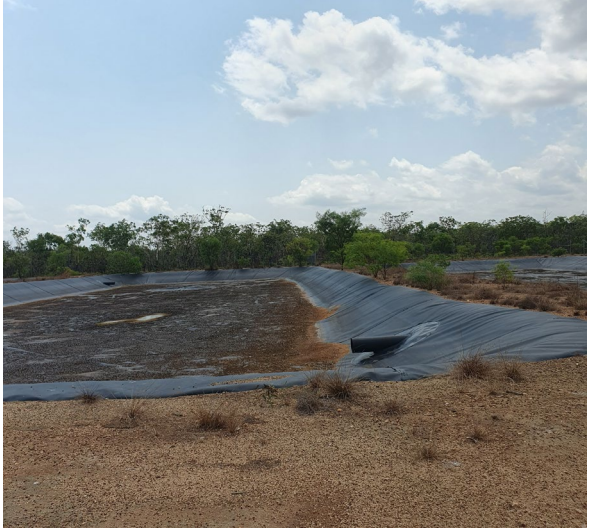
| <p><b>Site 13</b><br/>Discharge<br/>Ponds</p> | <p>No erosion.</p> <p>Recommend removal trees on crests of wall to maintain structural integrity. Residual soil binder. No works required.</p> <p>-12.7300383<br/>130.5345552</p> | |

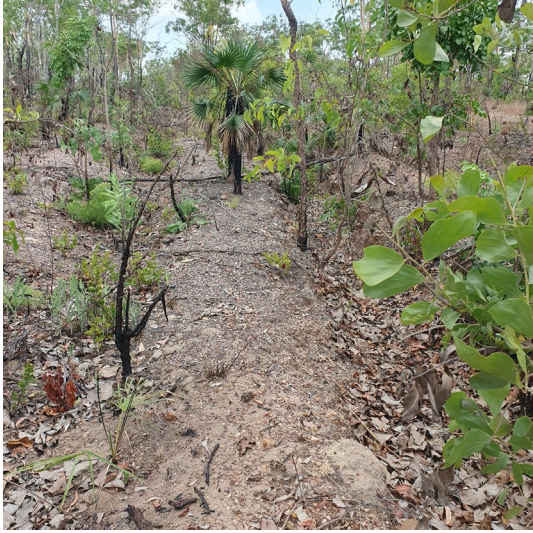
| <p><b>Site 14</b><br/>Road<br/>Access</p> | <p>Gully erosion. Downstream end of large gully. Look like large wheel ruts. This may be historic.</p> <p>-12.7352979<br/>130.5541765</p> | |

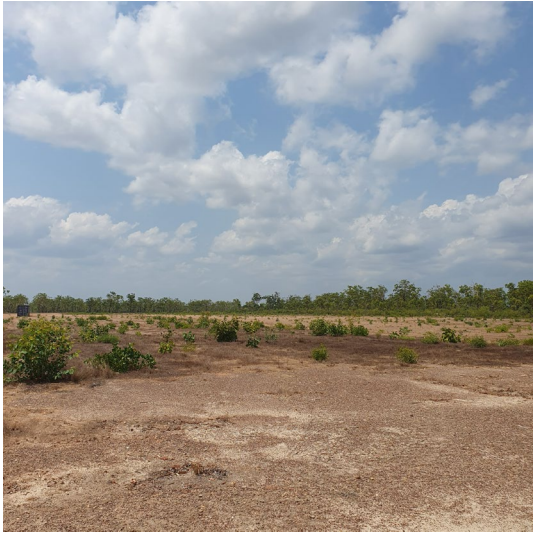
| <b>Site 15</b><br>Broodstock<br>Maturation<br>Centre | No erosion.<br>Slashed yearly. No inflow.<br>Direct rainfall.<br><br>-12.7251589<br>130.5427795 | |
