# **JERVOIS PROJECT EIS SUPPLEMENT TRAFFIC**

**CONSONE CONSULTING PTY LTD  
CLIENT: KGL RESOURCES**

KGL RESOURCES JERVOIS MINE – EIS SUPPLEMENT - TRAFFIC

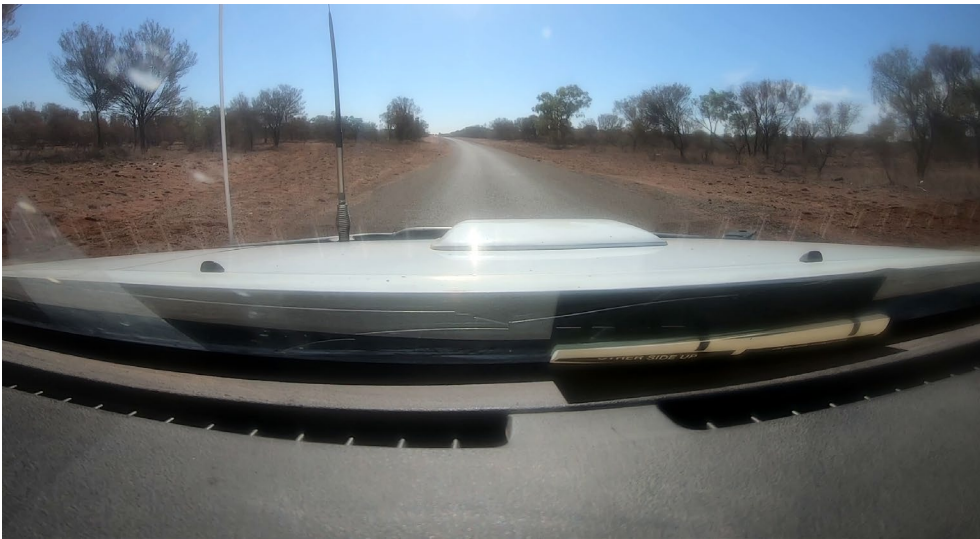
Over recent years the NT Government has been undertaking an ongoing upgrade of sections of the Plenty Highway that were originally single sealed lane with gravel shoulders. In the areas where the single lane has been widened the road is considered in good condition with a very good join between the single lane and the new widening.

Photo 2 - Widened Single seal to Double Seal

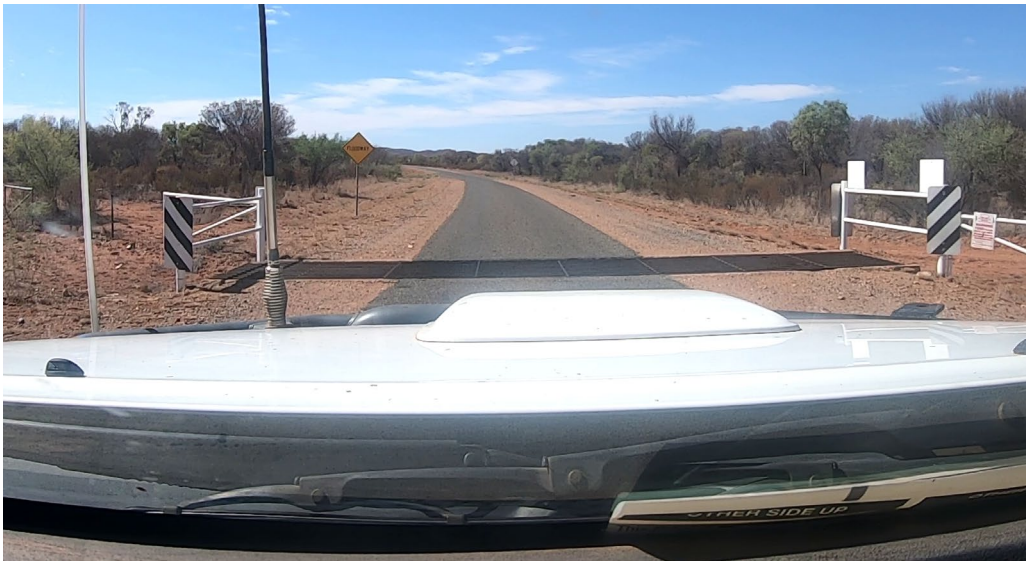
- In the location where the formation changes from double seal to single the transition taper treatment required under AUSTROADS Guidelines is not in place (refer Section 8 Road Safety)

- The overall condition of the seal apart from the edges is generally in good condition and suitable for widening in a similar manner to the upgrades that have been undertaken to widen the single lane seal previously

Photo 3 - Single Lane Seal and Gravel Shoulders

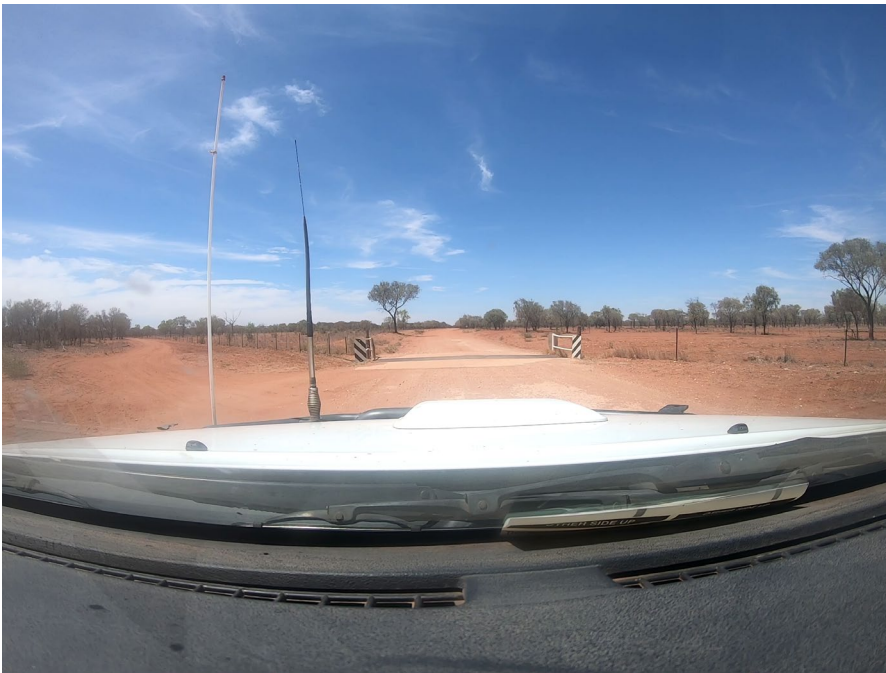
- Lack of delineation with little or no guide posts. Given the extensive clear zone in these sections this is not considered a major issue
- In some cases maintenance grades have been undertaken and the windrow from the grade has blocked off-let drains. This may lead to drainage issues in periods of inclement weather
- A small number of floodway's do not drain adequately – this over time will cause local failures of the wearing coarse
- Sections of the gravel formed roads are generally considered in good condition and with regular maintenance and ongoing re-sheeting program are suitable for the proposed traffic load
- In a number of locations table drain off-let drains do not daylight – (In many cases drains actually appear to drain uphill. This will be an issue for inundation of pavement during inclement weather).

Photo 4 - Gravel Pavement

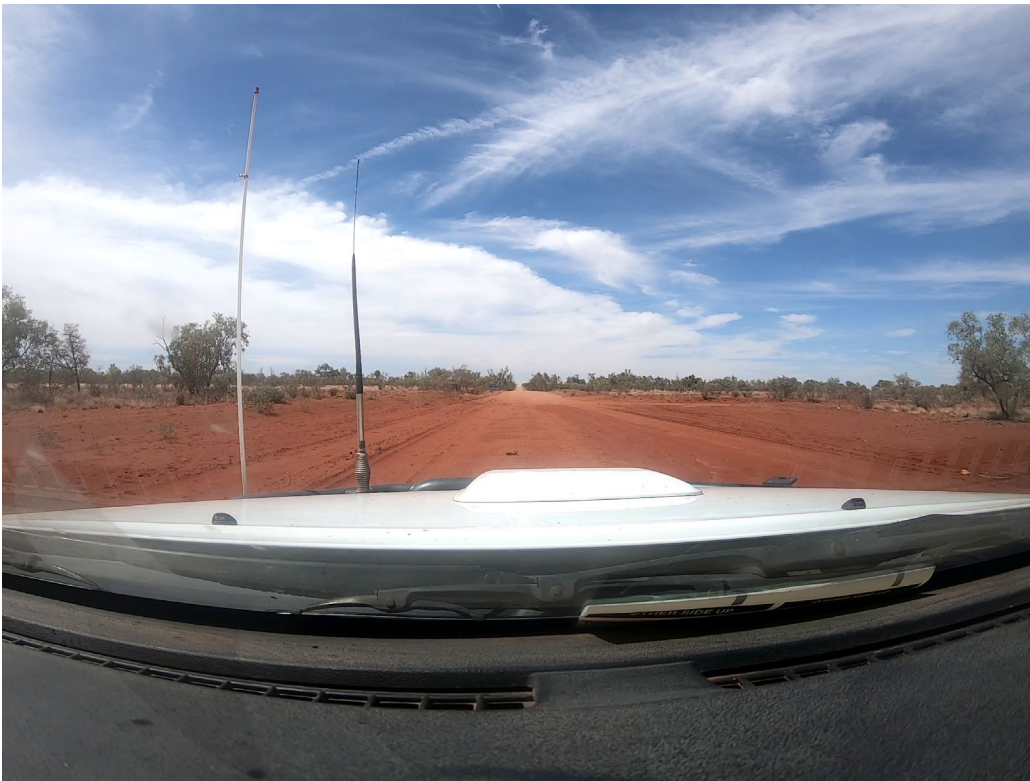
These sections are considered to be a priority for upgrade and maintenance and this is confirmed with DIPL.

Photo 5 - Sandy/Loam Gravel Pavement (Low Profile)

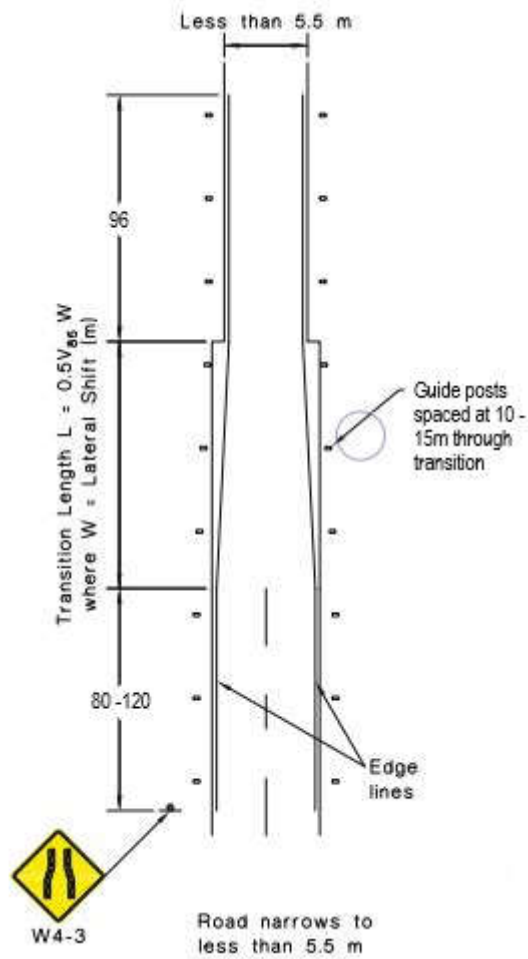
Guide posts are either missing or not installed in accordance with AS1742.2 at the narrowing treatments on both roads. Guide posts should be installed in accordance with Figure 1.

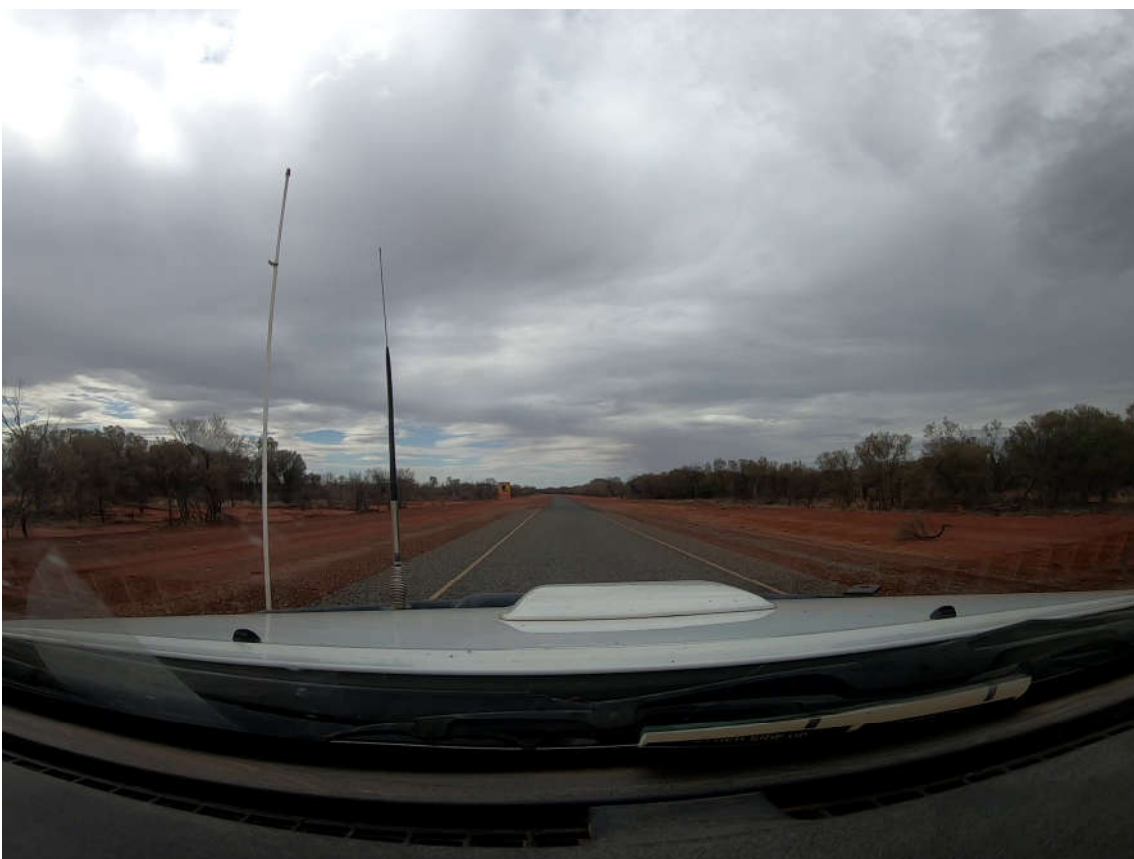
Photo 2 – One lane treatment Ch. 5.60km

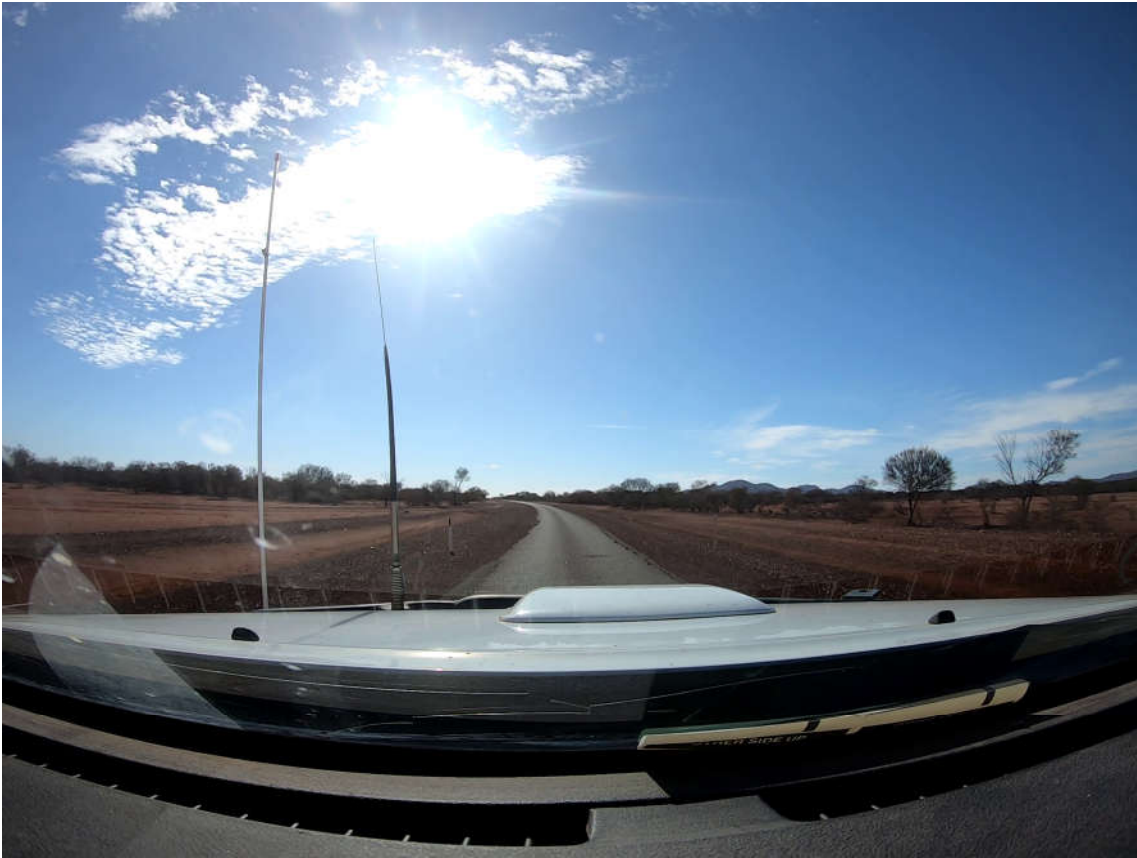
Photo 3 – Edge failing

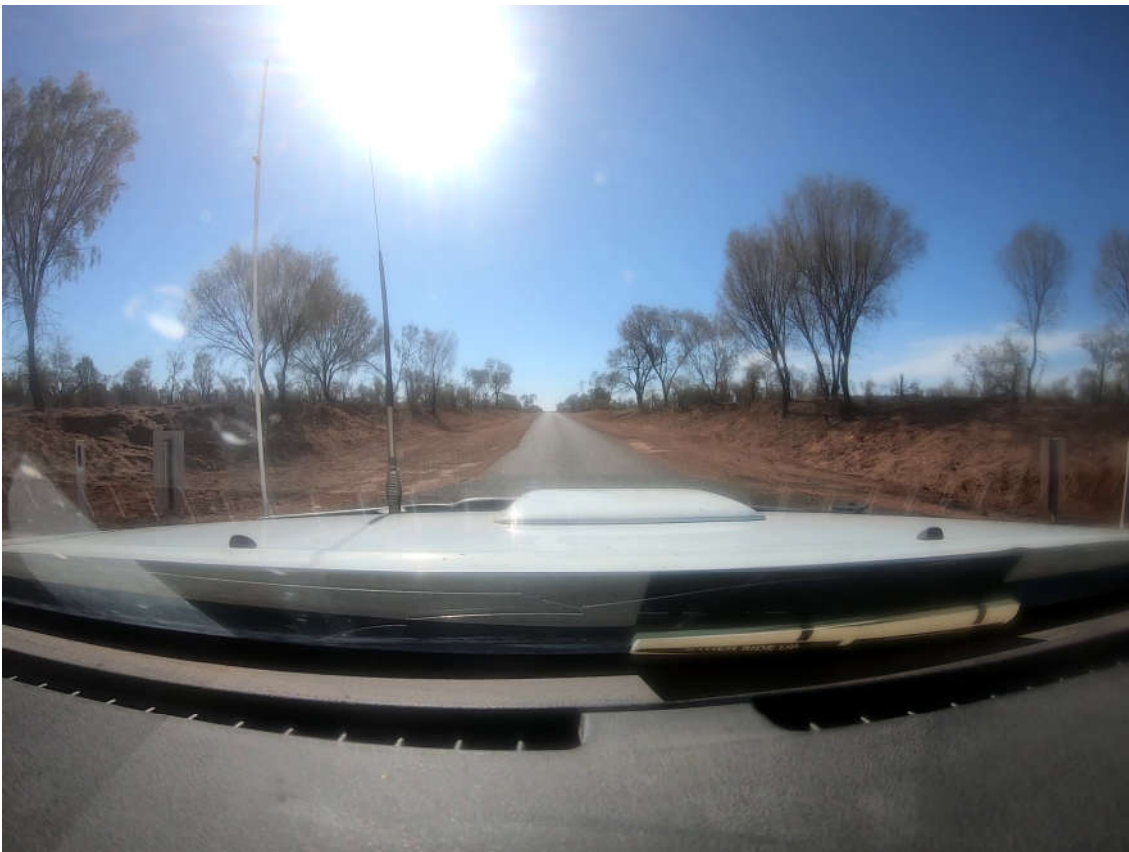
Photo 4 – Poor sight distance

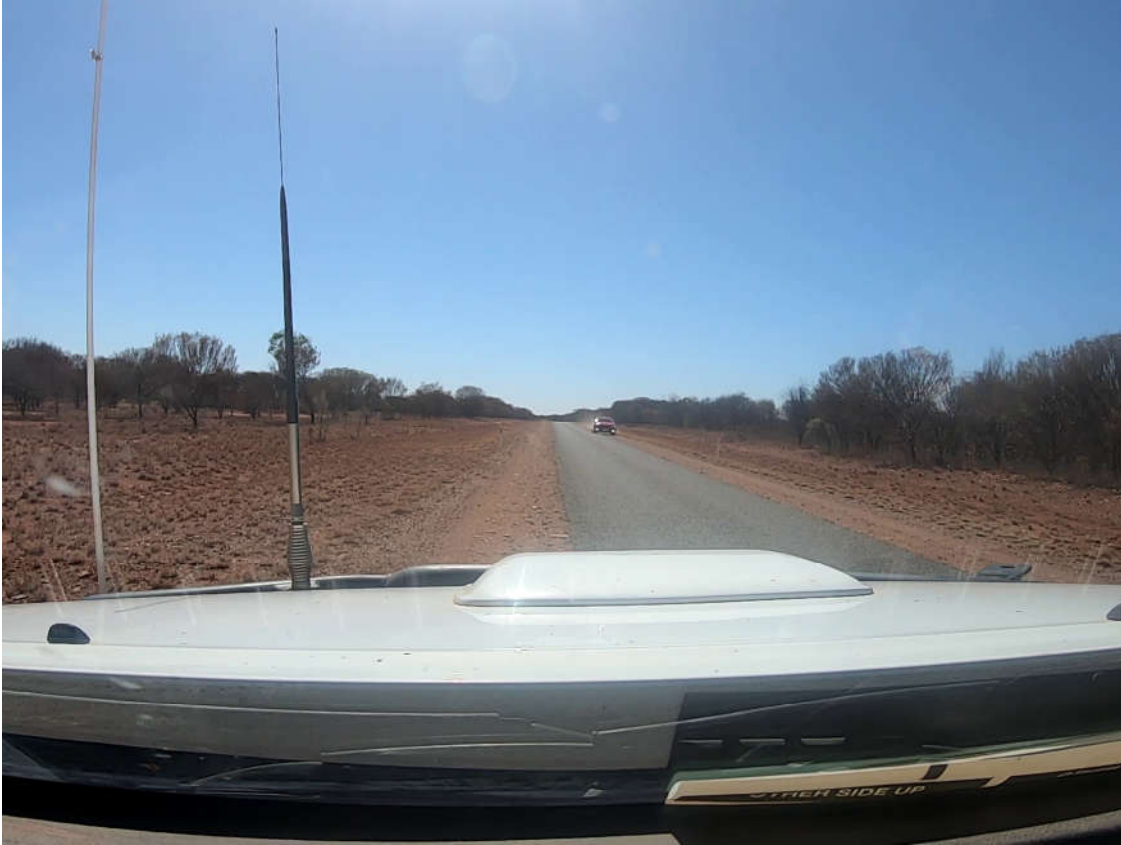
Photo 5 – Large drop off from seal to shoulder

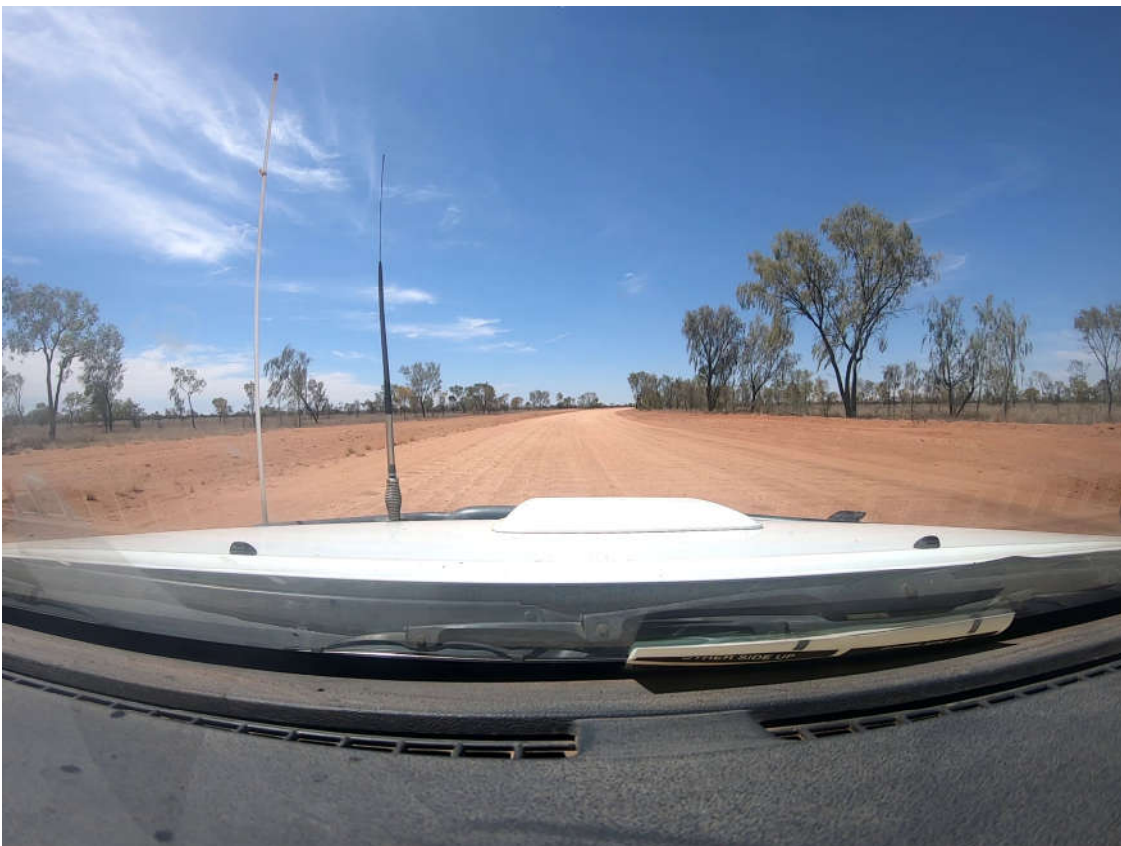
Photo 7 – Trees block sight distance through horizontal curve

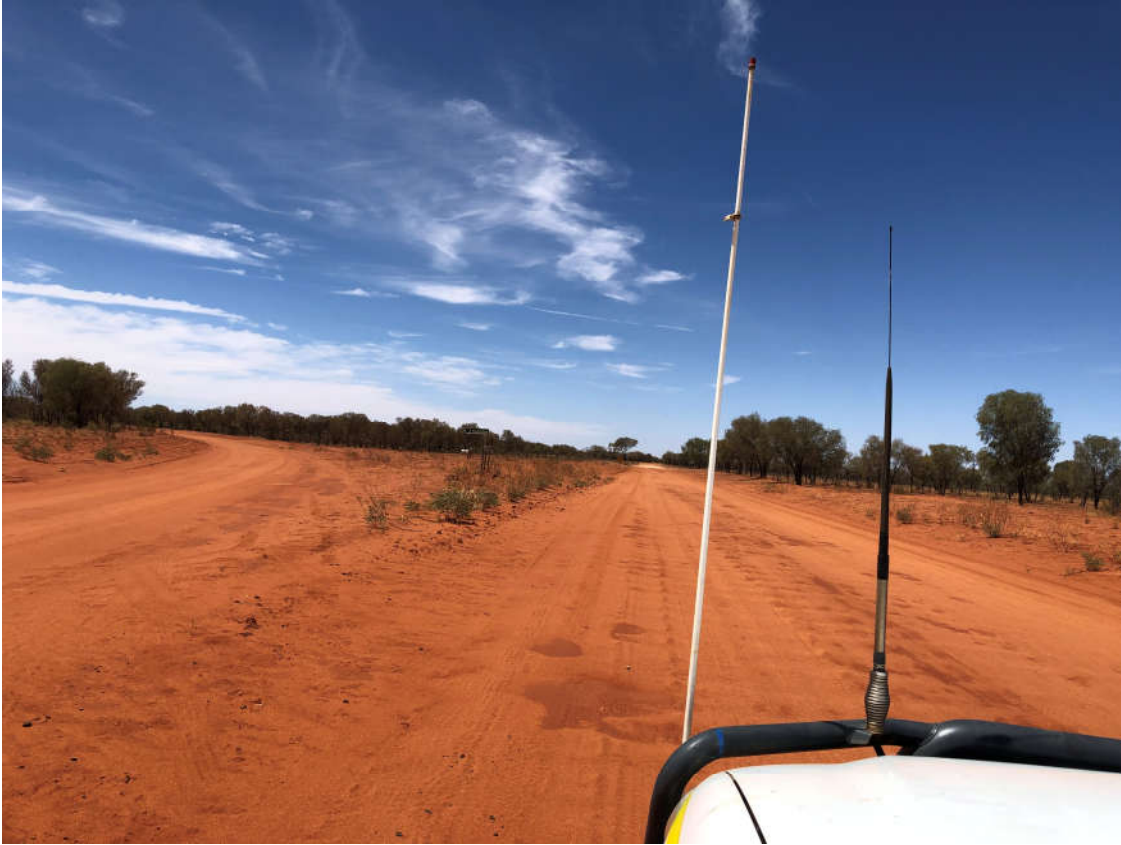
Photo 8 – Confusing intersection layout – Huckitta Intersection

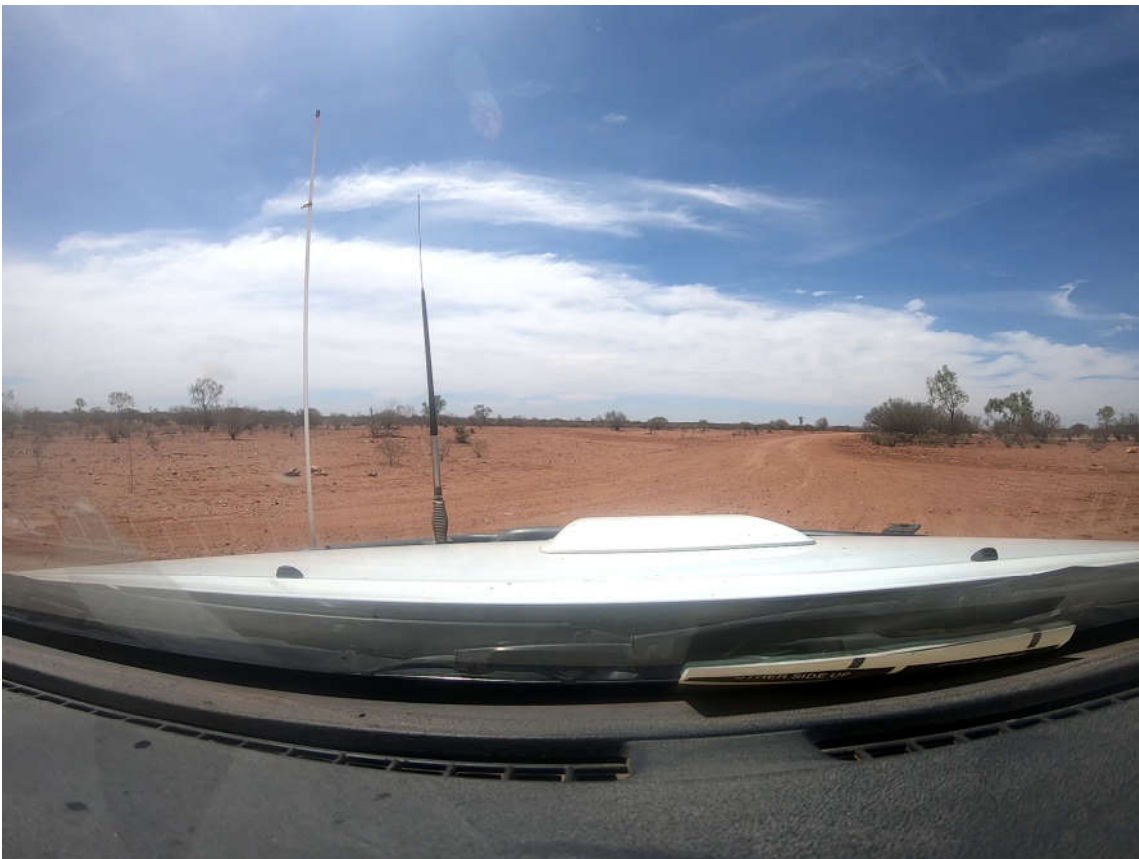
Photo 9 – Jinka turn off intersection – poor sight distance

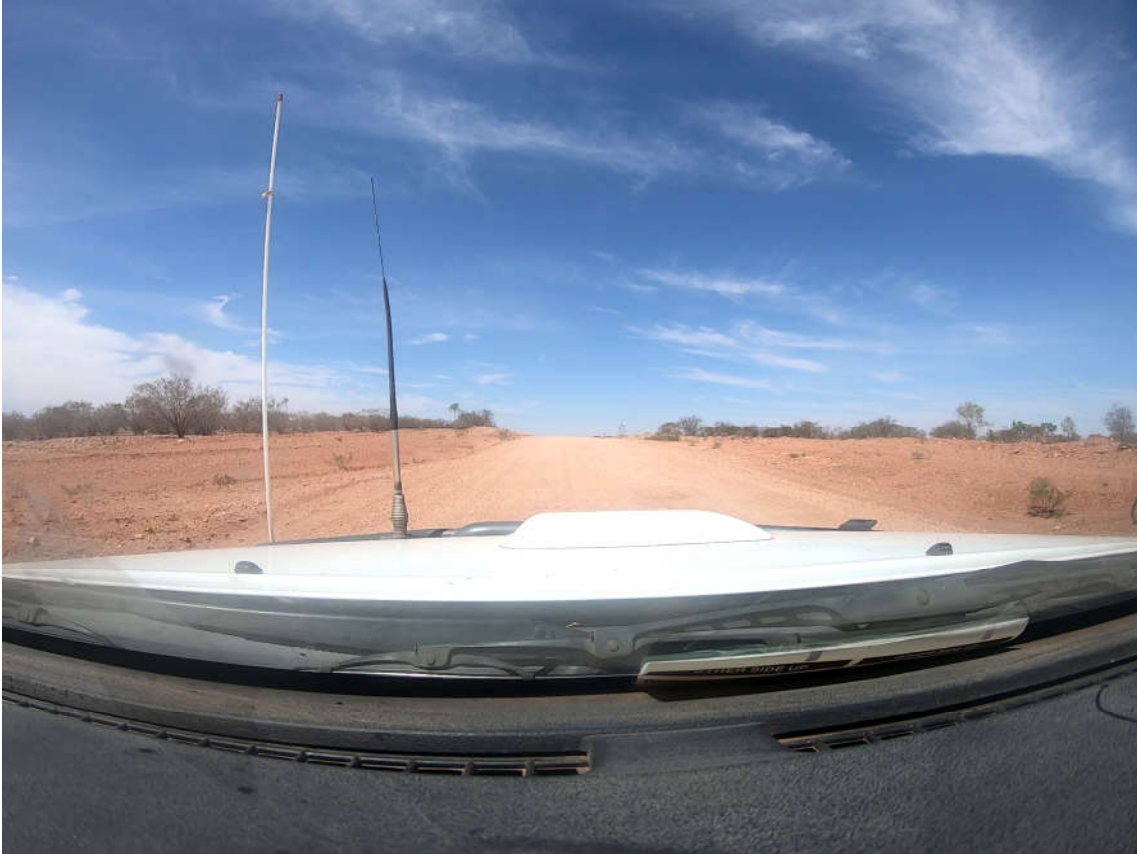
Photo 10 – Insufficient sight distance to crest at Ch. 229.09km

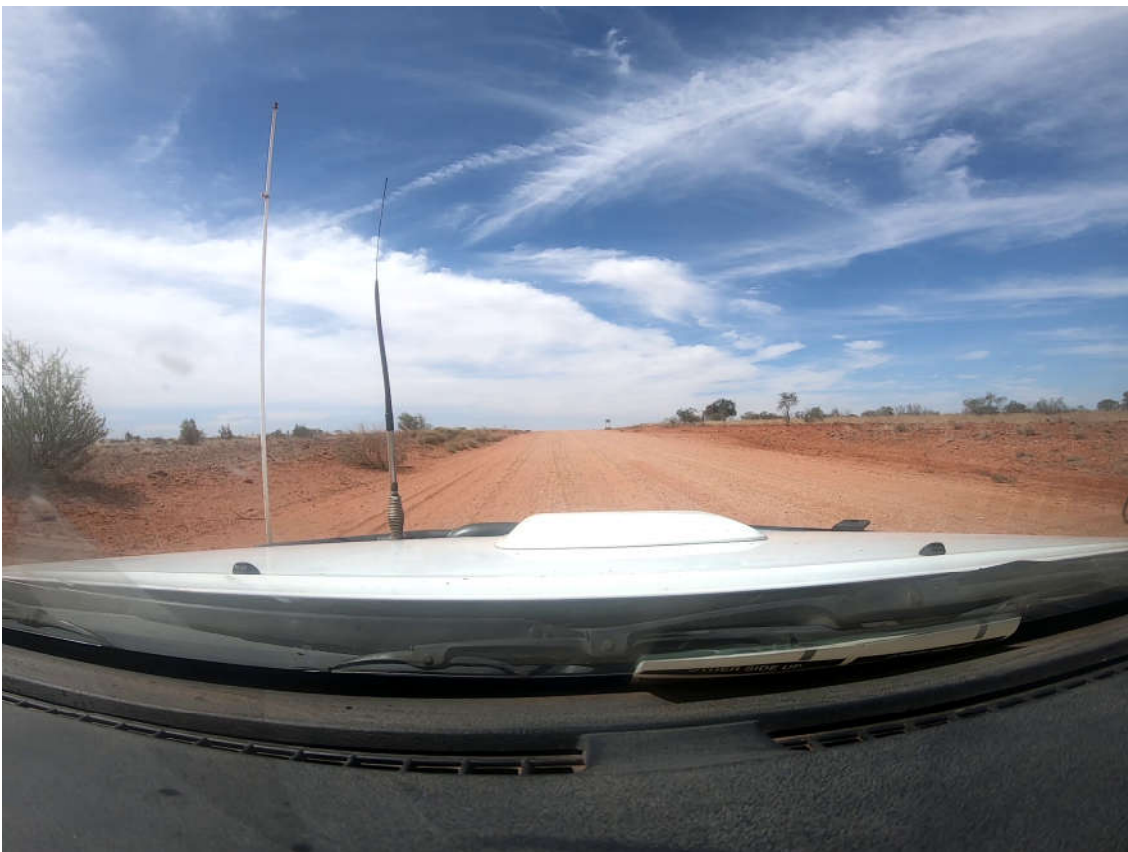
Photo 11 – Poor sight distance to crest at Ch. 273.20km

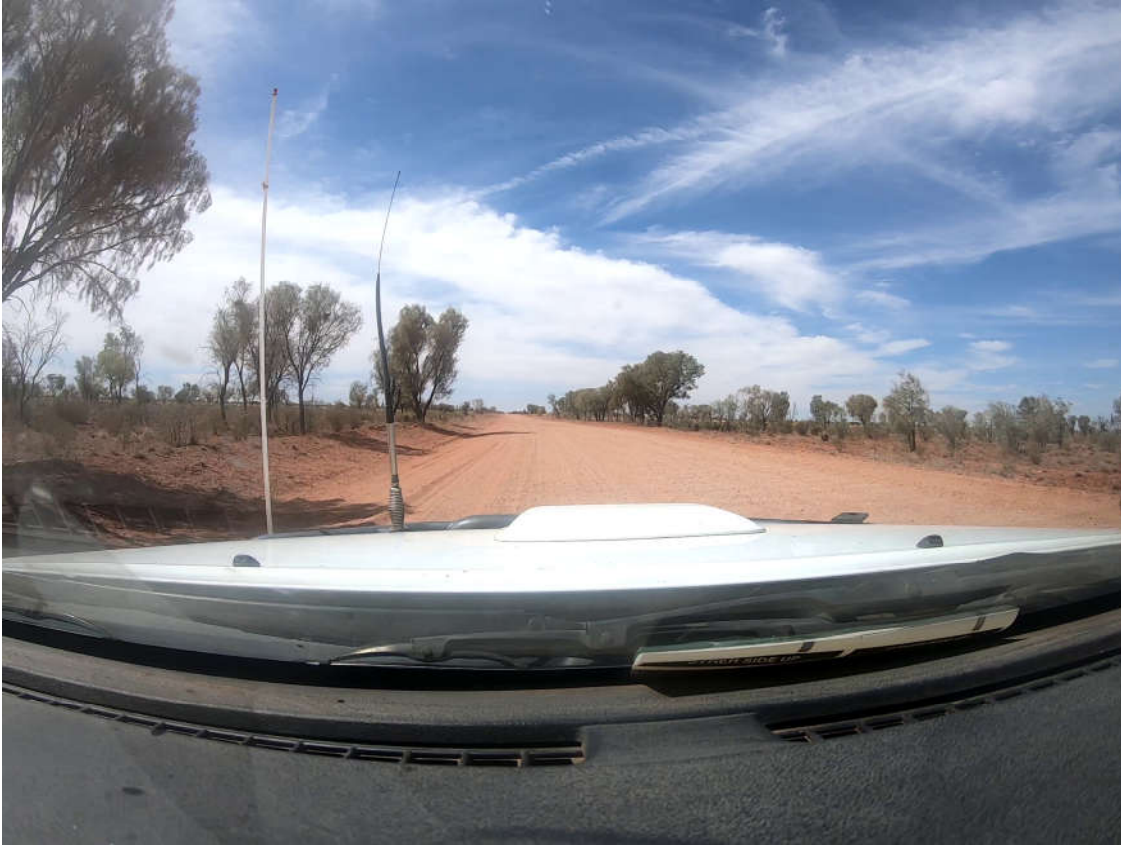
Photo 12 – Trees in clear zone

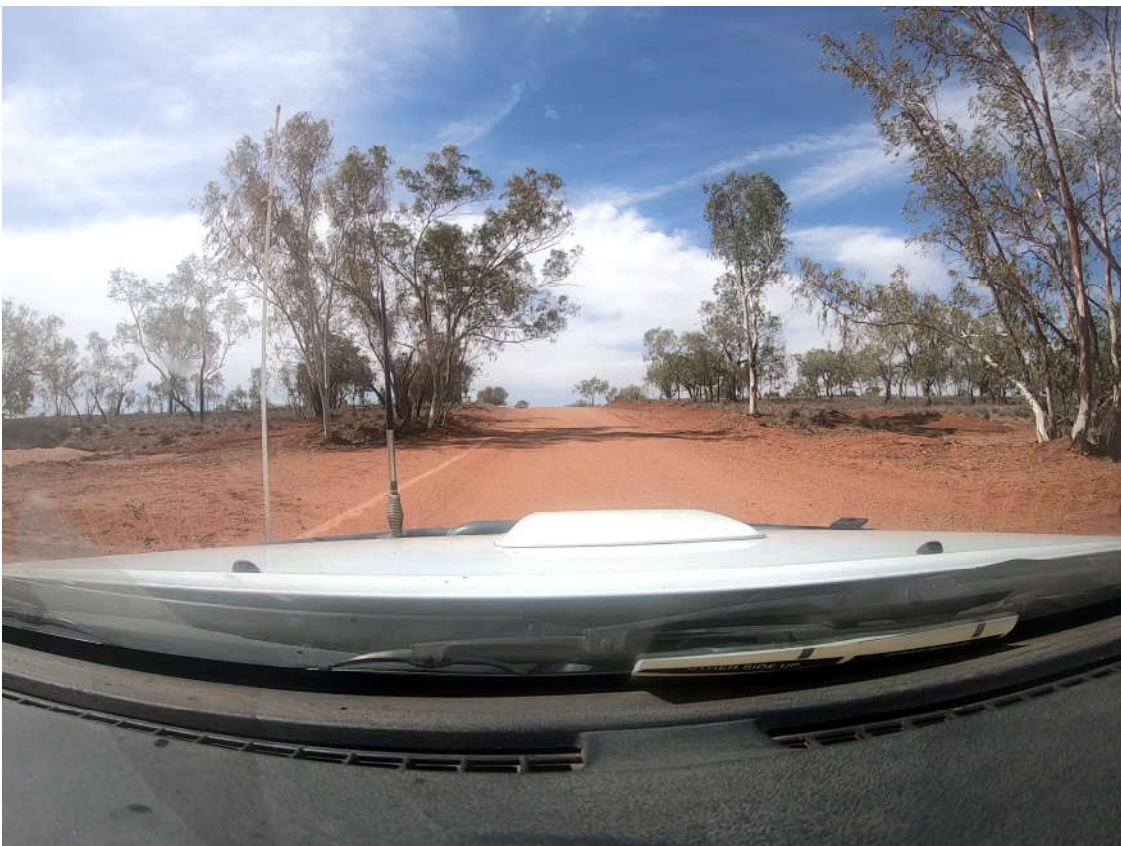
Photo 13 – Poor sight distance to crest

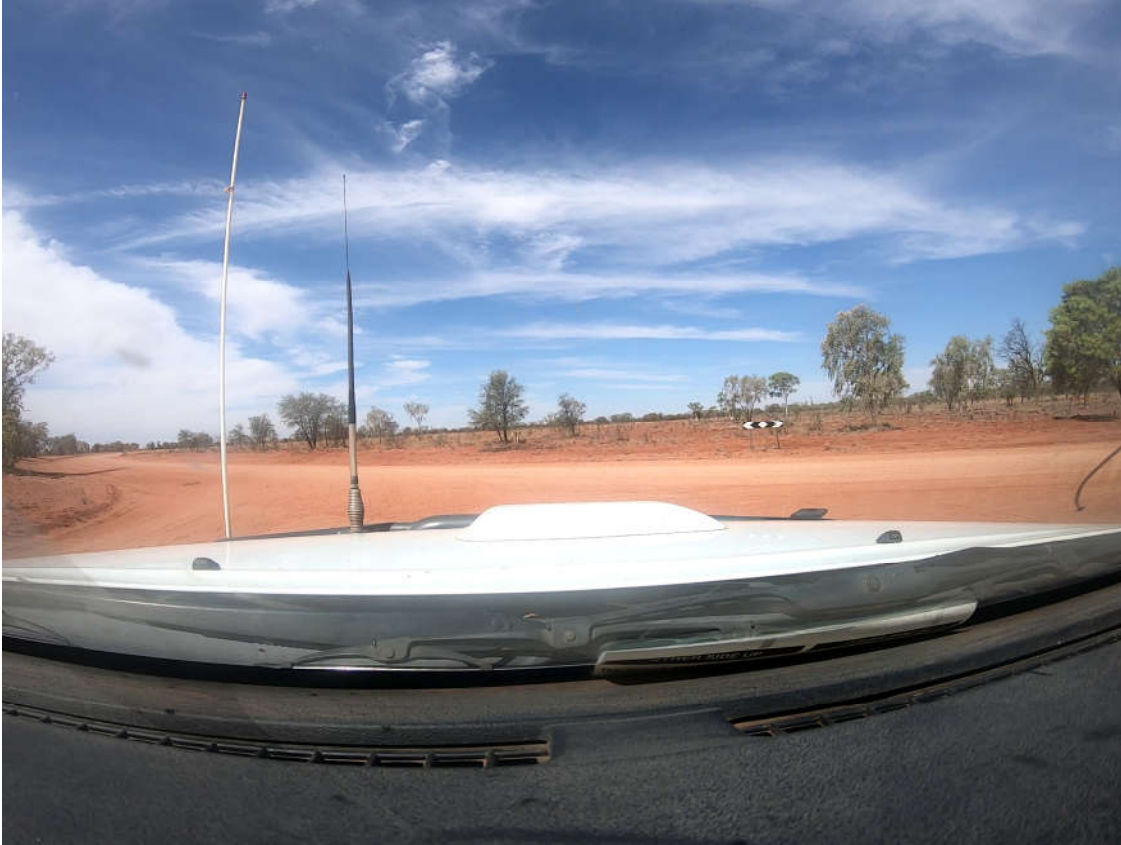
Photo 14 – Insufficient sight distance to Jervois intersection

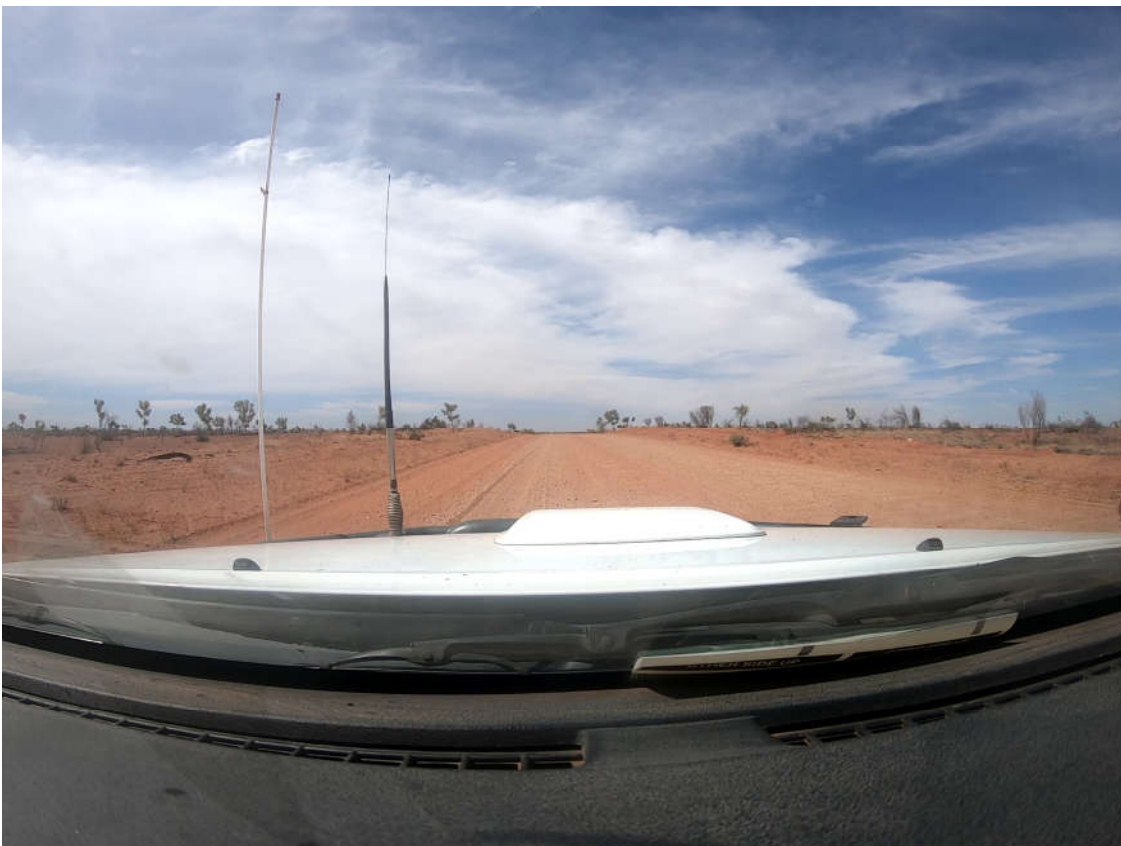
Photo 15 – Poor sight distance to crest

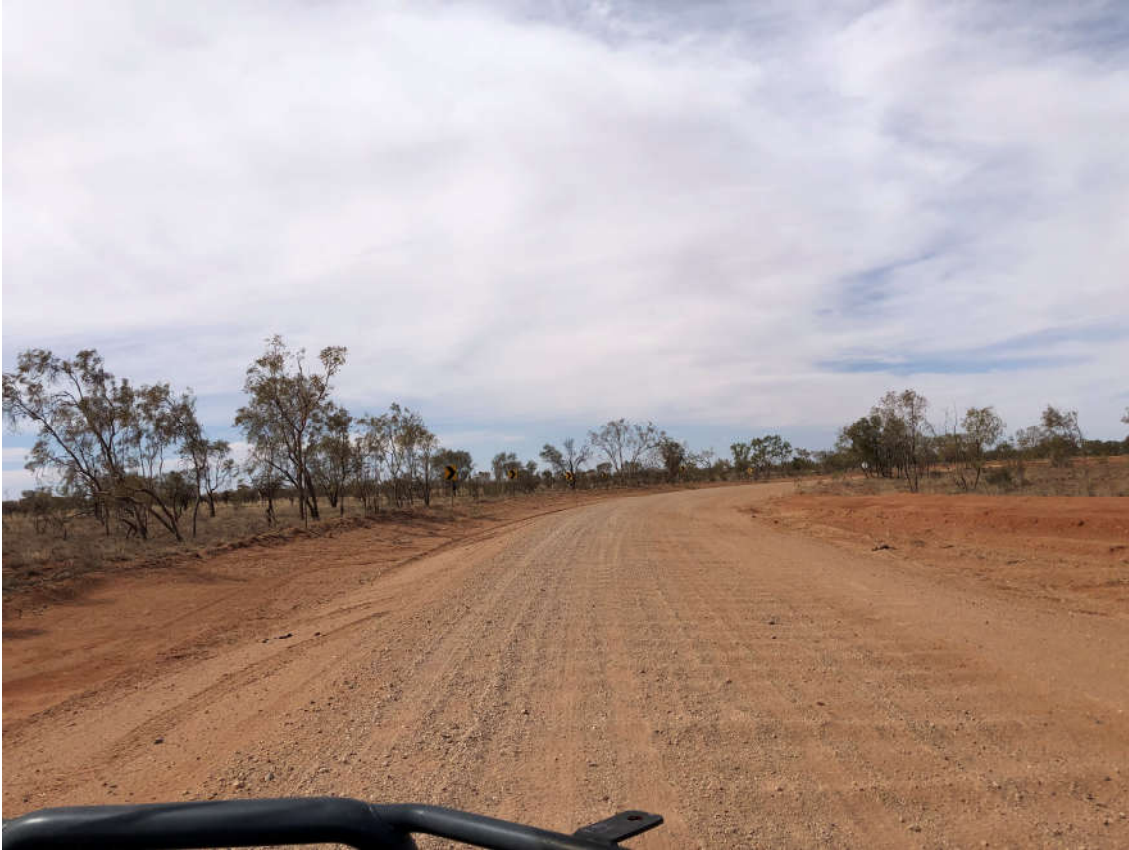
Photo 16 – Sub-standard horizontal curve immediately before Lucy Creek Access

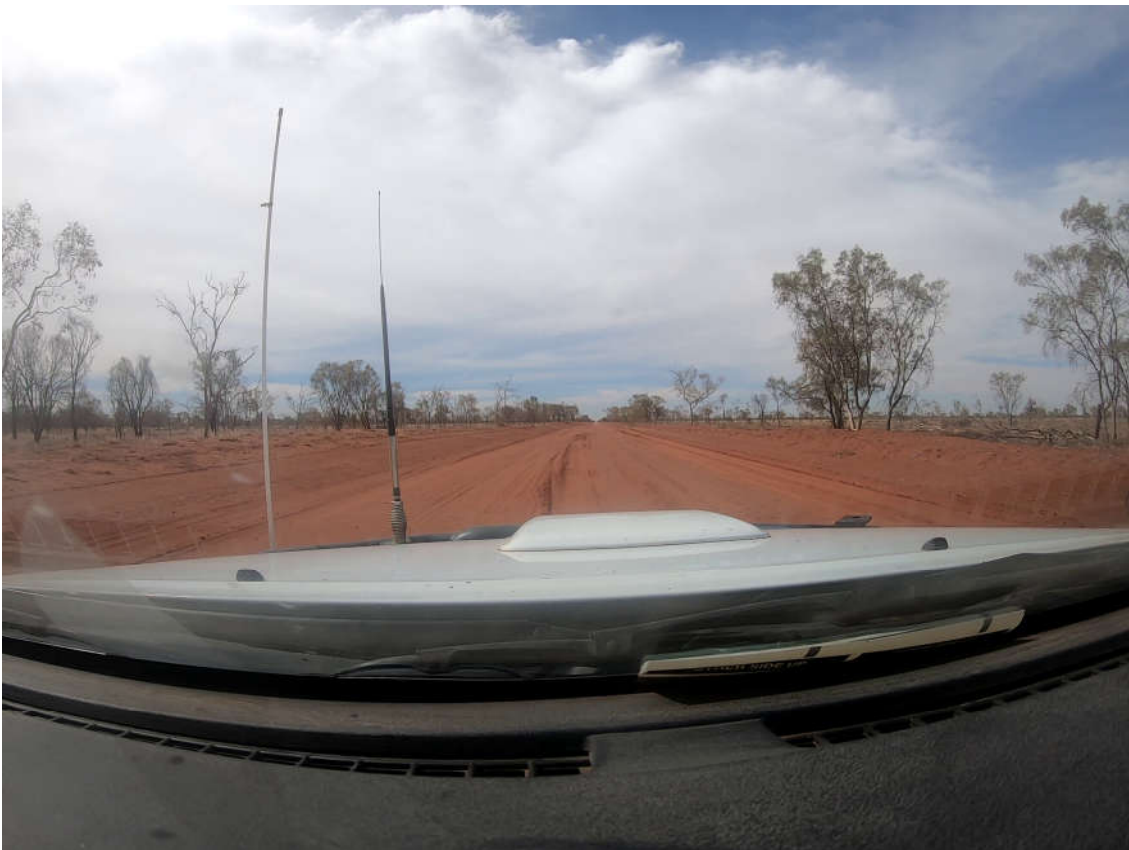
Photo 17 – Poor pavement with low profile and no stormwater egress

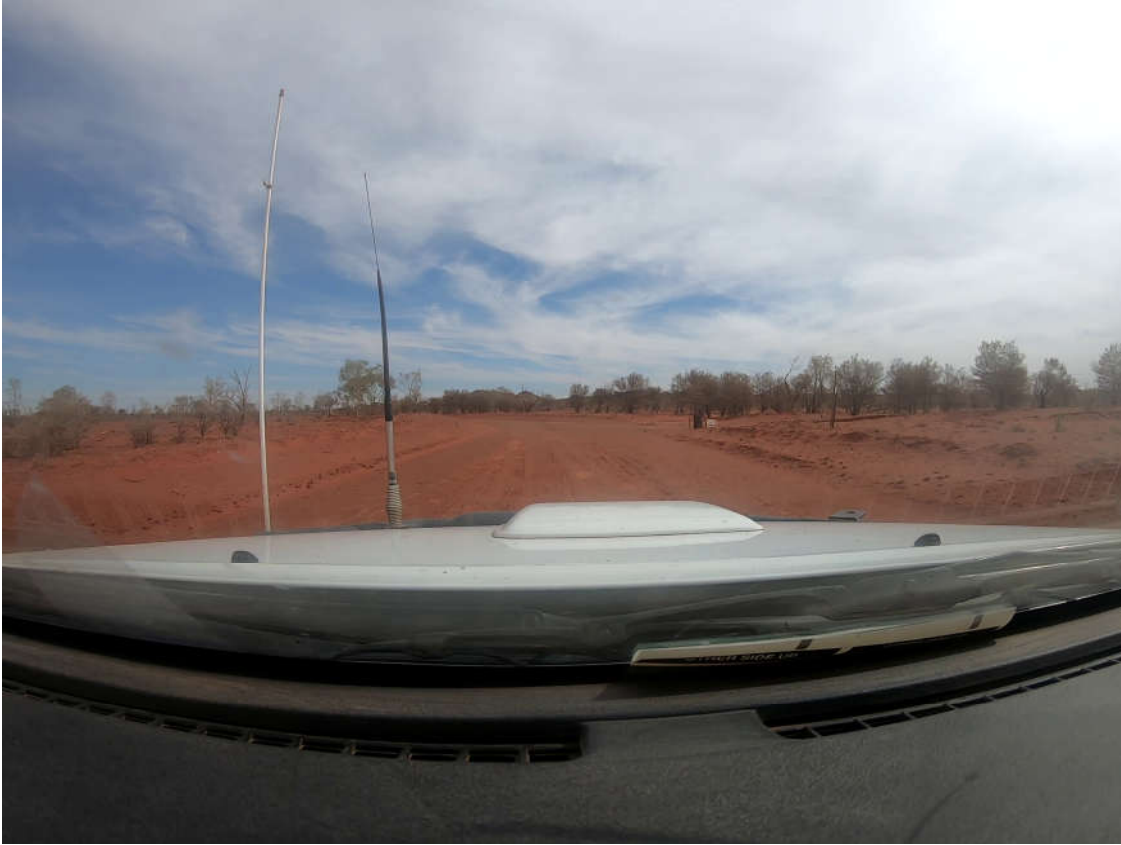
Photo 18 – Site access, poor angle of approach
