Site Audit Report ALC_1 by Dr Ian Swane

REMEDIATION OF ASBESTOS CONTAMINATION AT THE FORMER BARTALUMBA BAY
HOMESTEAD SITE, GROOTE EYLANDT, NORTHERN TERRITORY 0822

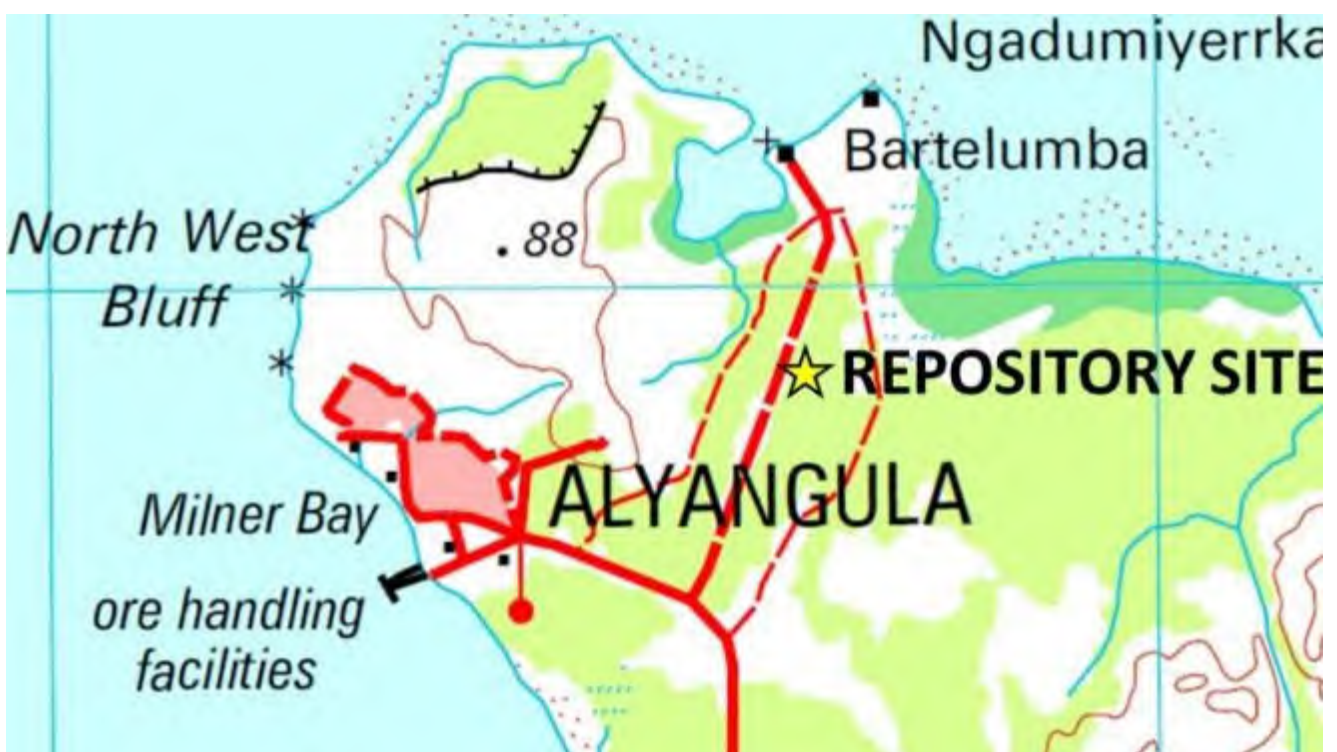
The Site Auditor assessed the significance of these data gaps in the site history assessment when reviewing the CSM in **Section 2.5**.

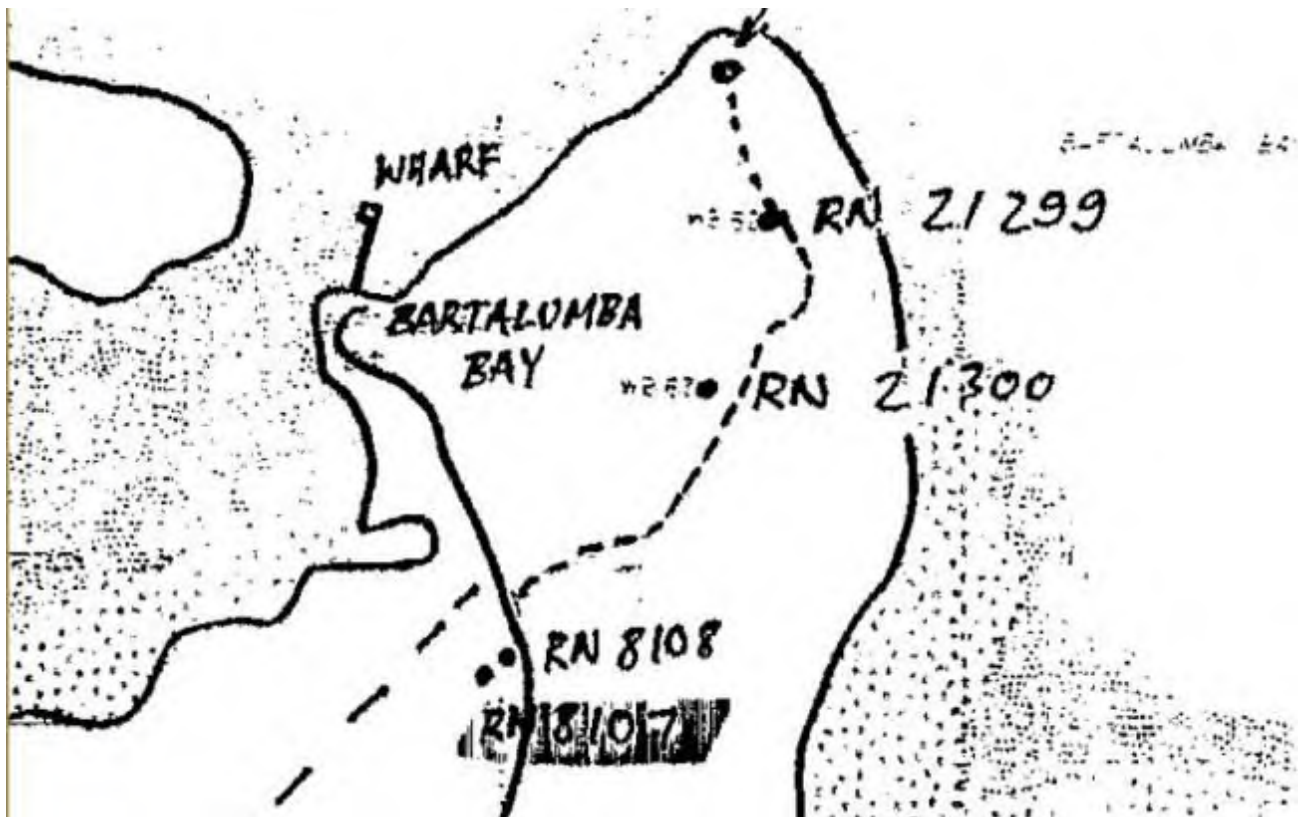
The Site Auditor considered the site condition assessments provided by the ESAs did not meet the documentation completeness DQI. The data gaps identified consisted of information on :

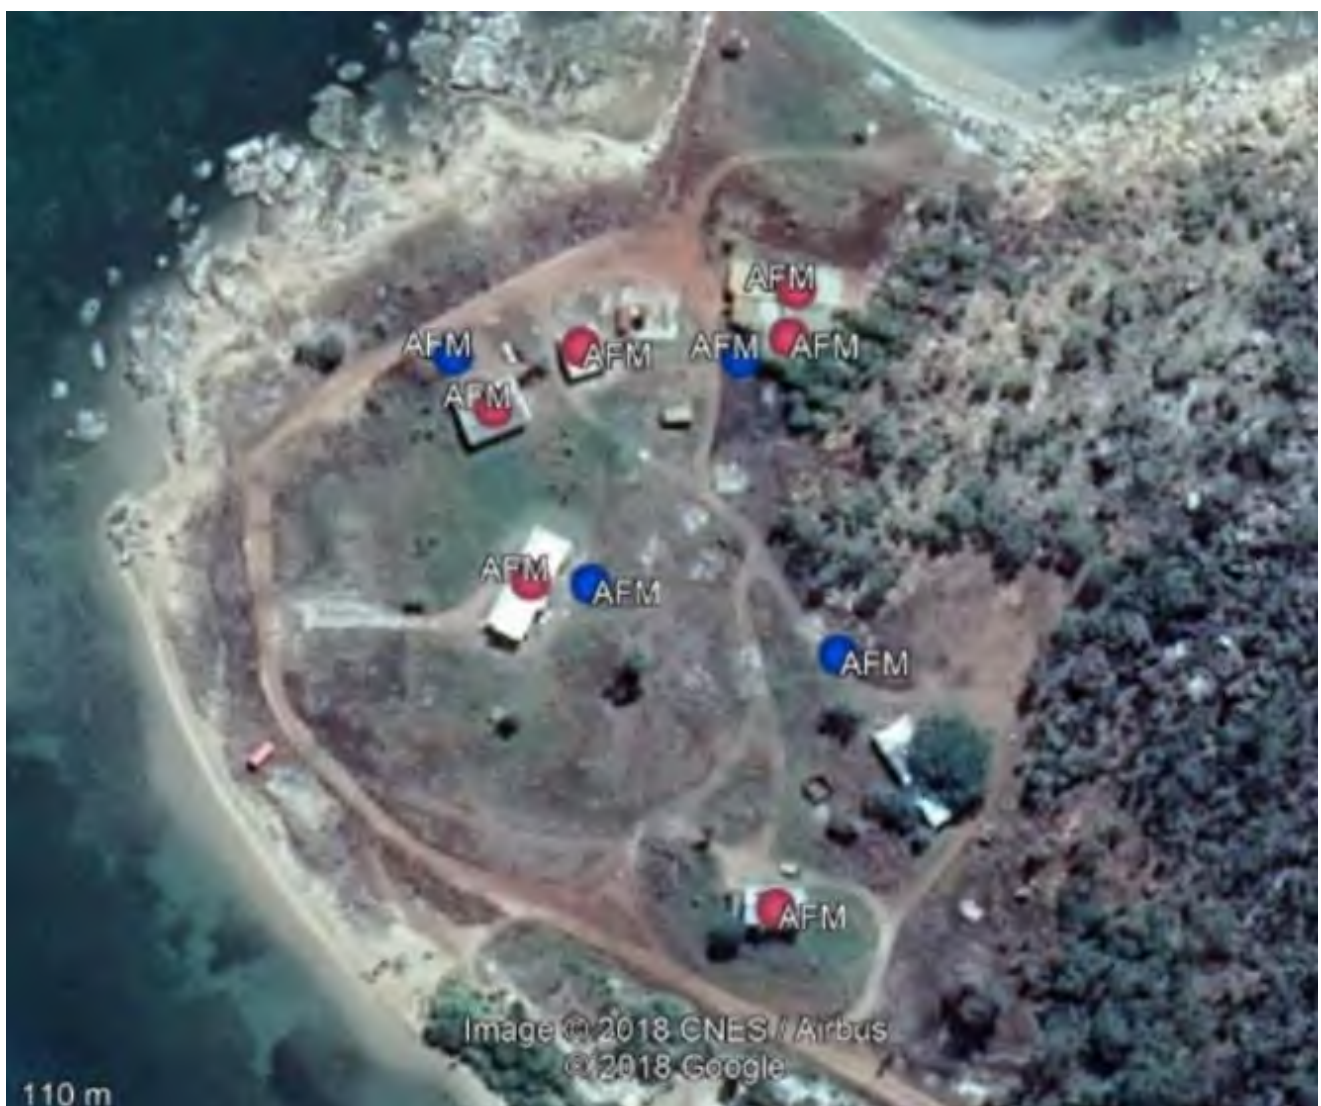
Agon concluded that the houses were fit for occupation because the airborne fibre levels were not detectable. The Site Auditor considered that insufficient data was obtained by the Agon (August 2018) asbestos survey to support this conclusion because of deficiencies in the investigation as described in **Section 2.7**. These included:

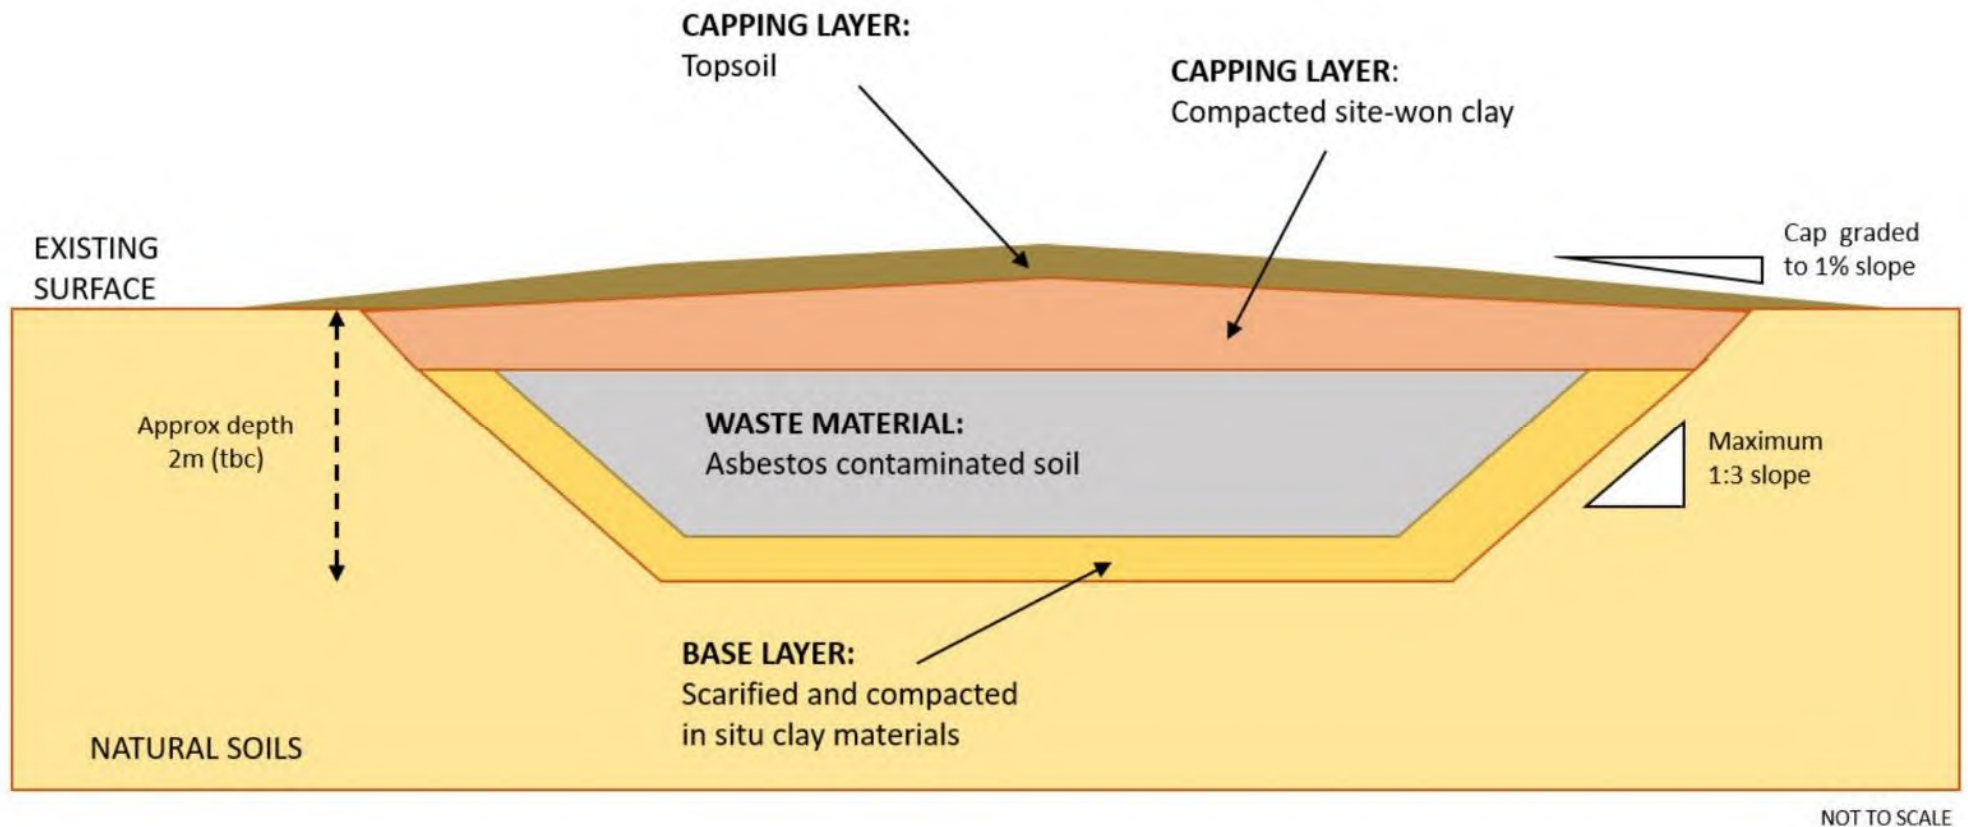
- The minimum cap thickness be increased to 1,000 mm (as recommended in Section 5.2.1 of the WA DOH (2009) asbestos guideline for open space areas);
- Procedures for measuring and validating the cap thickness needed to be provided;

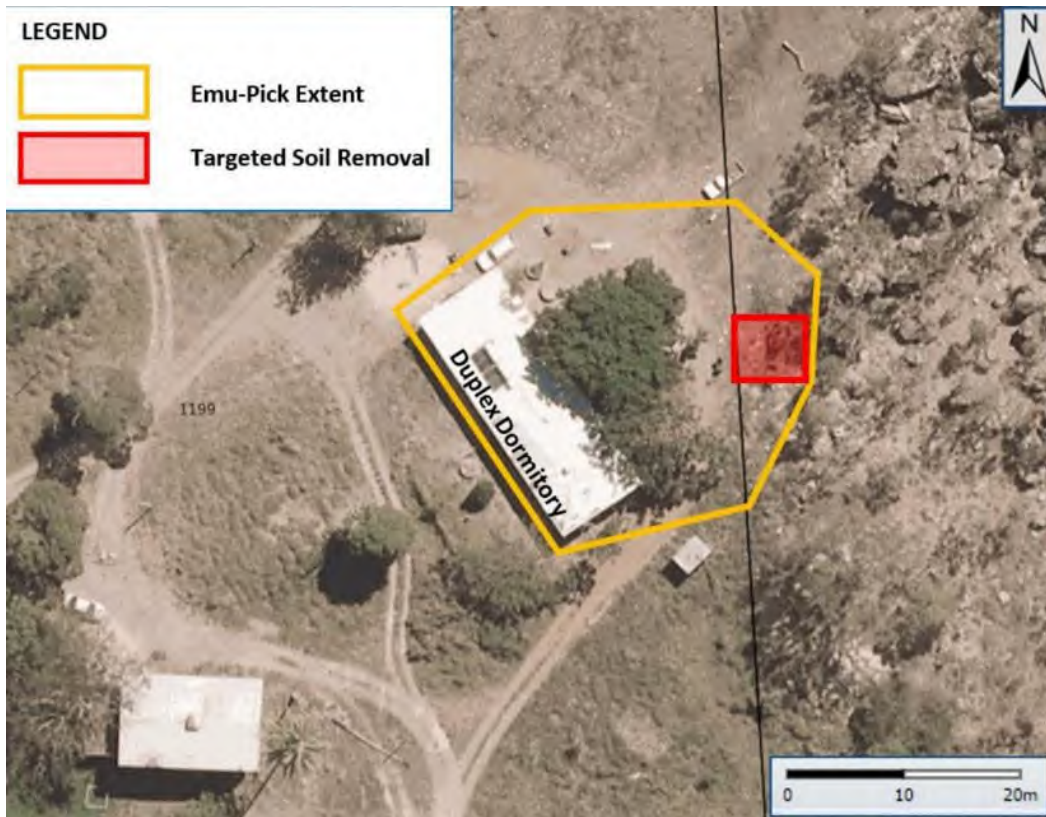
Figure 4-3 Reported Extent of Remediation at Recreation Club (Source: Fig 6, Ref [9])

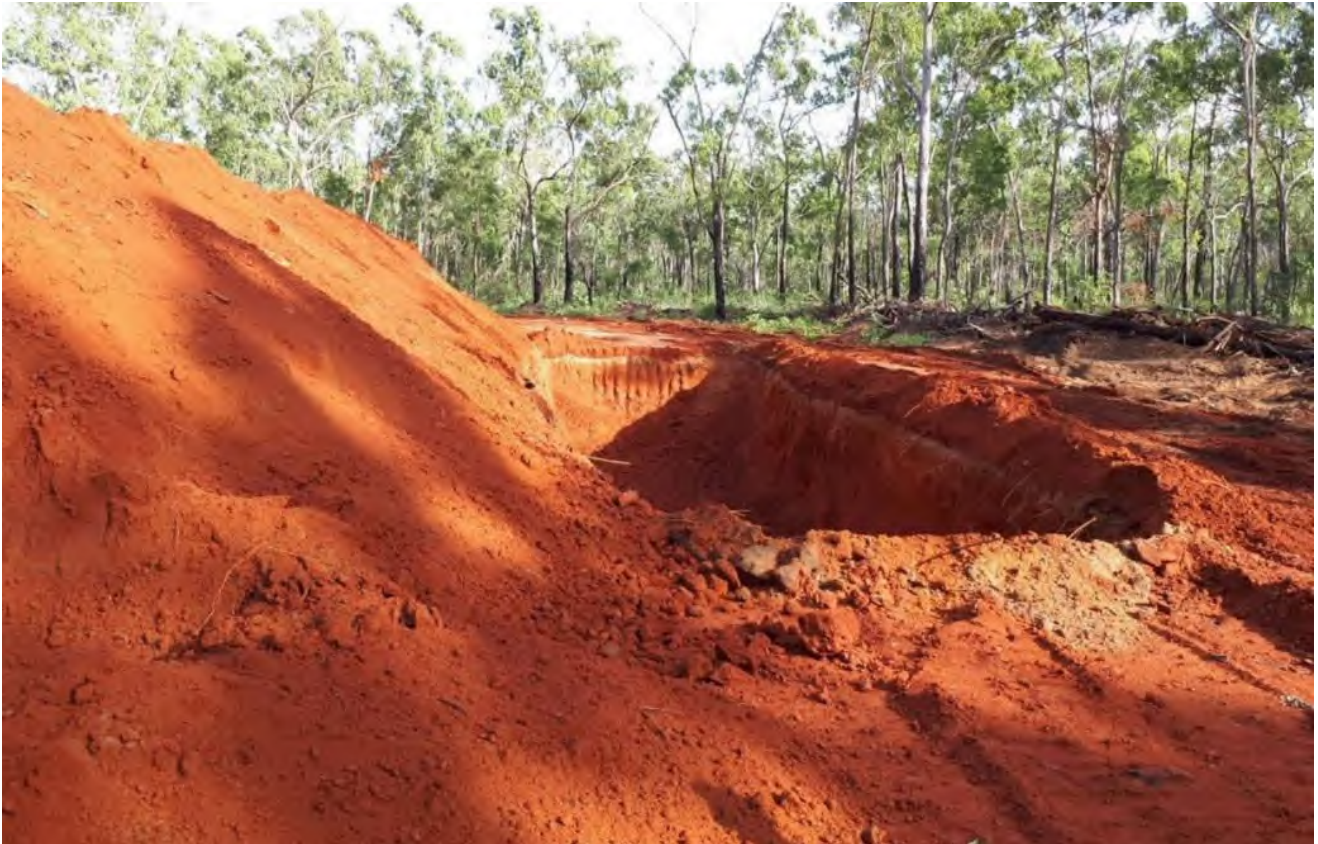
Figure 4-15 Final Condition of Containment Cell (7/02/2019)

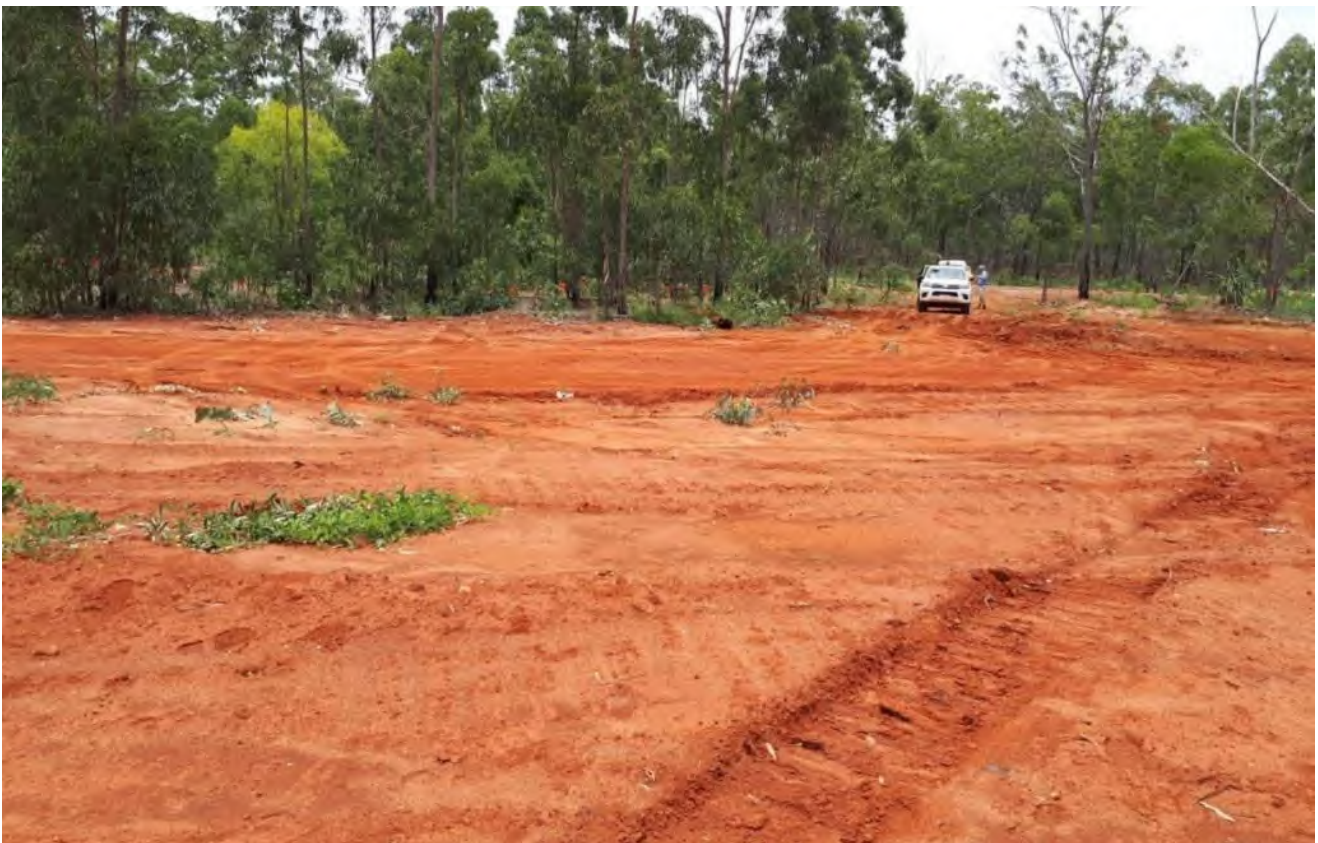
The Site Auditor considered the available Agon documentation supported the conclusion that the as-constructed cell was likely to provide a reasonably secure containment of the asbestos waste removed from the Homestead Site while the Disposal Site remained undisturbed and unused. This is because photos provided in the SRVR⁷⁹ showed:

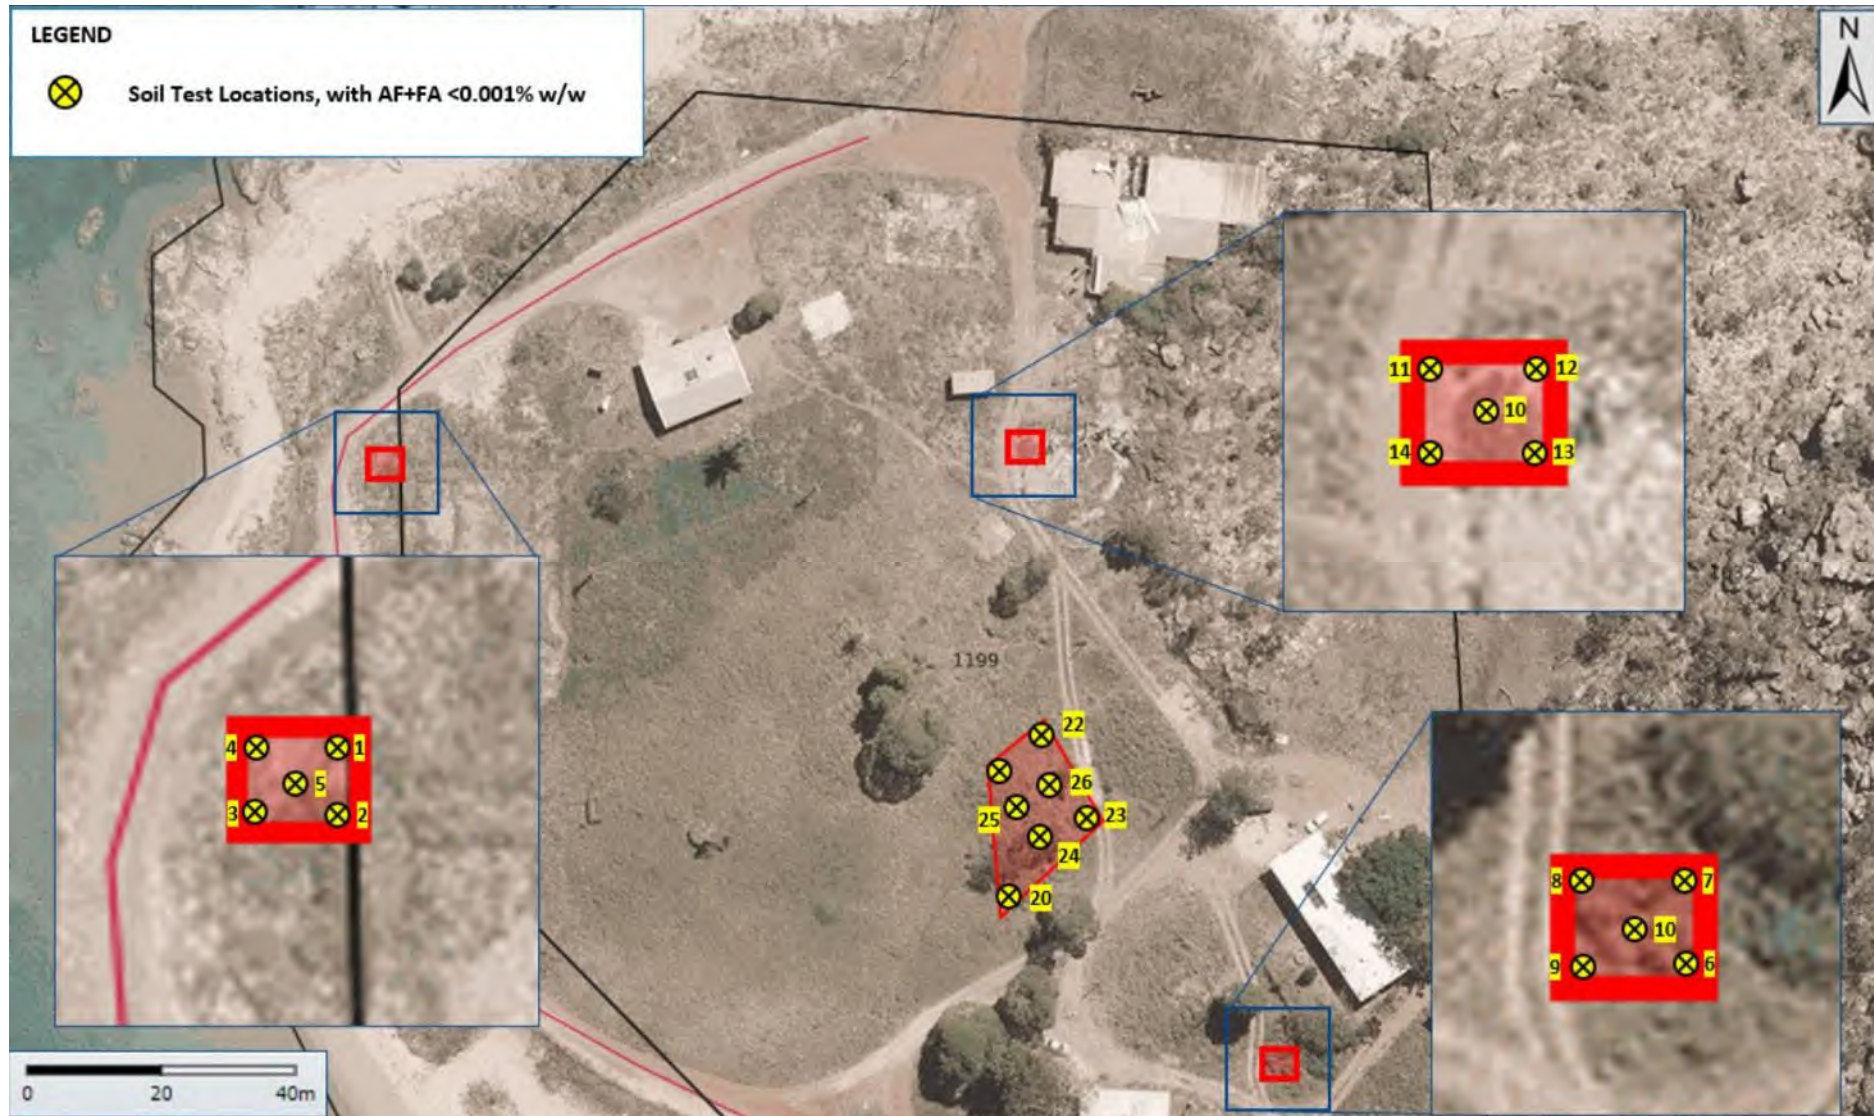
- A review be conducted of the containment cell construction with regard to the level of compliance with the Landfill BEMP guidance.

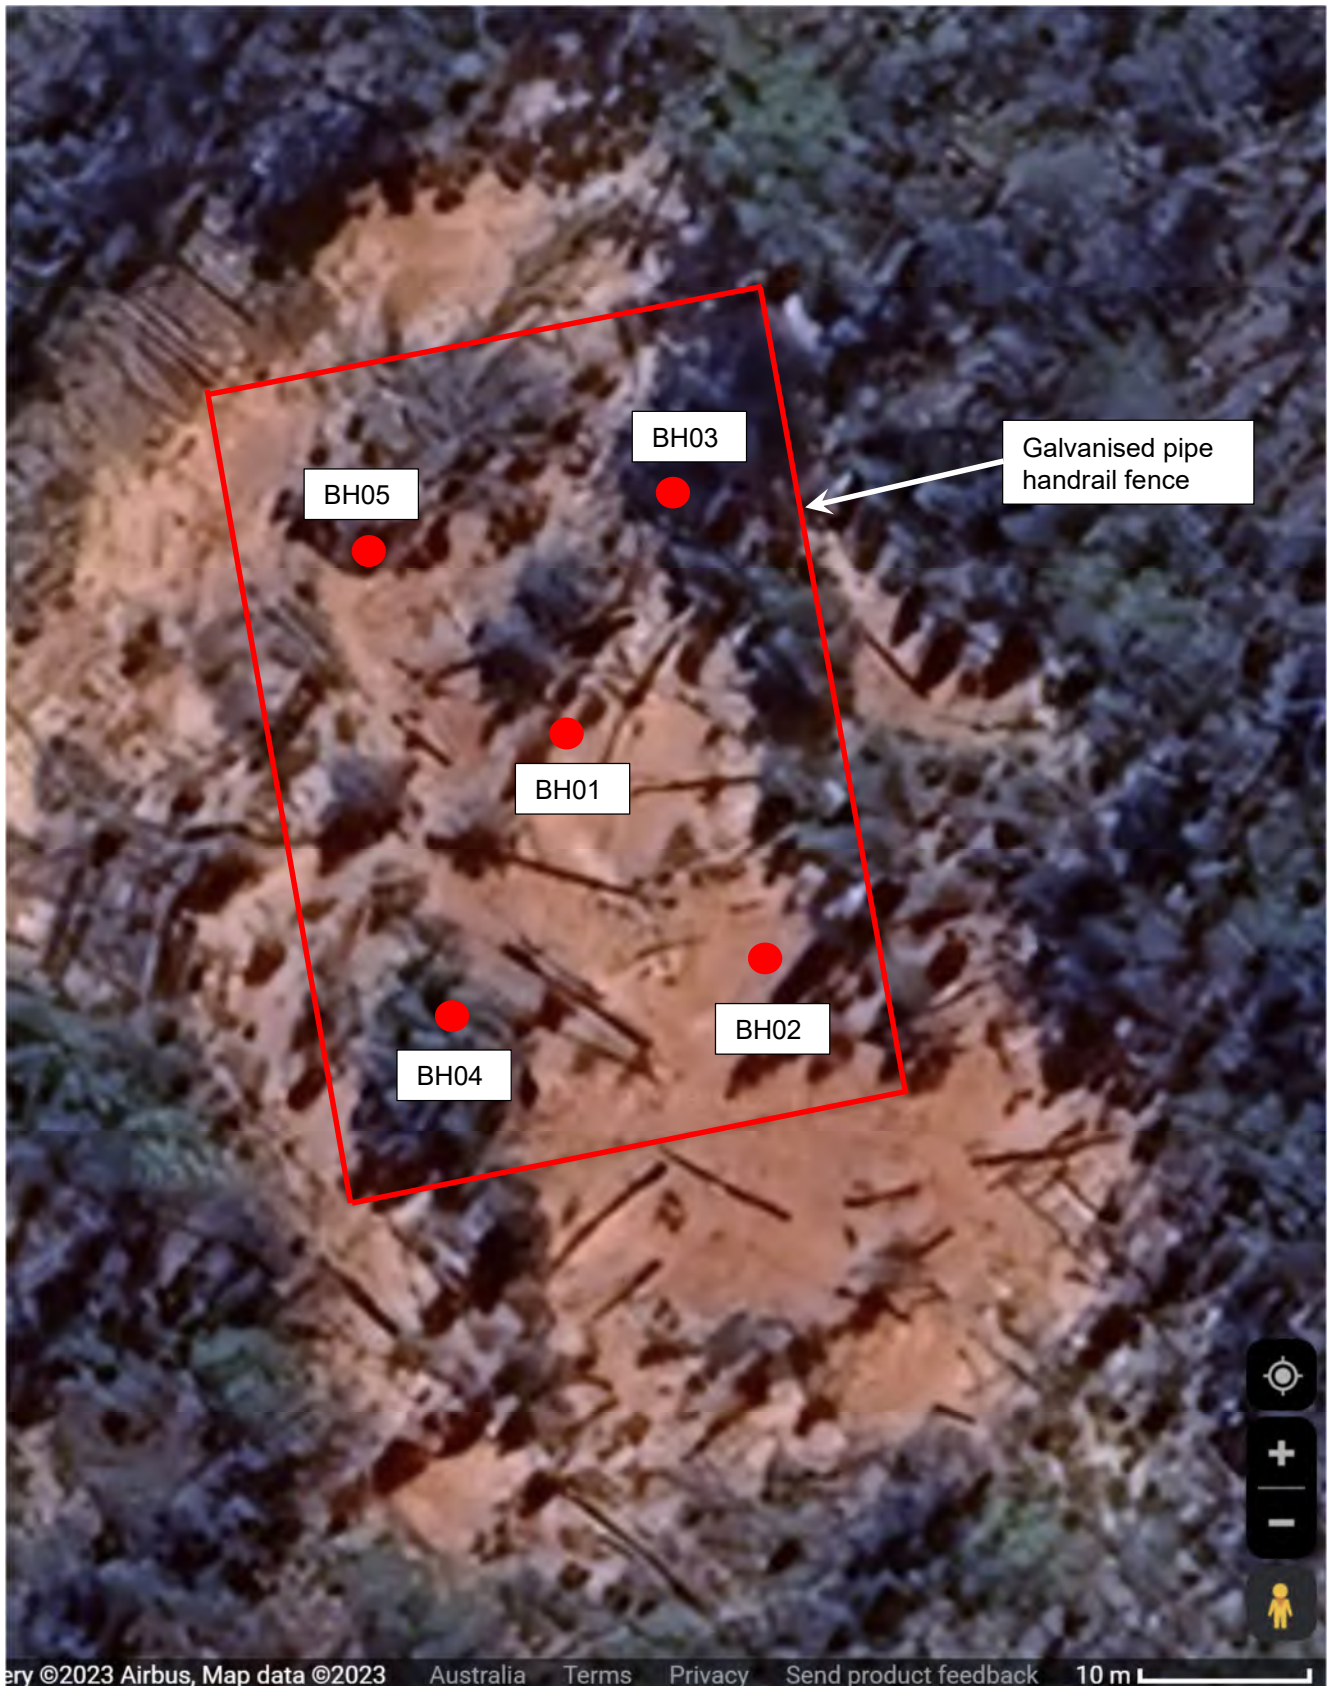
Details recorded for these sample locations are:

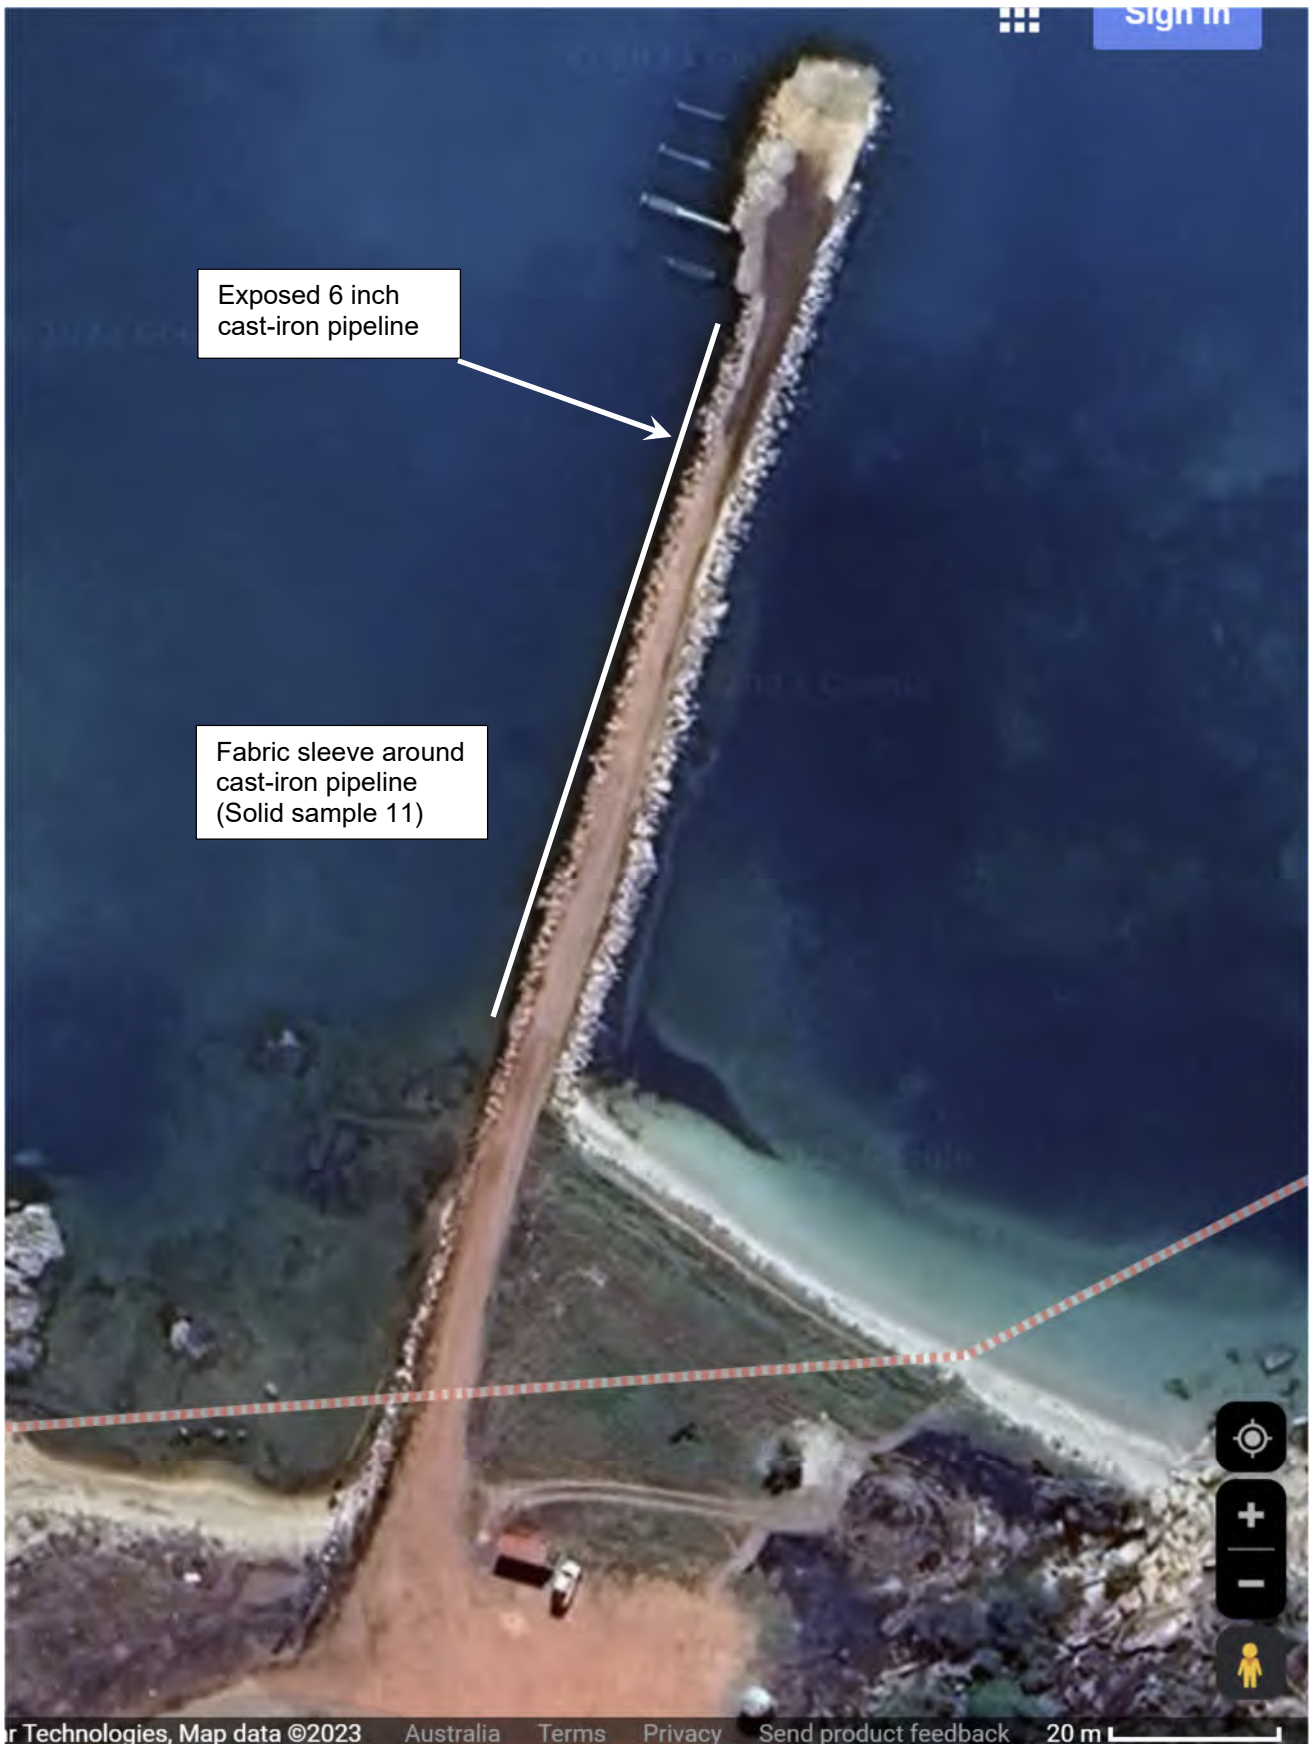
- No visible ACM was found at any other part of the Homestead Site;
- No odorous or stained soils indicative of hydrocarbon contamination was observed;
- The only bulk fuel storage in the area was a bunded AST containing diesel fuel for the generator (Photo 25); and
- An exposed pipeline ran along the western toe of the rock jetty. The pipeline was old and brown at its joints. The pipe was wrapped in fabric, possibly for insulation. No evidence of ACM gaskets were found. The pipe was possibly used for wastewater from the process building.

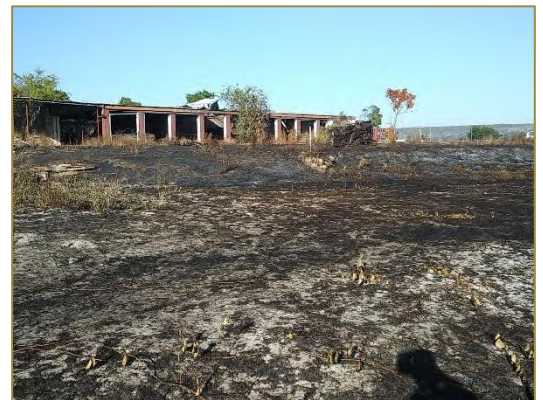
Photograph 10 – Dense grass cover burnt to the north elevation of the Recreation Club (July 2018)

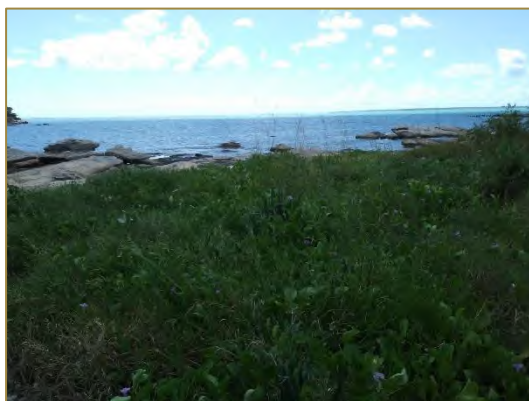
Photograph 11 – Vegetative cover across the foreshore (May 2018)

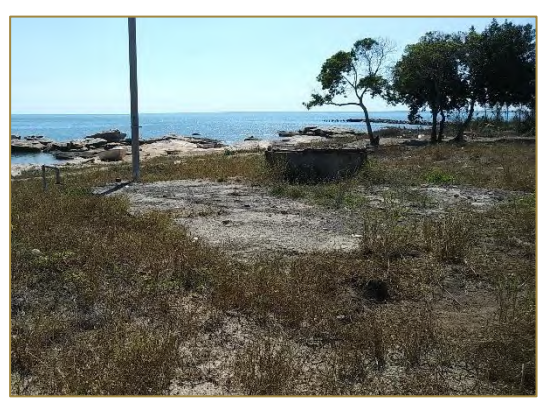
Photograph 12 – Vegetative cover burnt across the foreshore (July 2018)

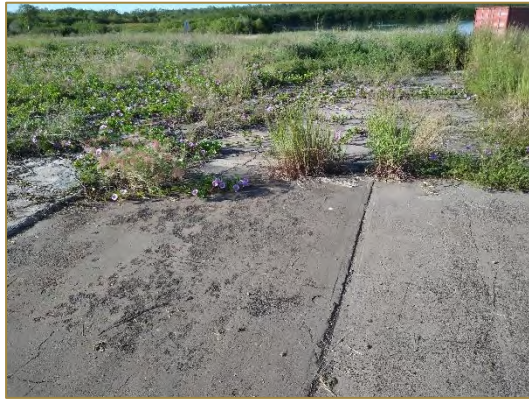
Photograph 13 – ACM debris on concrete pads across the site, with surrounding vegetation cover (May 2018)

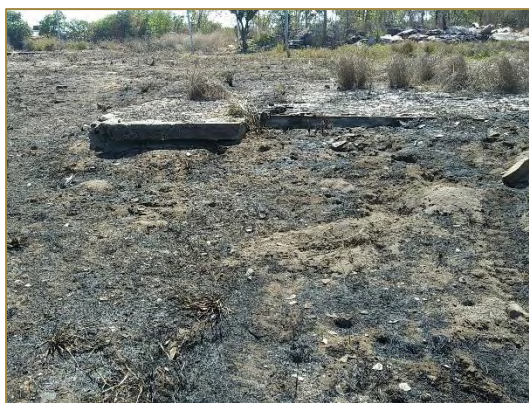
Photograph 15 – ACM debris on concrete pads across the site, with surrounding vegetation cover burnt, exposing further debris (July 2018)

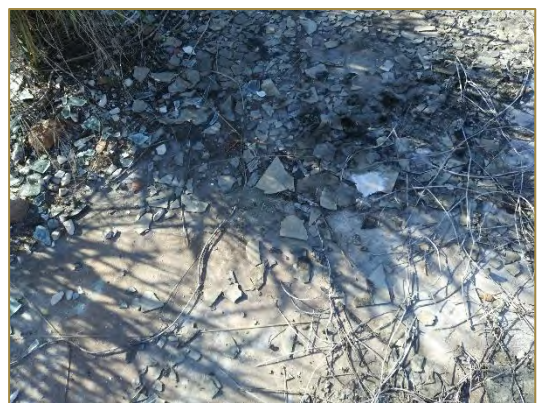
Photograph 16 – ACM debris on concrete pads across the site

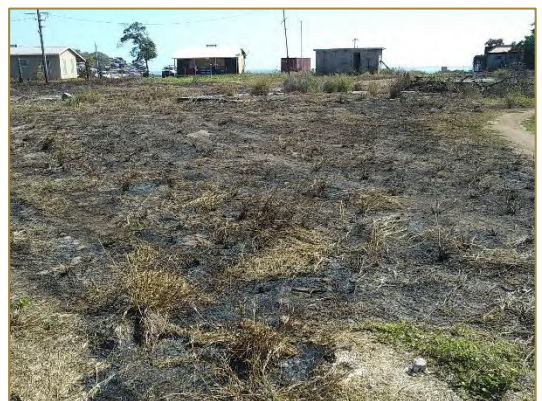
Photograph 18 – Vegetative cover burnt across site (July 2018)

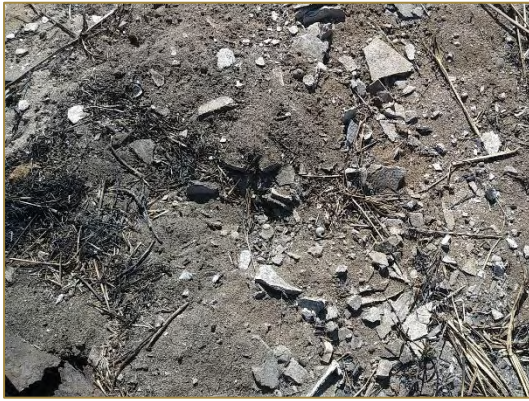
Photograph 19 – ACM debris spread across surface of central depression

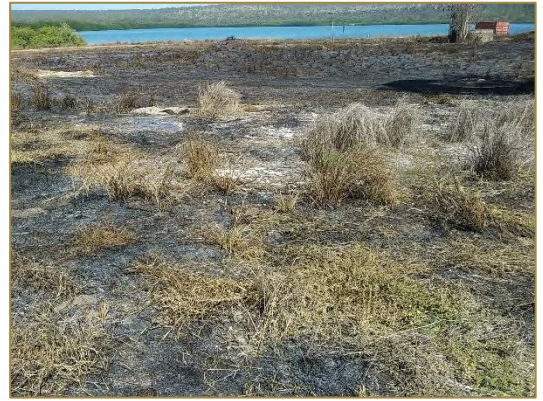
Photograph 20 – Recently burnt central depression

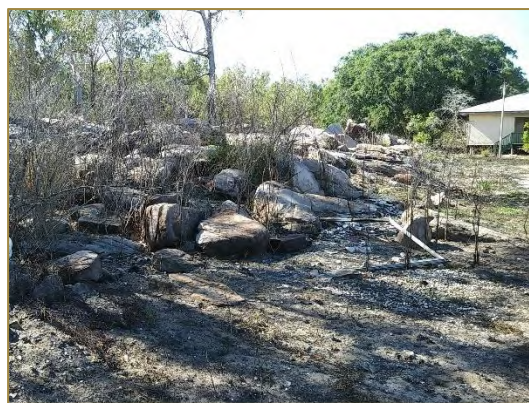
Photograph 21 – ACM debris spread across area encompassing the rock wall, north of the Duplex Dormitory

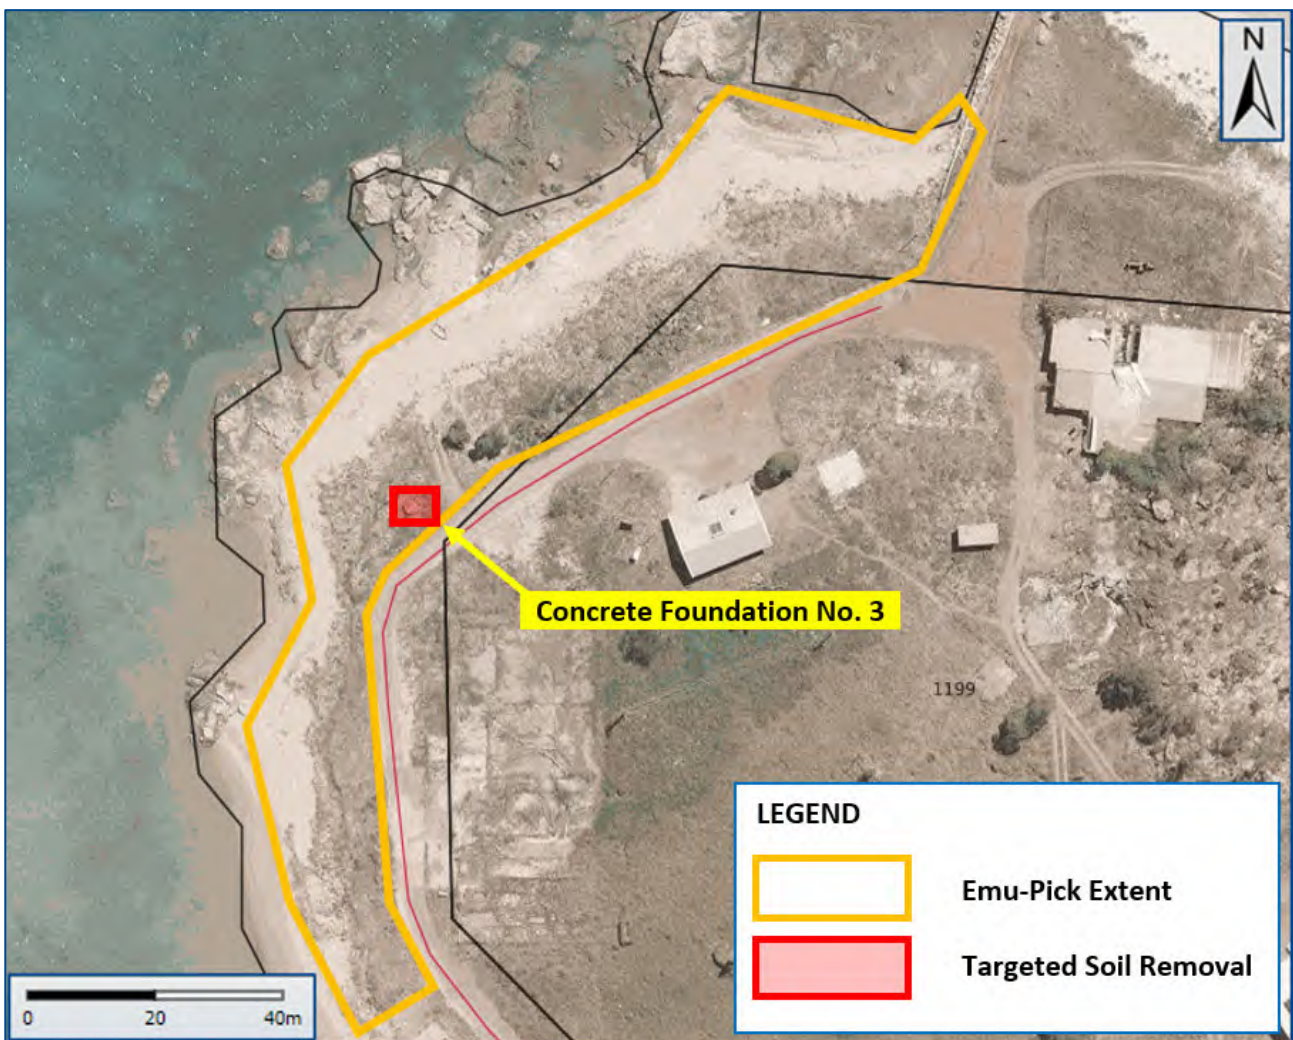
Figure 7 *Extent of Asbestos Remediation at the Foreshore*

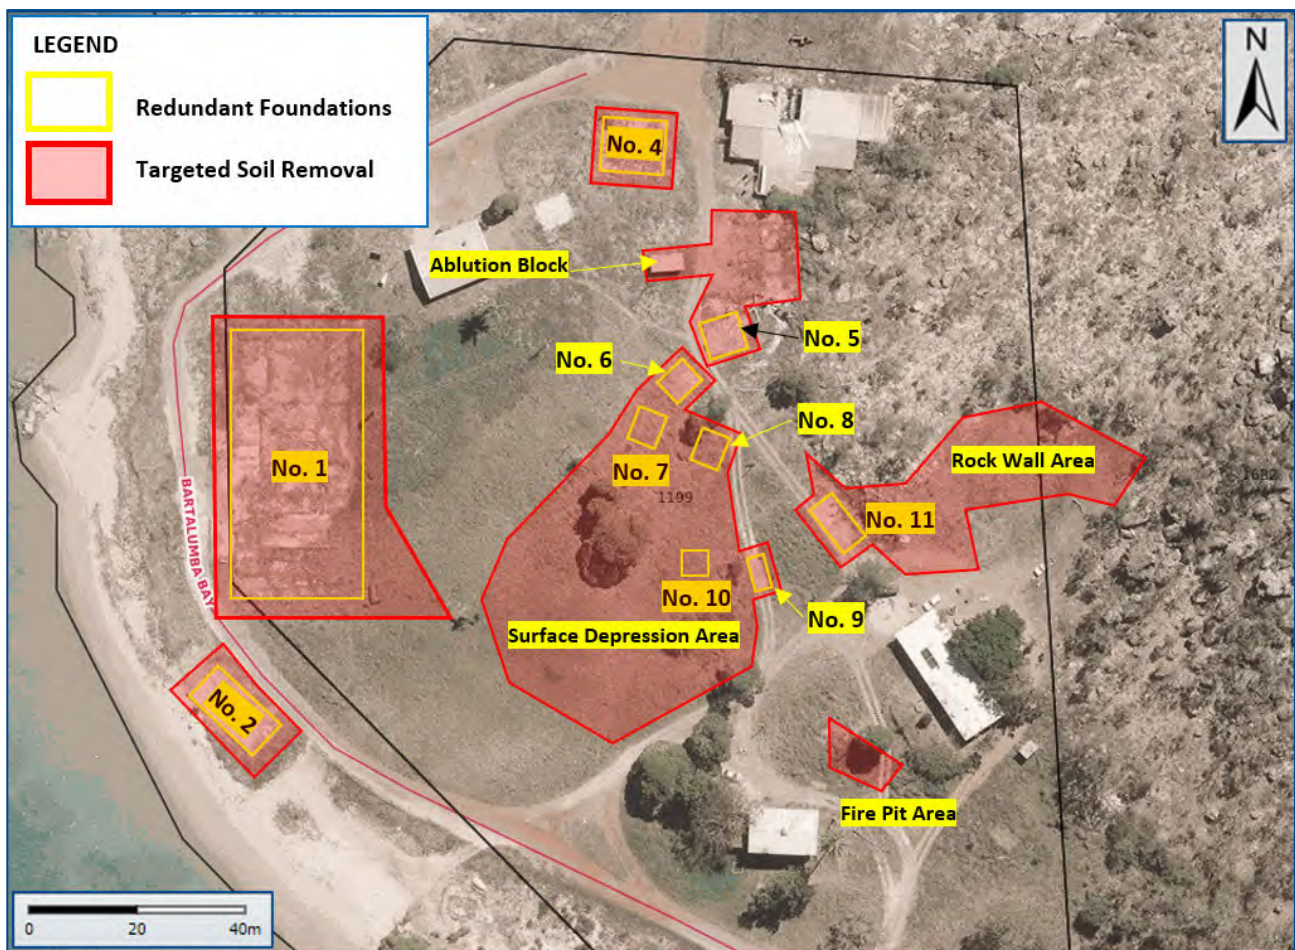
Figure 8 *Extent of Asbestos Remediation Across Site Grounds*

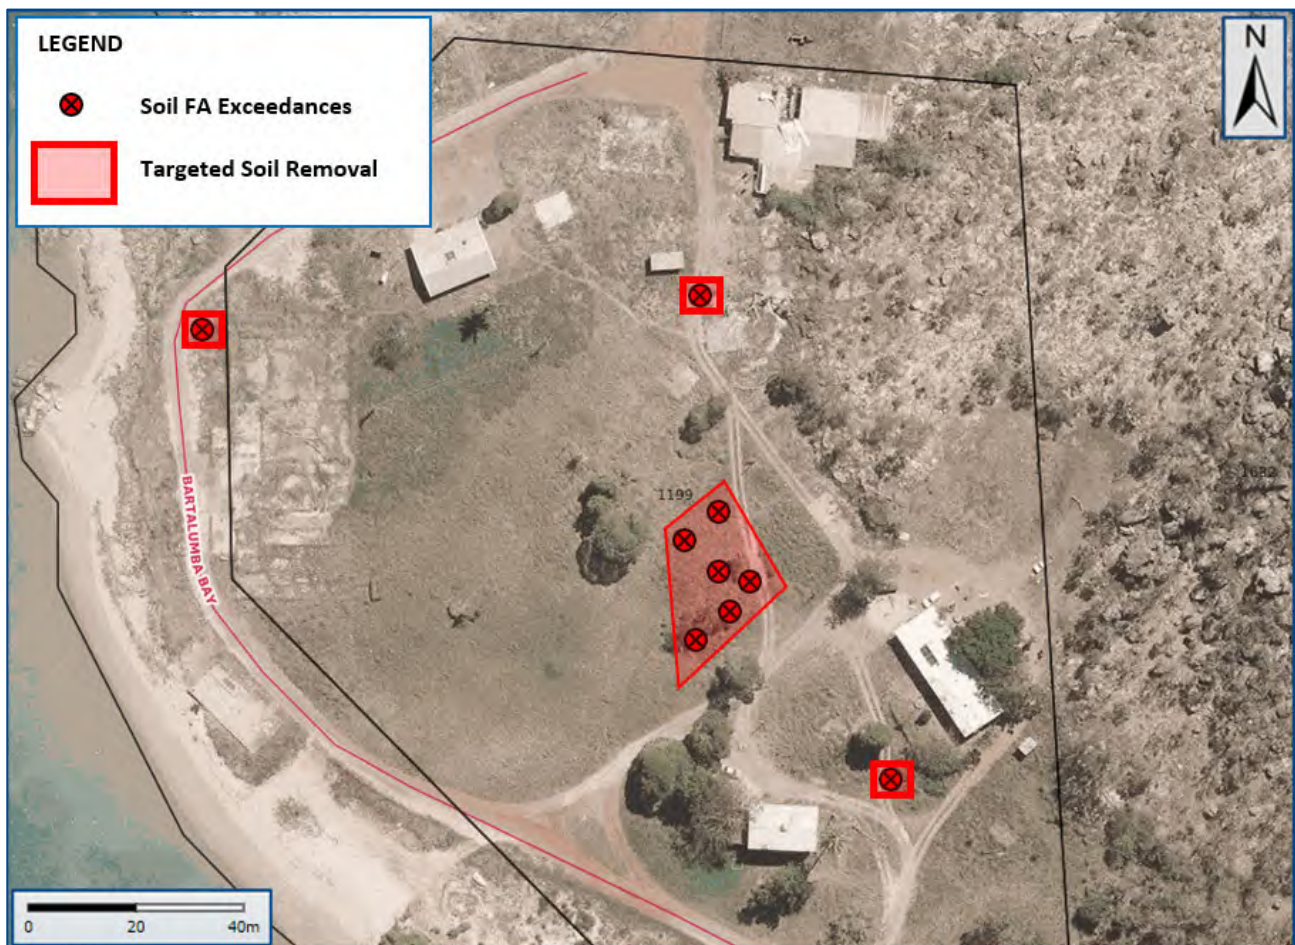
Figure 9 Phase 2 Targeted Soil Remediation Extent (Approximate)

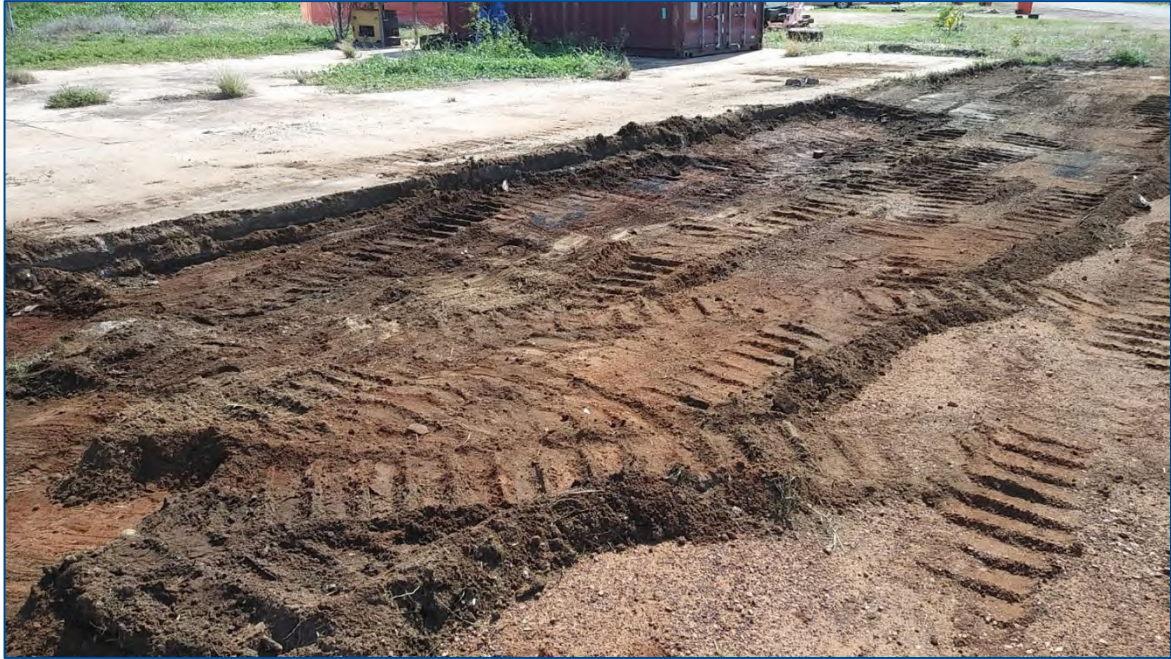
Asbestos contaminated soil removal around redundant concrete foundation No. 4 (12/11/2018)

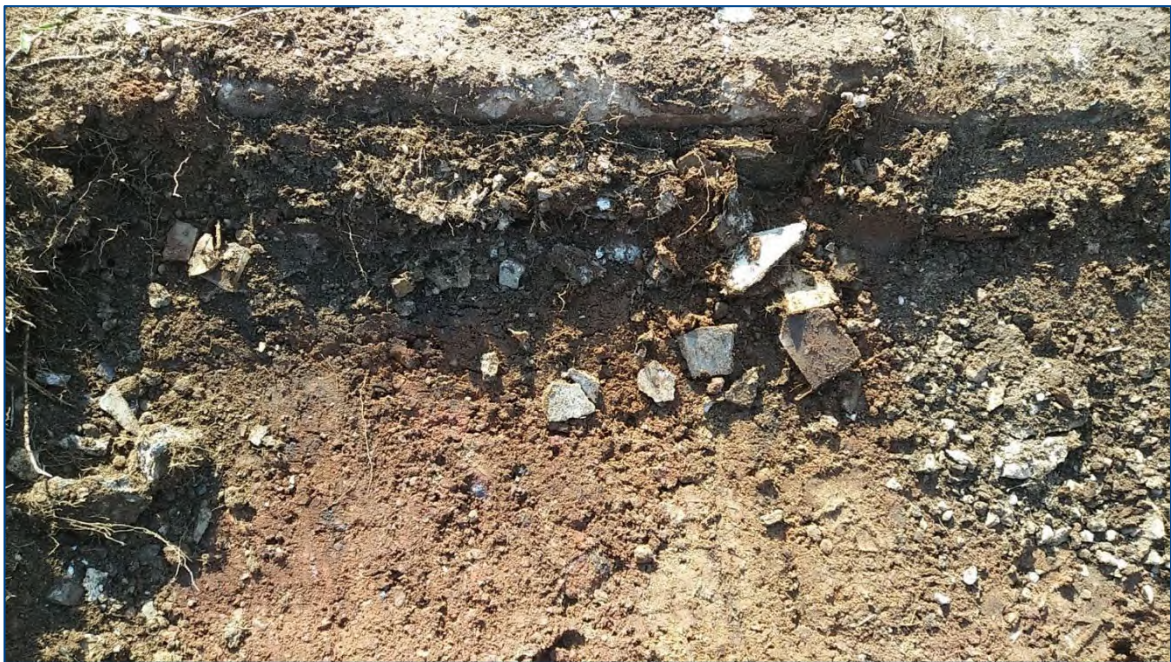
Asbestos contaminated soil removal around redundant concrete foundation No. 4 (12/11/2018)
