Site Audit Report ALC_1 by Dr Ian Swane

REMEDIATION OF ASBESTOS CONTAMINATION AT THE FORMER BARTALUMBA BAY
HOMESTEAD SITE, GROOTE EYLANDT, NORTHERN TERRITORY 0822

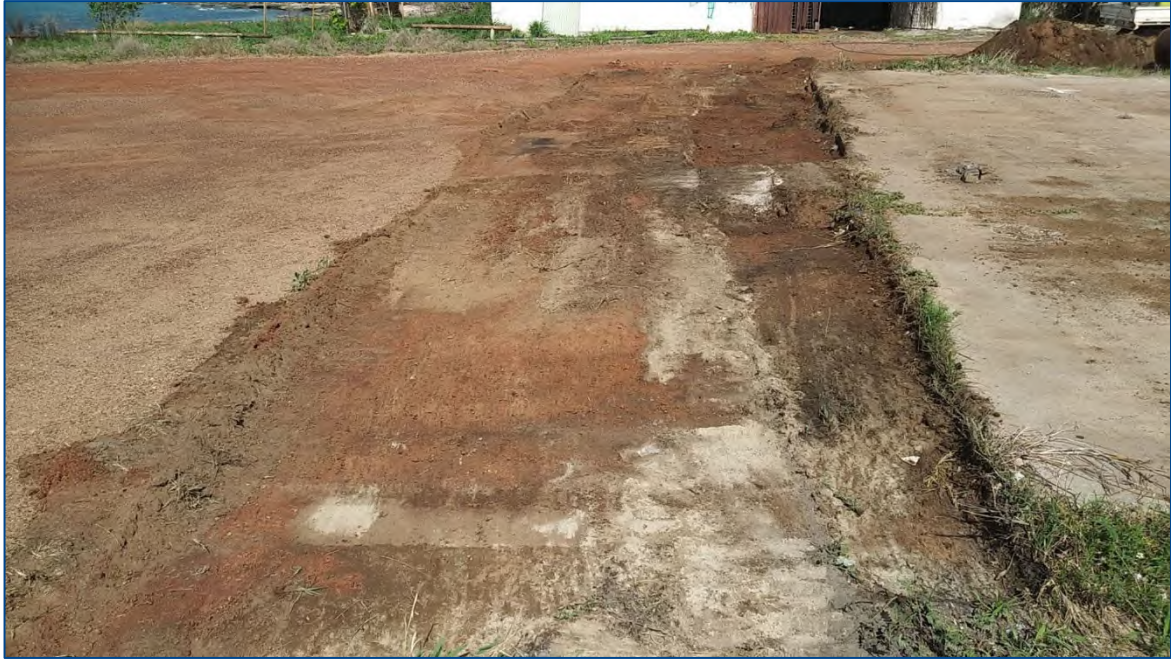
Completed removal around redundant concrete foundation No. 4 (12/11/2018)

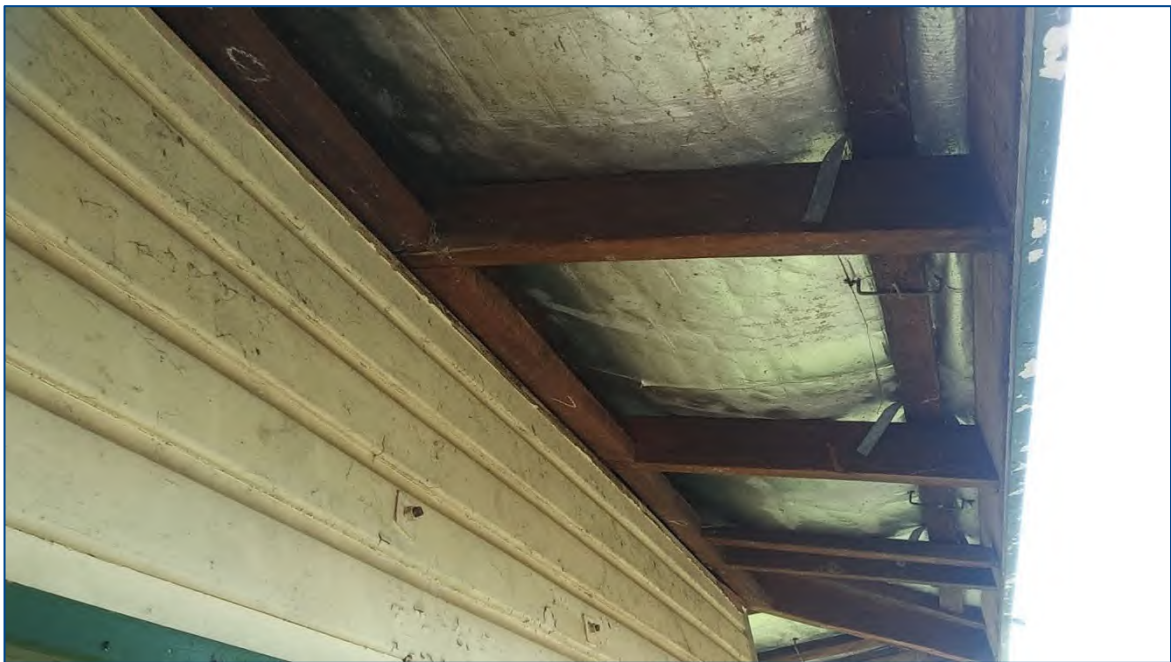
Removal of external eave linings of the Duplex Dormitory (12/11/2018)

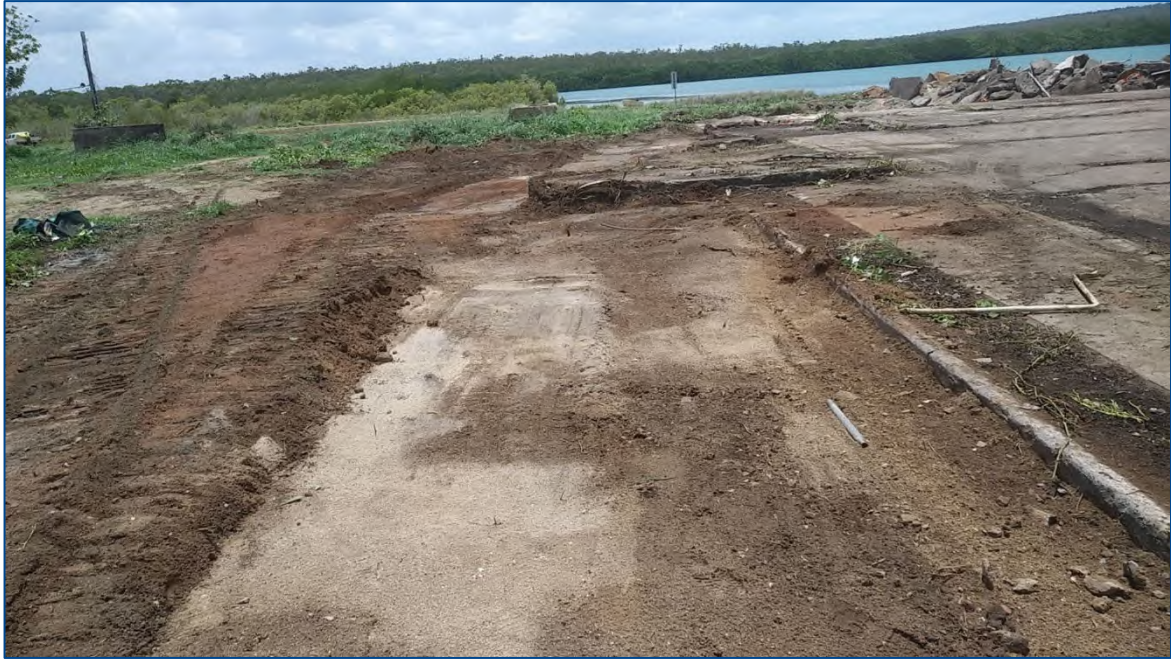
Asbestos contaminated soil removal from around the Redundant Concrete Foundation No.1
(16/11/2018)

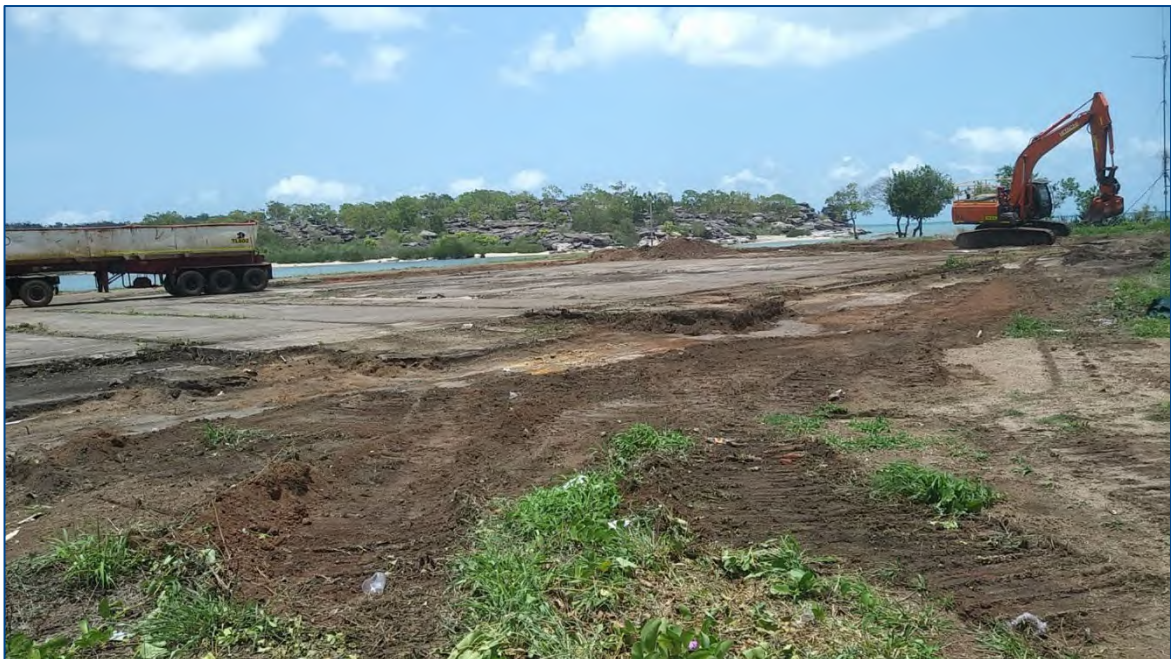
Asbestos contaminated soil removal from around the Redundant Concrete Foundation No.1
(16/11/2018)

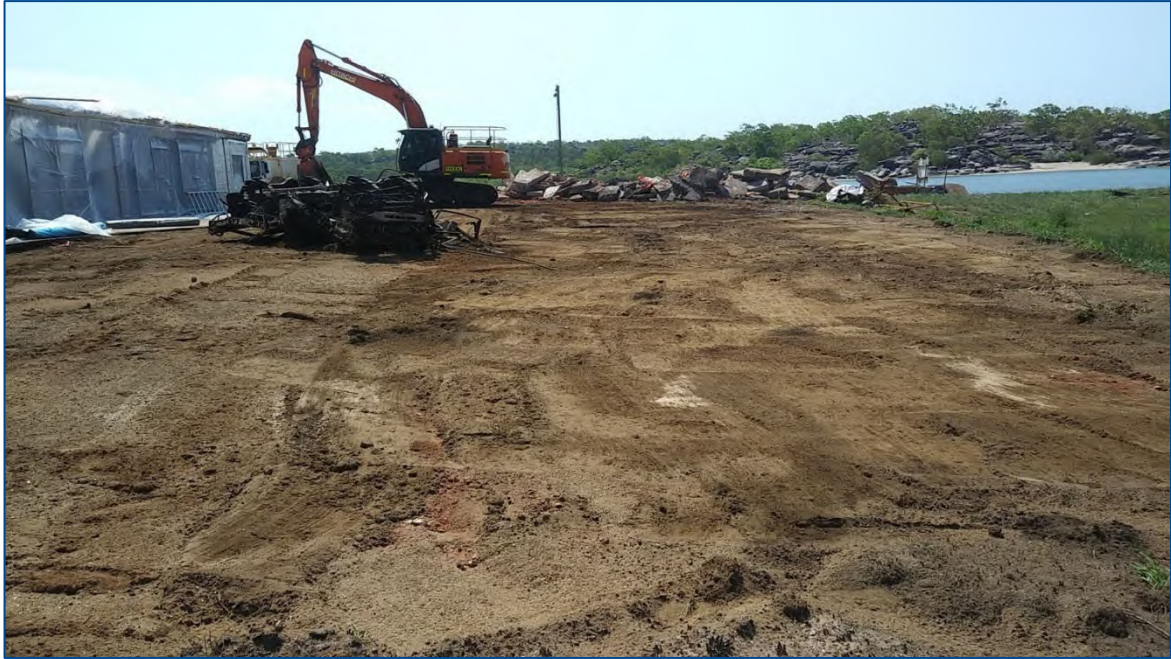
Asbestos contaminated soil removal from north of the Recreation Club (17/11/2018)

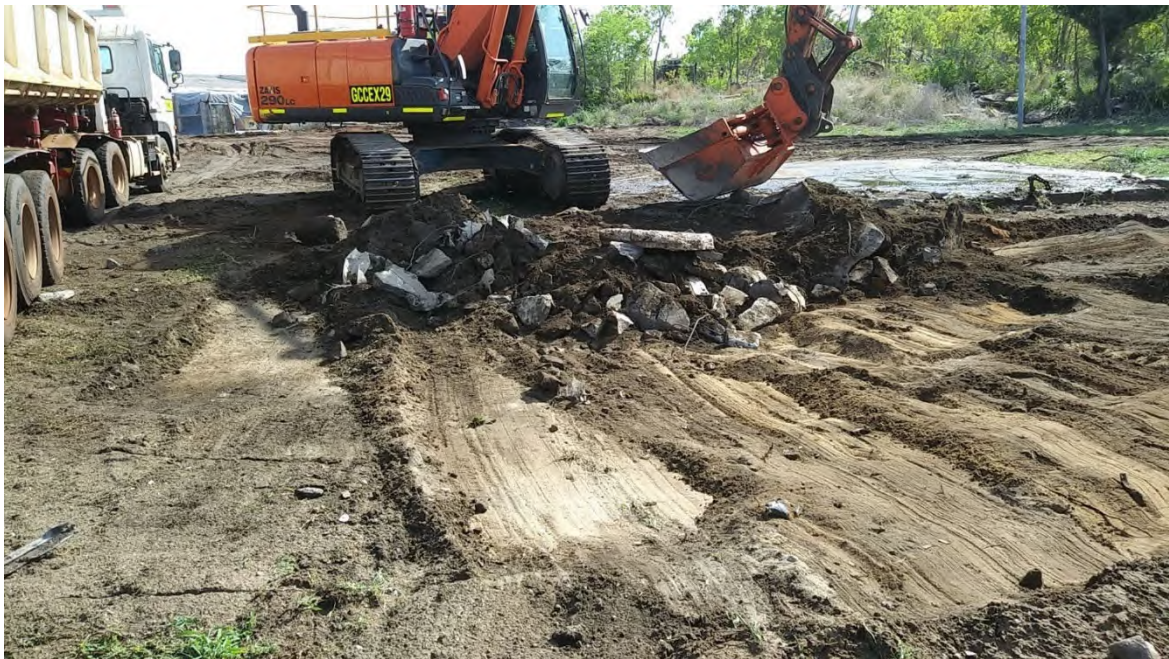
Asbestos contaminated soil removal from redundant concrete foundation No. 5 (18/11/2018)

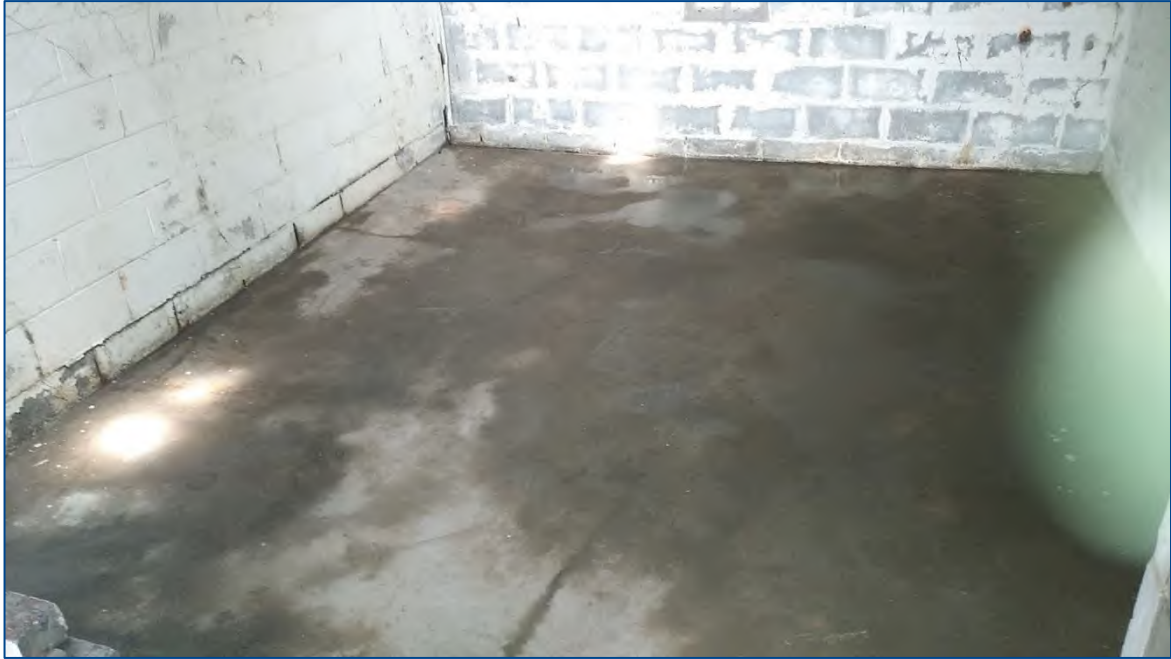
Decontaminated room of Recreation Club (18/11/2018)

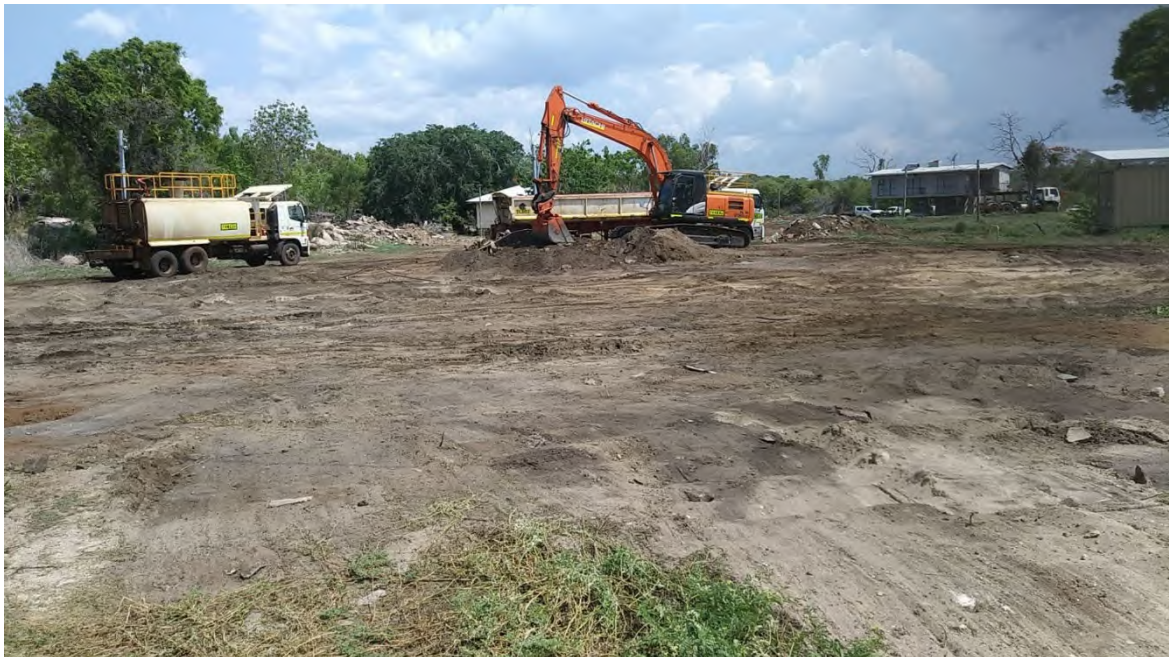
Asbestos contaminated soil removal from central site area, encompassing multiple redundant concrete foundations (19/11/2018)

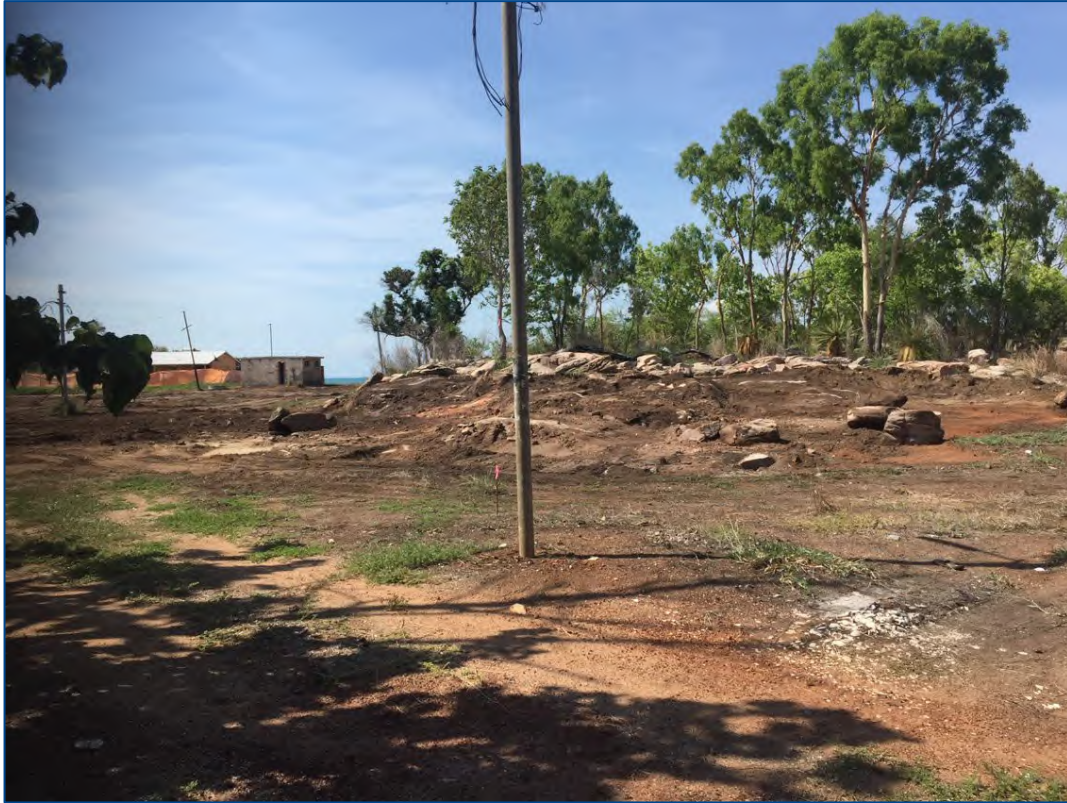
Asbestos contaminated soil removal from rock wall area (20/11/2018)

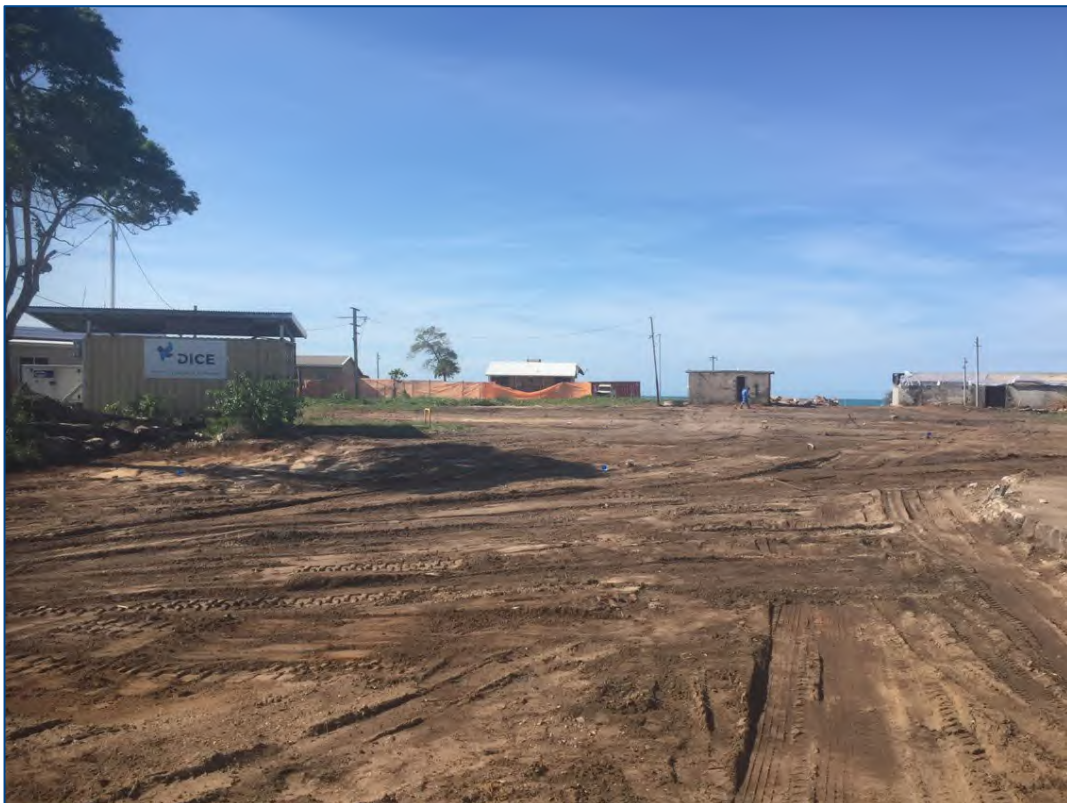
Final site condition looking north across central site area (22/11/2018)

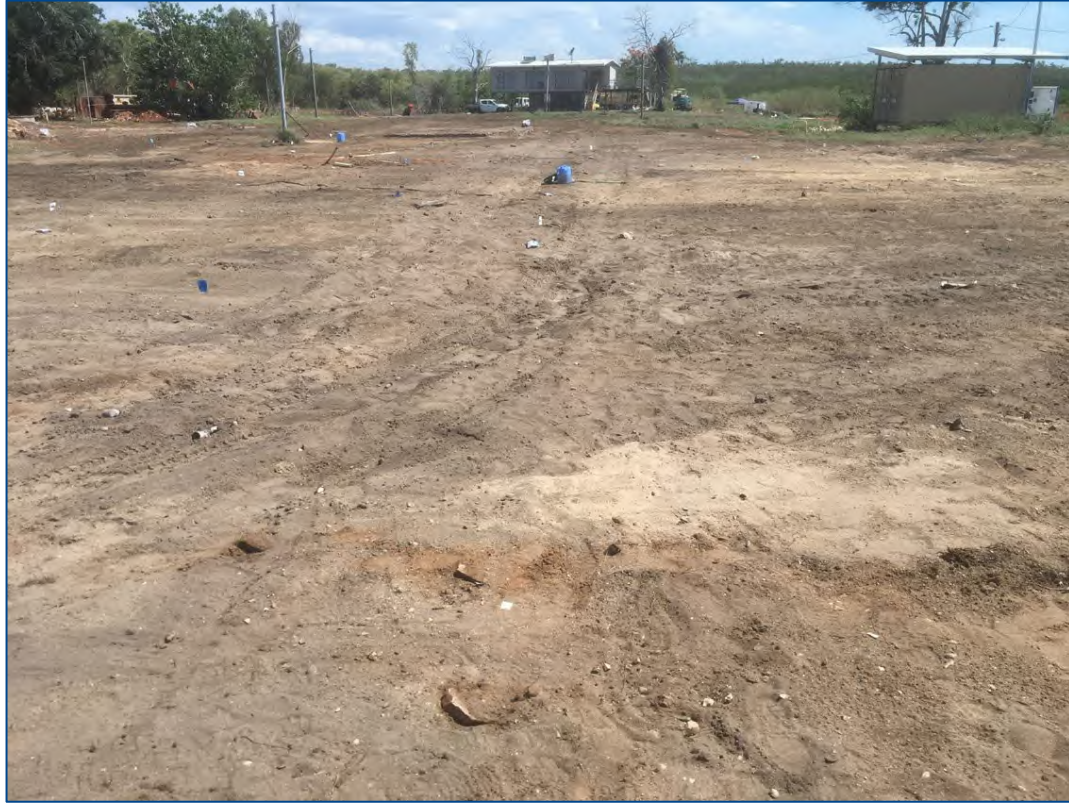
Final site condition looking south across central site area (22/11/2018)

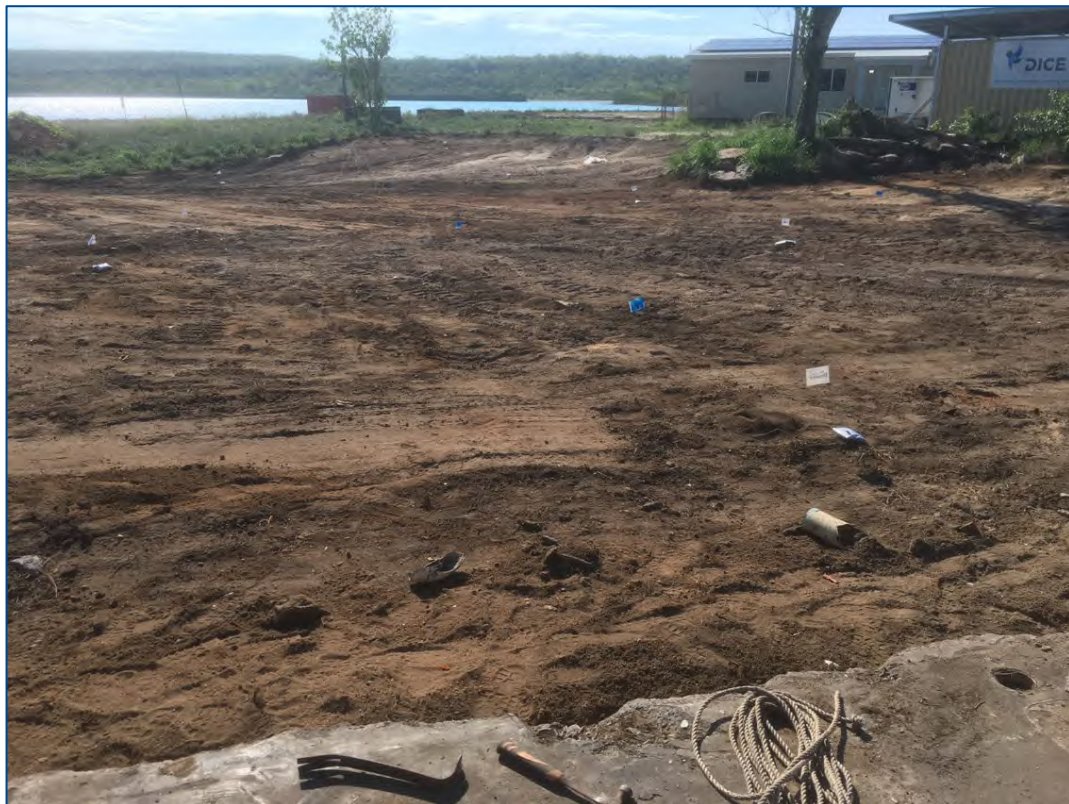
Final site condition looking north-west across central site area (22/11/2018)

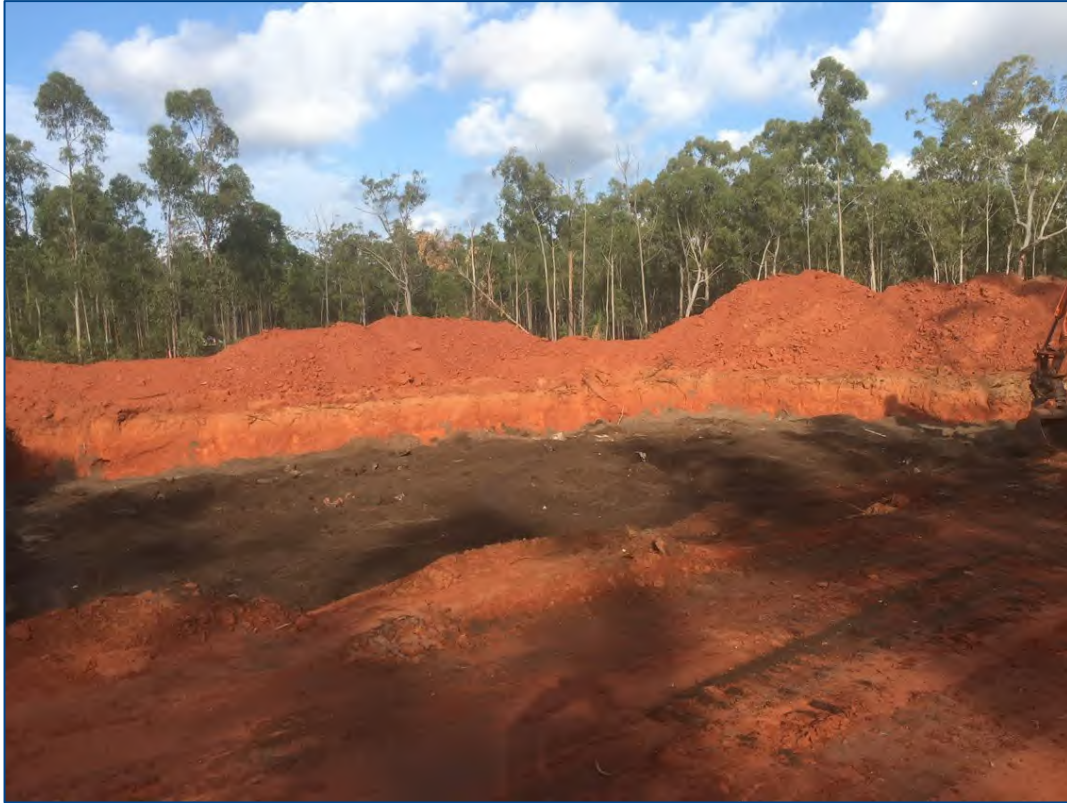
Containment cell prior to capping (23/11/2018)

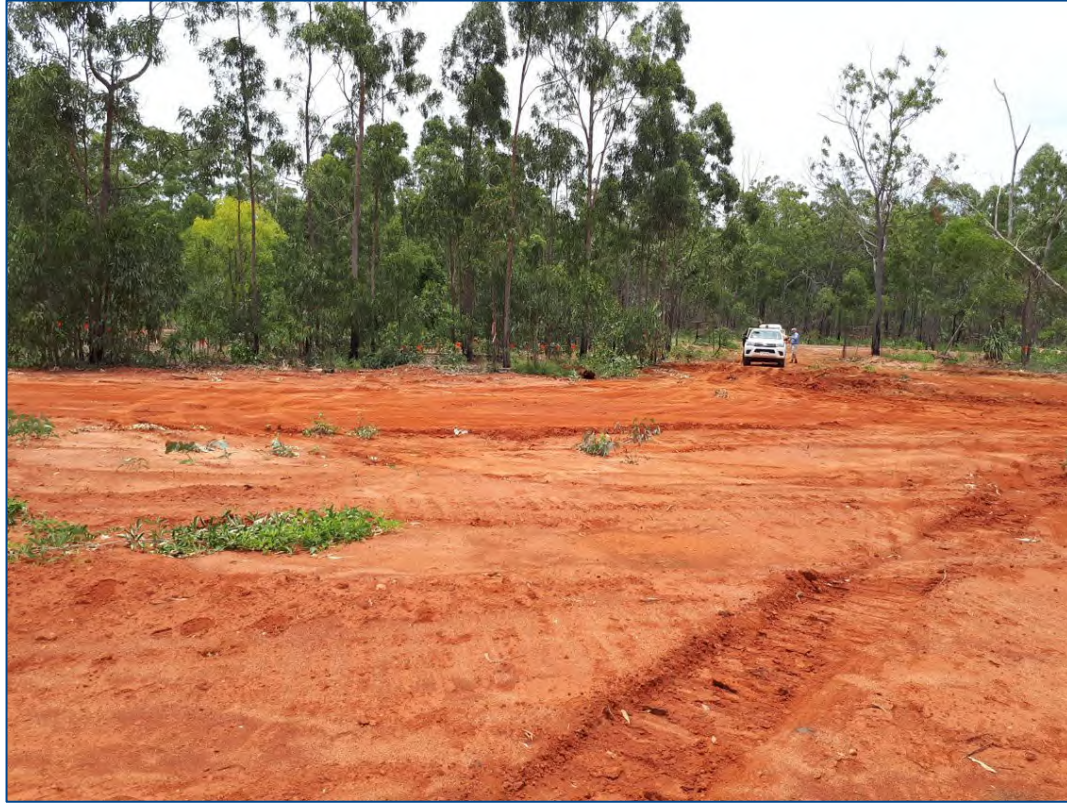
Final condition of containment cell (7/02/2019)

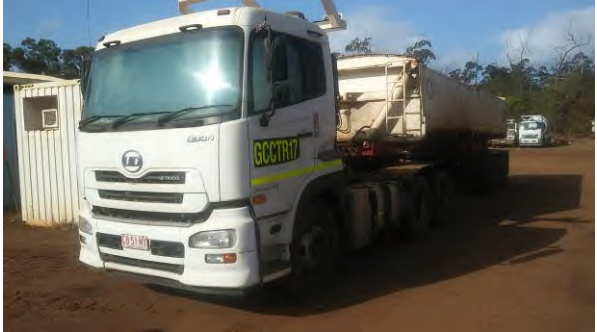
REPORT DATE:	Thursday, 8 November 2018	
CLIENT:	Anindilyakwa Land Council	
REMOVAL CONTRACTOR	Darwin Asbestos and Demolition Services	
ORDER / PROJECT NO.	N/A	
NOTIFICATION NO.	N/A	
SITE NAME:	Bartalumba Bay Homestead Asbestos Remediation Project	
SITE ADDRESS:	Bartalumba Bay	
SUBURB:	Groote Eylandt	
ASBESTOS ASSESSOR:	Jack Pilkington Licence No.: NTWS-AA-463514	
WORKS UNDERTAKEN:	Significant smoke was generated within the UD Truck (License No. CB51MY), and no leaks were visible on inspection. The vehicle is allowed access into the asbestos contaminated work area.	
RESULT:	PASS	
NOTES:	Prior to successfully passing a smoke test the window seals were taped, to improve the integrity of the seal.

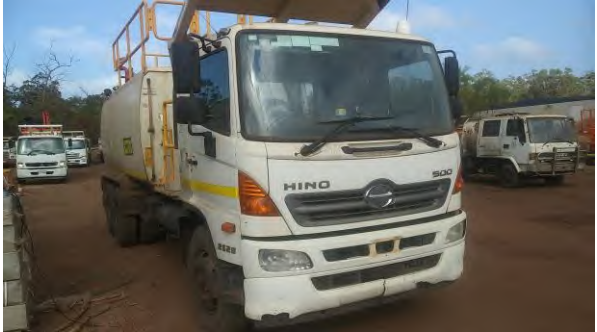
REPORT DATE:	Thursday, 8 November 2018	
CLIENT:	Anindilyakwa Land Council	
REMOVAL CONTRACTOR	Darwin Asbestos and Demolition Services	
ORDER / PROJECT NO.	N/A	
NOTIFICATION NO.	N/A	
SITE NAME:	Bartalumba Bay Homestead Asbestos Remediation Project	
SITE ADDRESS: SUBURB:	Bartalumba Bay Groote Eylandt	
ASBESTOS ASSESSOR:	Jack Pilkington Licence No.: NTWS-AA-463514	
WORKS UNDERTAKEN:	Significant smoke was generated within the HINO 500 Water Truck (Vehicle No. GCCTR13), and no leaks were visible on inspection. The vehicle is allowed access into the asbestos contaminated work area.	
RESULT:	PASS	
NOTES:	Prior to successfully passing a smoke test the window seals were taped, to improve the integrity of the seal.

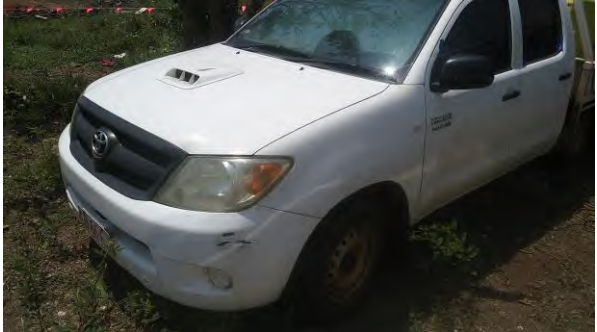
REPORT DATE:	Monday, 12 November 2018	
CLIENT:	Anindilyakwa Land Council	
REMOVAL CONTRACTOR	Darwin Asbestos and Demolition Services	
ORDER / PROJECT NO.	N/A	
NOTIFICATION NO.	N/A	
SITE NAME:	Bartalumba Bay Homestead Asbestos Remediation Project	
SITE ADDRESS:	Bartalumba Bay	
SUBURB:	Groote Eylandt	
ASBESTOS ASSESSOR:	Jack Pilkington Licence No.: NTWS-AA-463514	
WORKS UNDERTAKEN:	Significant smoke was generated within the TOYOTA Hilux Ute (License No. CB66FJ), and no leaks were visible on inspection. The vehicle is allowed access into the asbestos contaminated work area.	
RESULT:	PASS	
NOTES:	Prior to successfully passing a smoke test the window seals were taped, to improve the integrity of the seal.

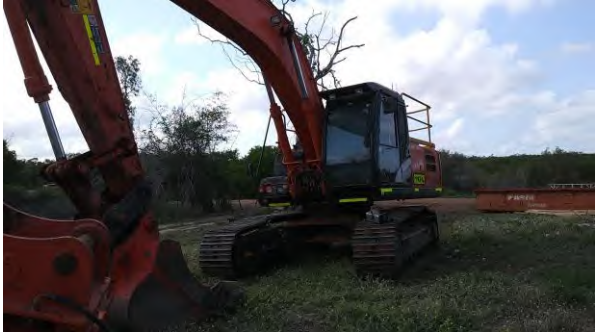
REPORT DATE:	Tuesday, 13 November 2018	
CLIENT:	Anindilyakwa Land Council	
REMOVAL CONTRACTOR	Darwin Asbestos and Demolition Services	
ORDER / PROJECT NO.	N/A	
NOTIFICATION NO.	N/A	
SITE NAME:	Bartalumba Bay Homestead Asbestos Remediation Project	
SITE ADDRESS: SUBURB:	Bartalumba Bay Groote Eylandt	
ASBESTOS ASSESSOR:	Jack Pilkington Licence No.: NTWS-AA-463514	
WORKS UNDERTAKEN:	Significant smoke was generated within the HITACHI Zaxis 290LC Excavator (Serial No. HCDDA20F000405400), and no leaks were visible on inspection. The plant is allowed access into the asbestos contaminated work area.	
RESULT:	PASS	
NOTES:	N/A

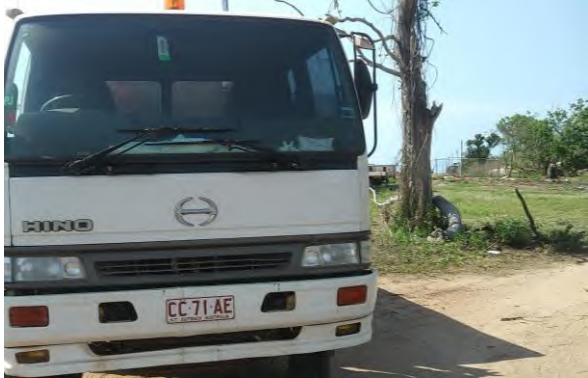
REPORT DATE:	Wednesday, 14 November 2018	
CLIENT:	Anindilyakwa Land Council	
REMOVAL CONTRACTOR	Darwin Asbestos and Demolition Services	
ORDER / PROJECT NO.	N/A	
NOTIFICATION NO.	N/A	
SITE NAME:	Bartalumba Bay Homestead Asbestos Remediation Project	
SITE ADDRESS: SUBURB:	Bartalumba Bay Groote Eylandt	
ASBESTOS ASSESSOR:	Jack Pilkington Licence No.: NTWS-AA-463514	
WORKS UNDERTAKEN:	Significant smoke was generated within the HINO Hook Truck (License No. CC71AE), and no leaks were visible on inspection. The vehicle is allowed access into the asbestos contaminated work area.	
RESULT:	PASS	
NOTES:	Prior to successfully passing a smoke test the window seals were taped, to improve the integrity of the seal.

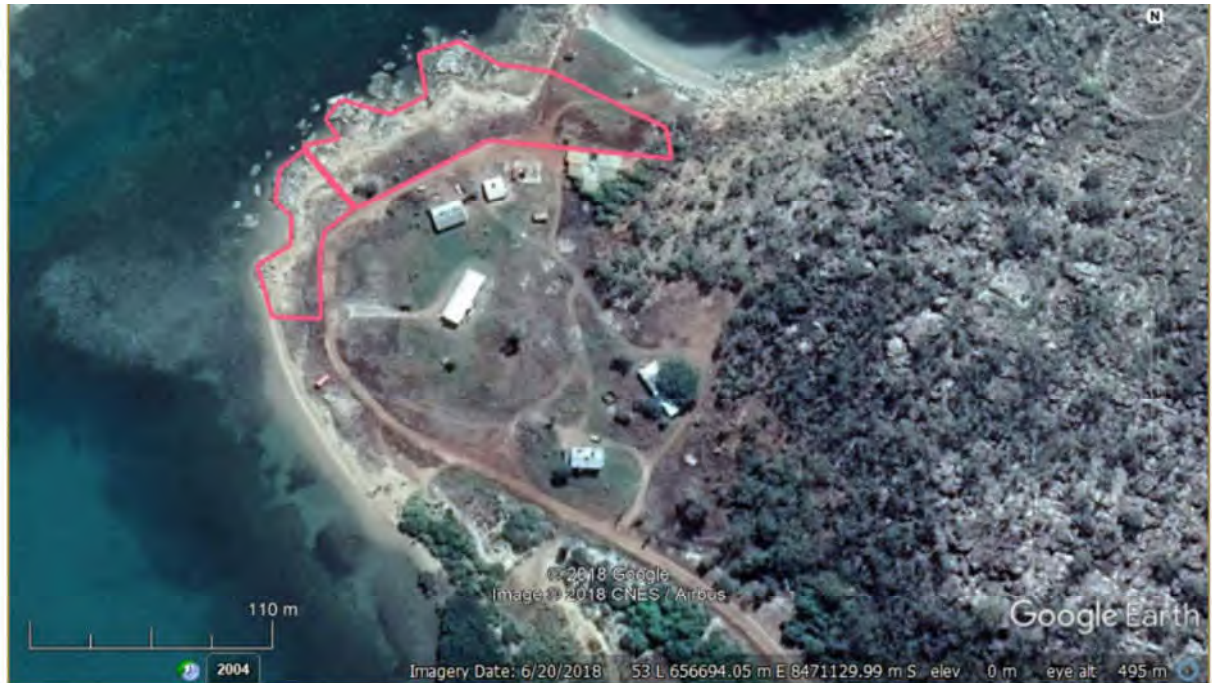
Figure 1: Asbestos contamination across the Foreshore of the Bartalumba Bay Homestead

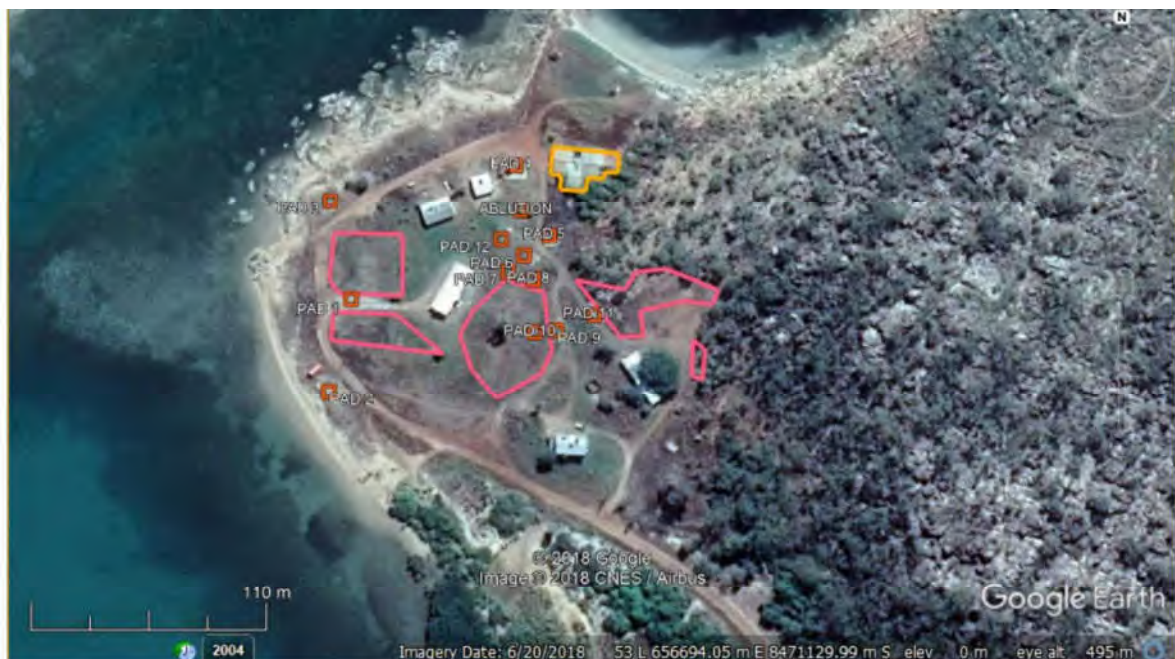
Figure 2: Areas of significant asbestos contamination across the Grounds of the Bartalumba Bay Homestead

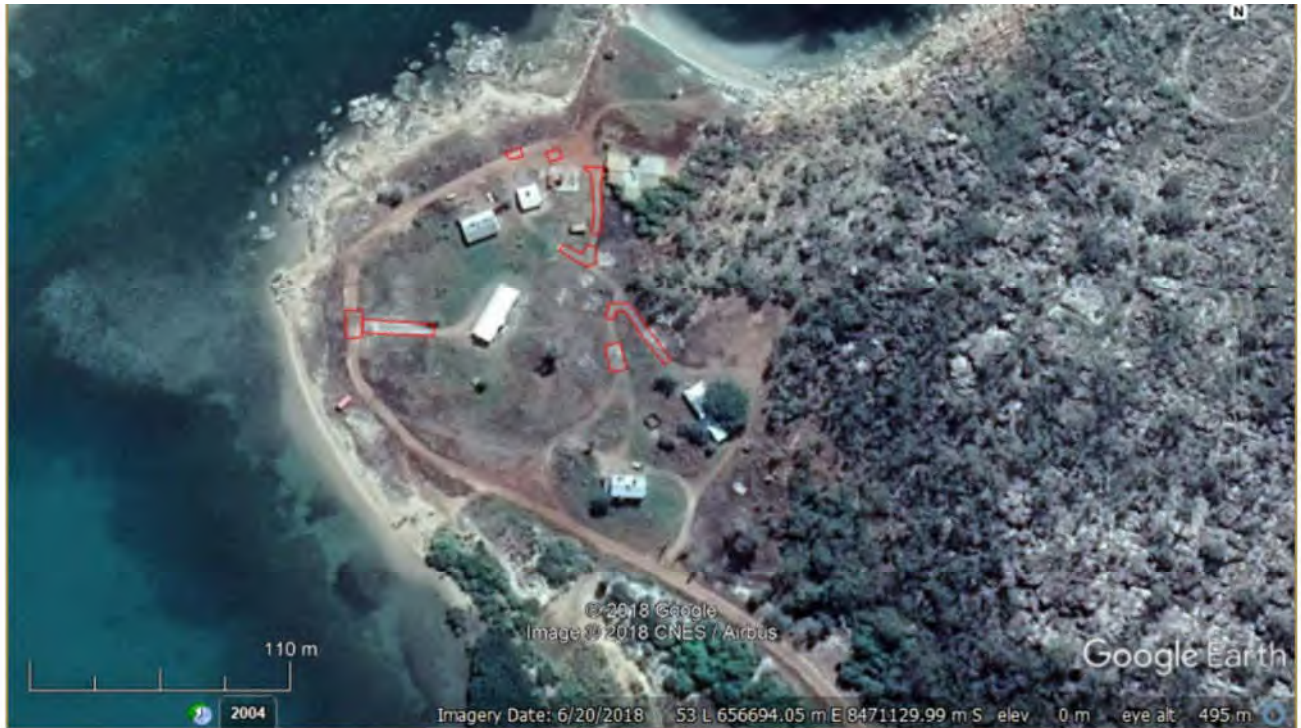
Figure 3: Areas of asbestos contamination on the Roadways of the Bartalumba Bay Homestead

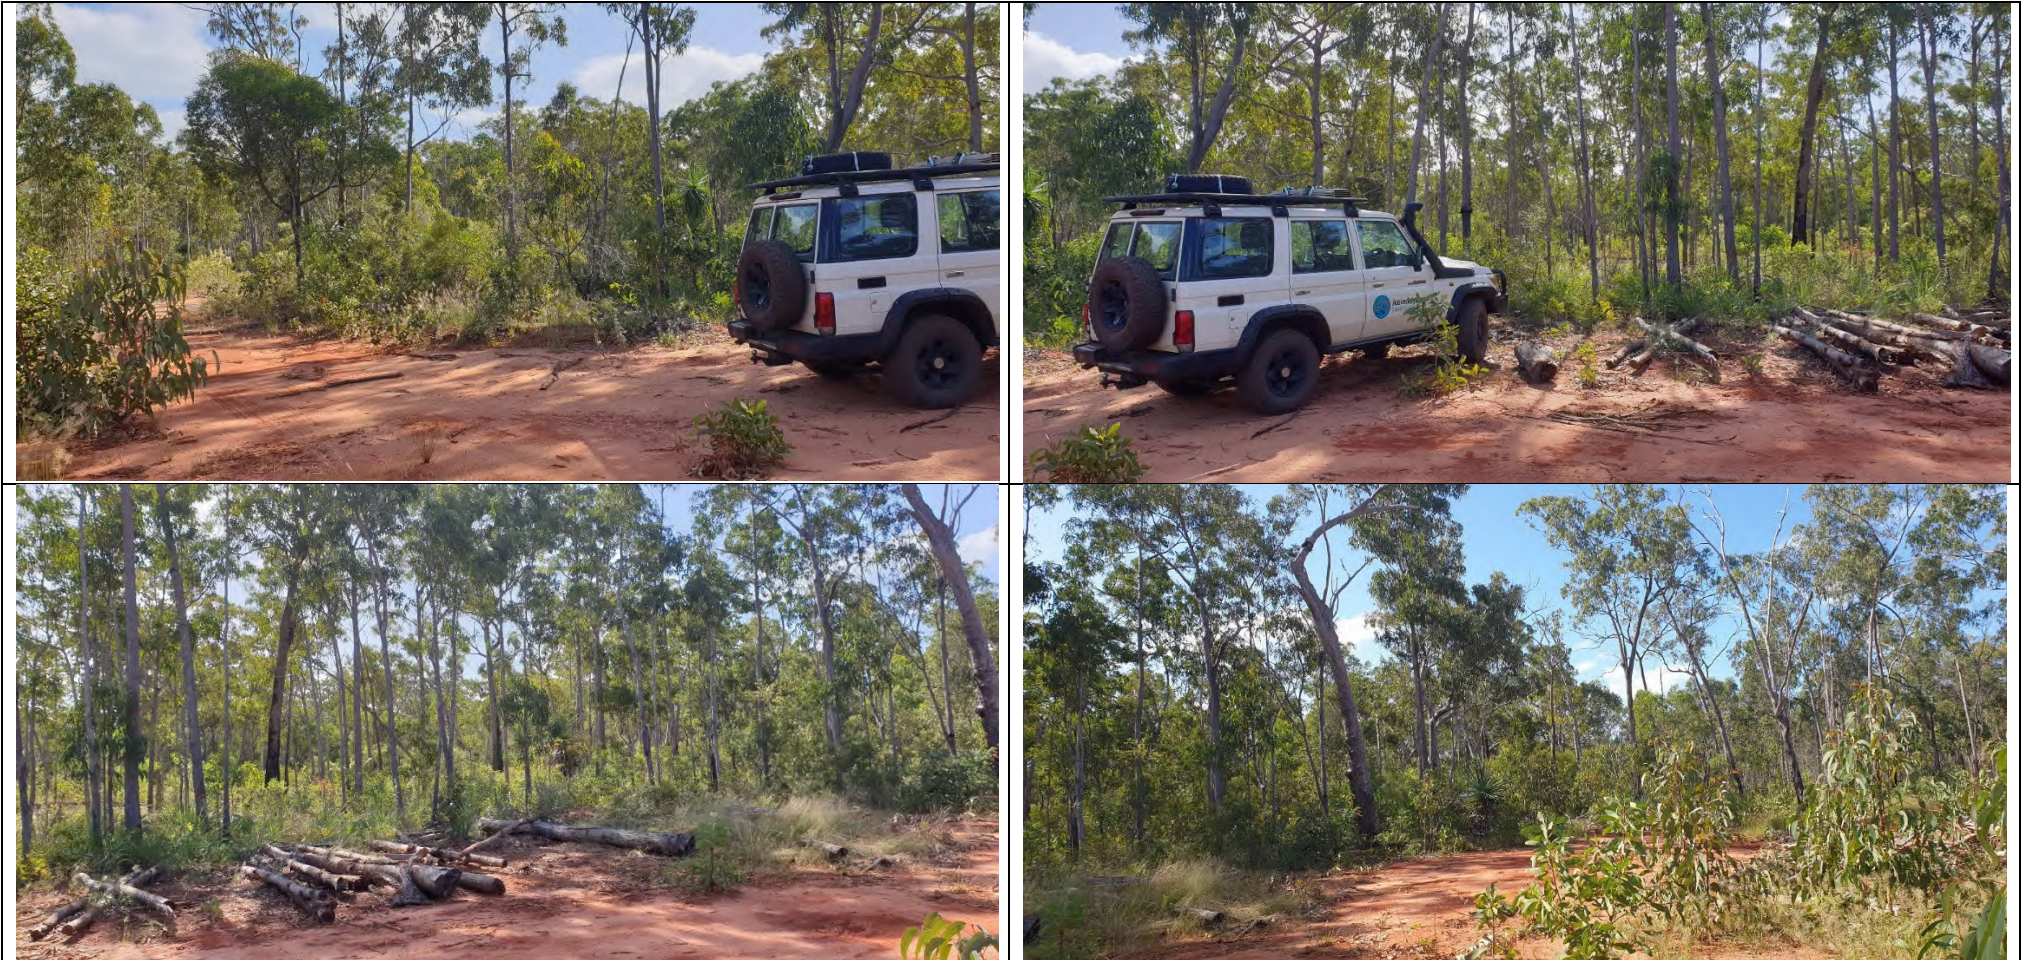
Photo 11 Condition of natural bushland to north of Disposal Site

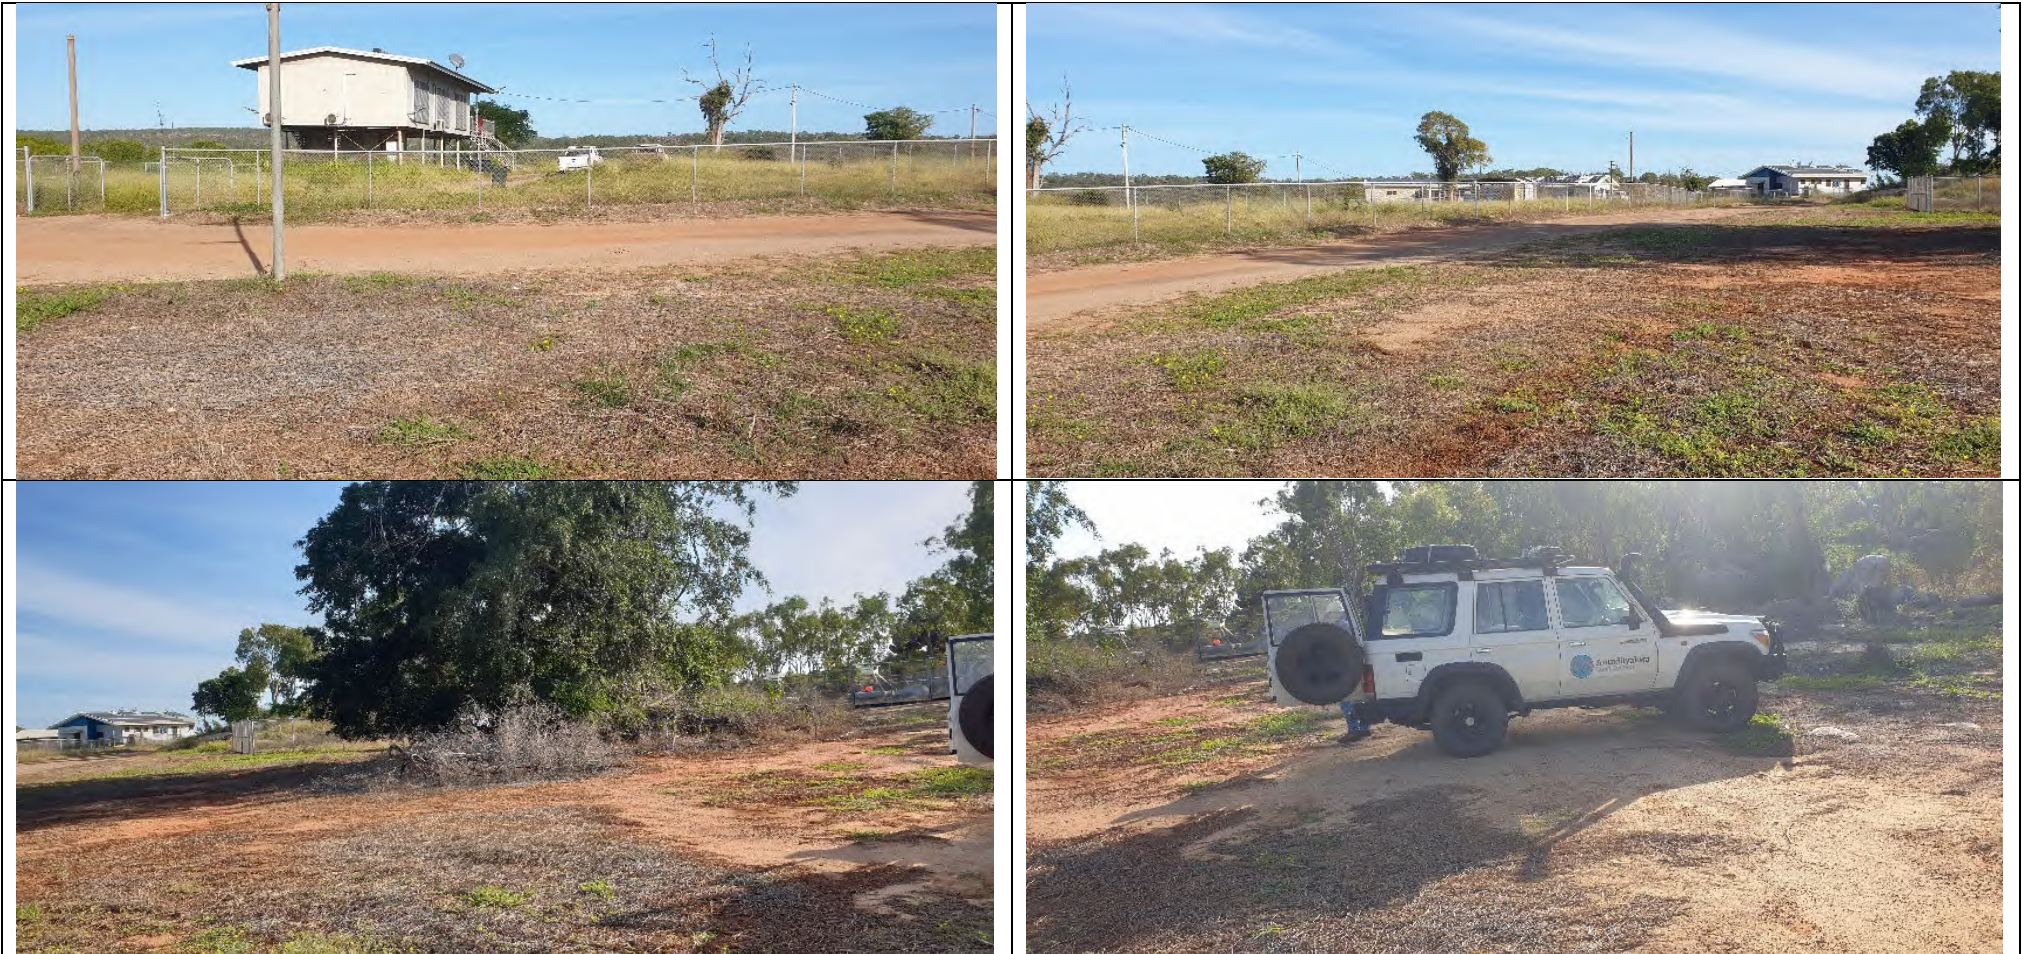
Photo 12 Former Duplex Building area looking north

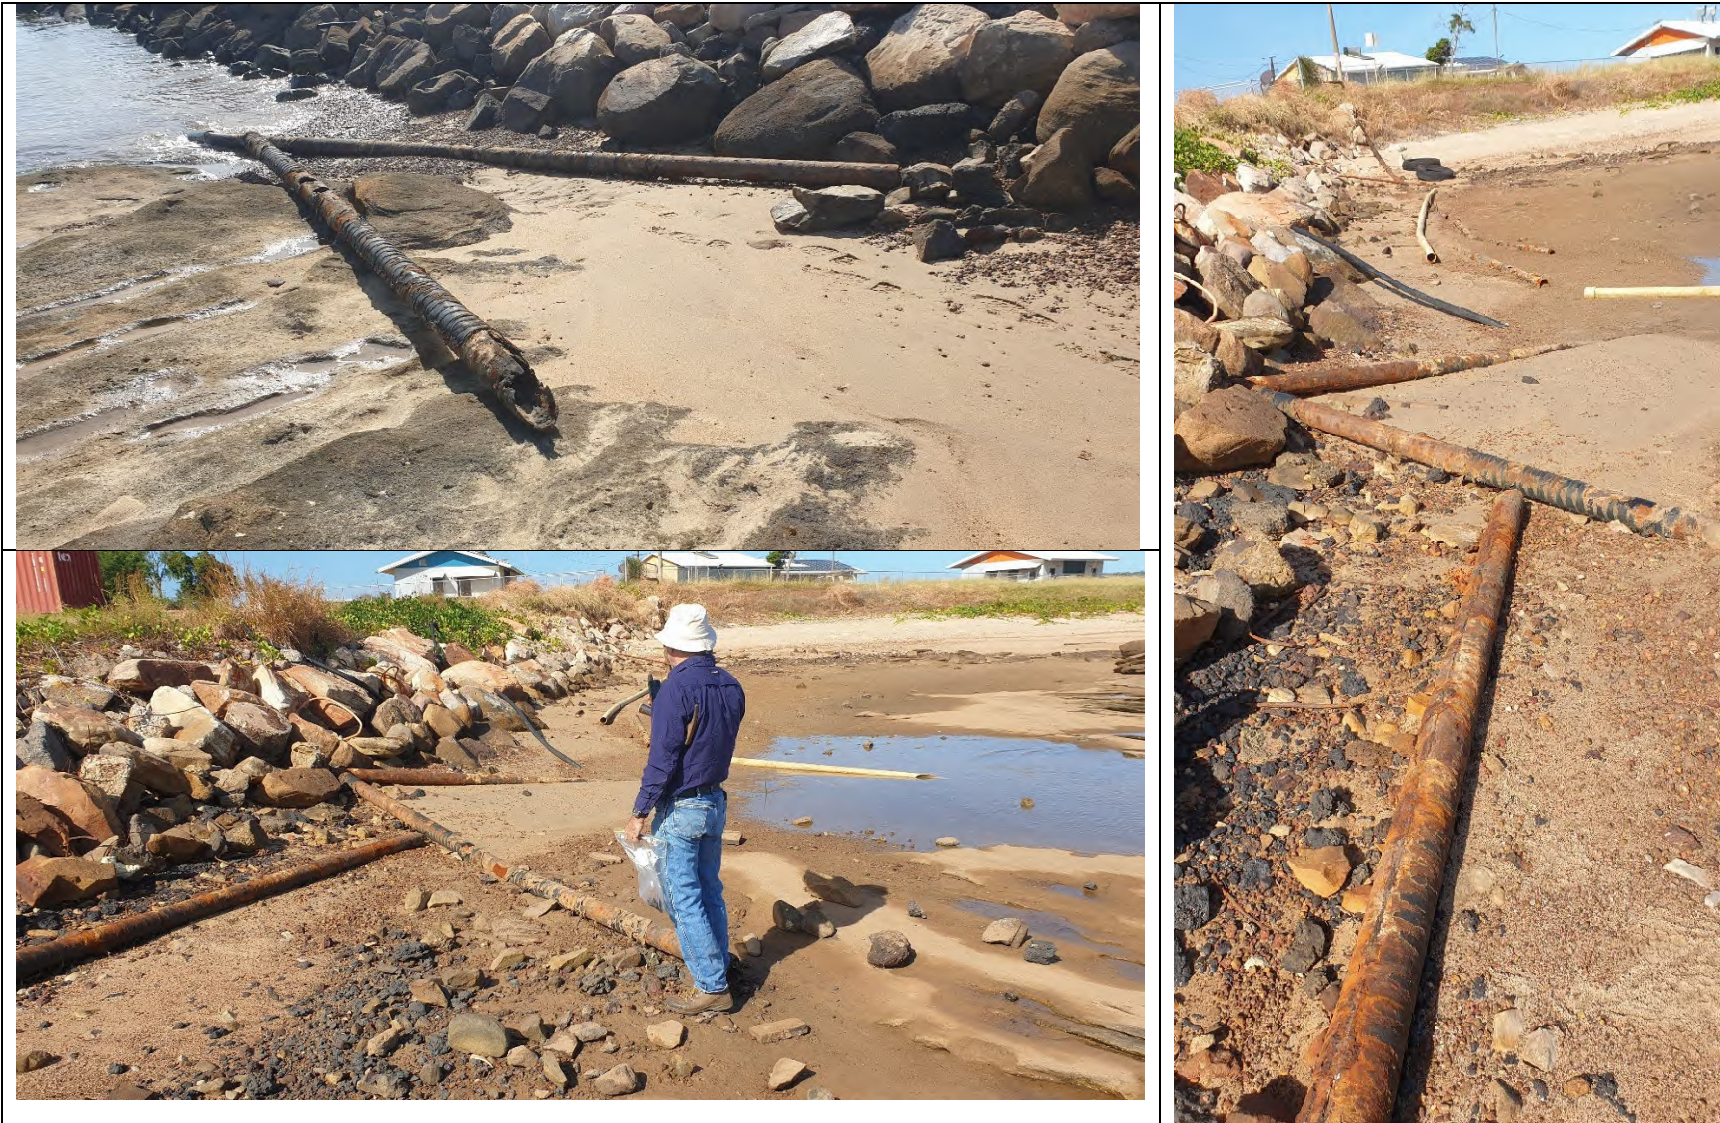
Photo 21 View of broken up cast-iron wastewater pipeline located along western side of Jetty
