Site Audit Report ALC_1 by Dr Ian Swane

REMEDIATION OF ASBESTOS CONTAMINATION AT THE FORMER BARTALUMBA BAY
HOMESTEAD SITE, GROOTE EYLANDT, NORTHERN TERRITORY 0822

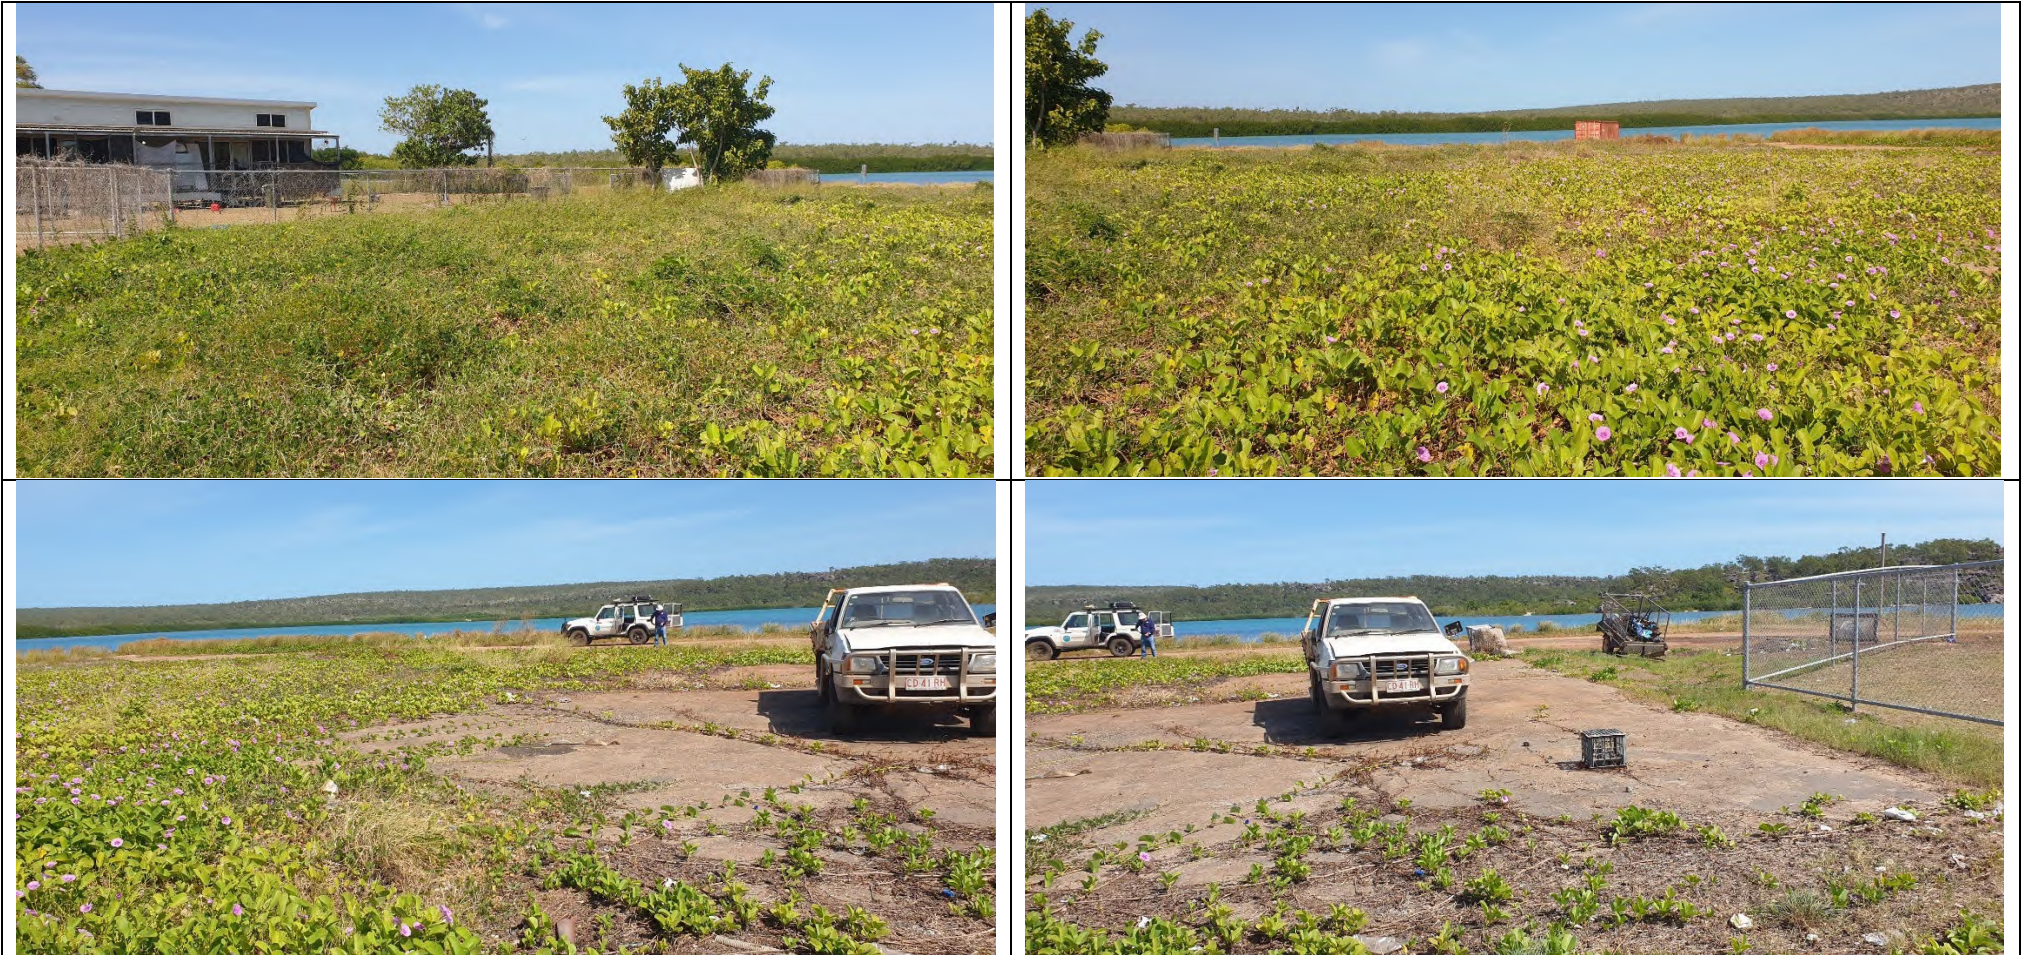
Photo 22 View of former process building area looking south to west
