**Pirlangimpi, Pickertaramoor and Milikapiti Access Roads
Melville Island, NT**

**Hydrogeological Assessment & Roadworks Water Supply
Strategy**

*A report prepared by Maria Woodgate (TGS) for the Northern Territory Department of
Infrastructure, Planning and Logistics*

September 2020

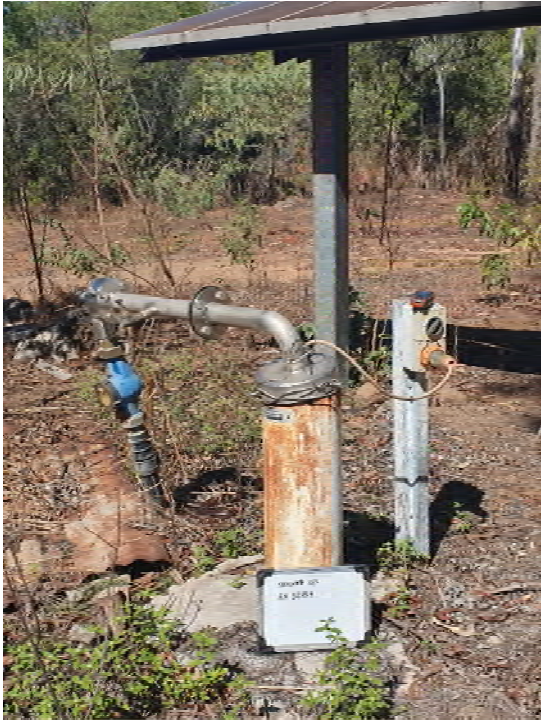
Taracumbi Outstation Bore RN32883

5.5	3	Taracumbi outstation bore RN032883	686452	8716413	1	This bore is currently equipped so the pump would need to be pulled. The bore is meant to be supplying the houses but is disconnected due to leaking pipes. Set pump at 7.5m (or use existing installed pump & adjust headworks for take).	TLC approval via LURF needed.

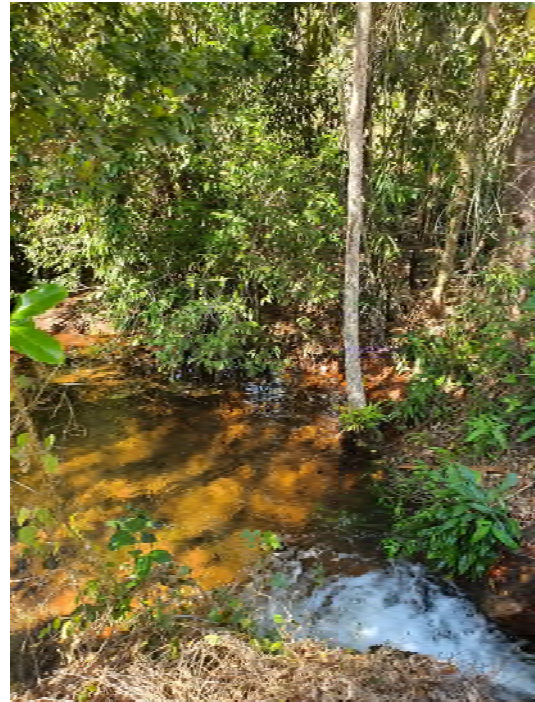
Taracumbi Creek at Outstation – Estimated Flow 3-4L/s

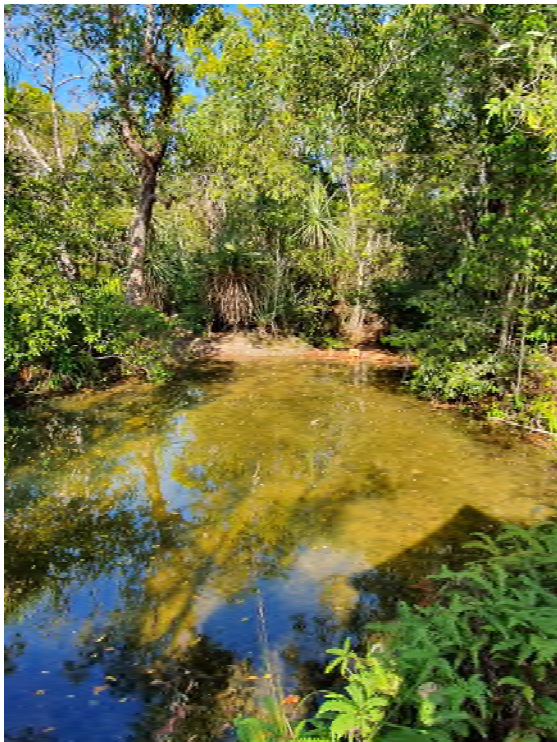
9 Mile Waterhole

15.2 Turnoff	1	9 Mile waterhole	683850	8724740	na	This waterhole has good access and a turnaround area. Needs gravel on track to stop erosion.	LURF required to take water from creek.
19	2	New Bore Target MR4	683768	8728504.		Side of road. Estimate drill depth 130m (into Moonkinu sandstone member – deep aquifer). Expect flow rate 3 L/s.	TLC approval via LURF
24	1	New Bore Target MR5	682933	8732869		Side of road. Estimate drill depth 50m (into Van Diemen Sandstone – shallow aquifer). Expect flow rate 2 L/s.	TLC approval via LURF
31	1	Farm Bore RN027856	681231	873105	3 L/s	Farm bore currently at full capacity (current drought conditions) and can't promise it can be used. Regarding post-wet future use, I am awaiting a response from Scott Simpson Tiwi Enterprises regarding potential use after he assessed capacity and demand.	Need approval from Tiwi Enterprises.

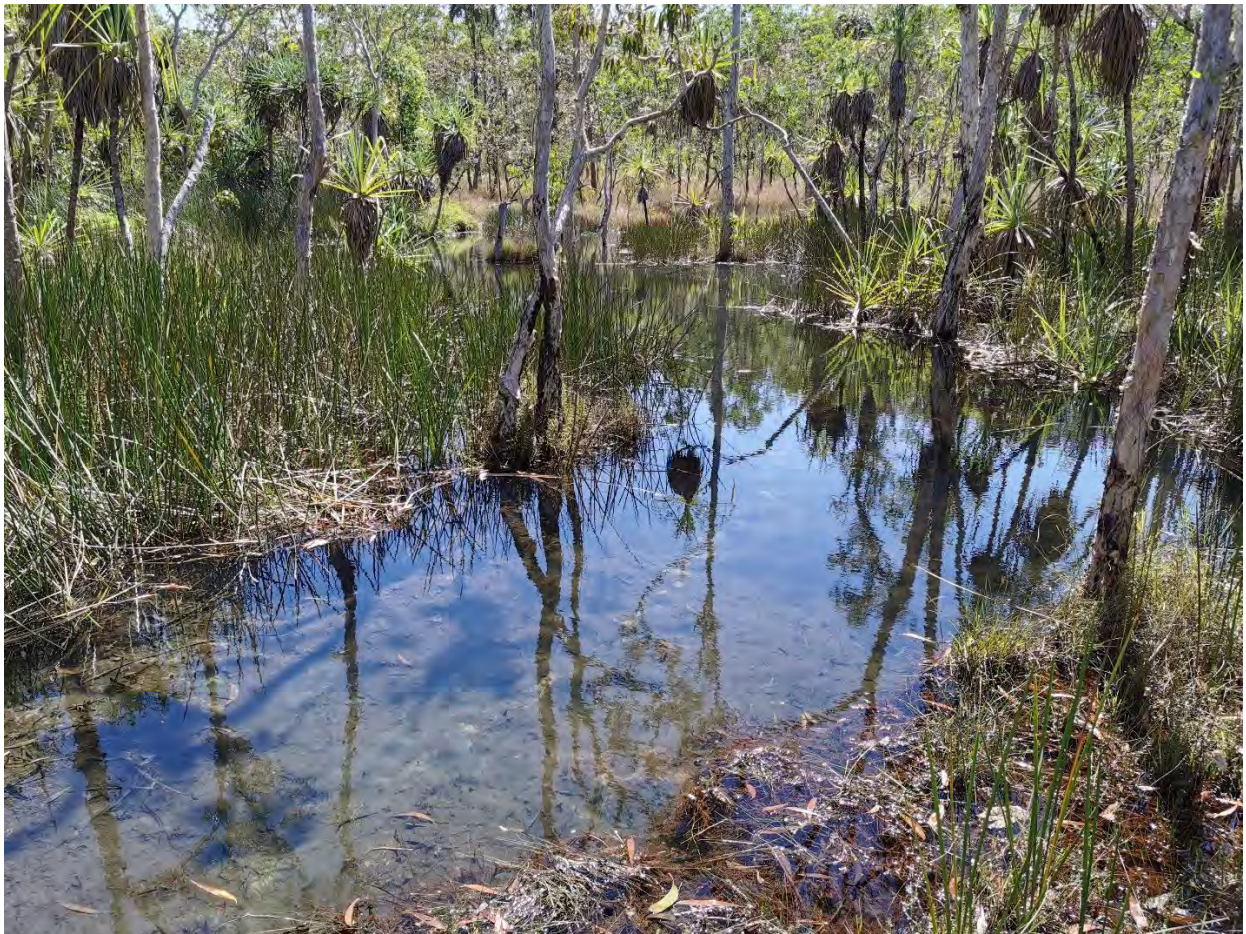
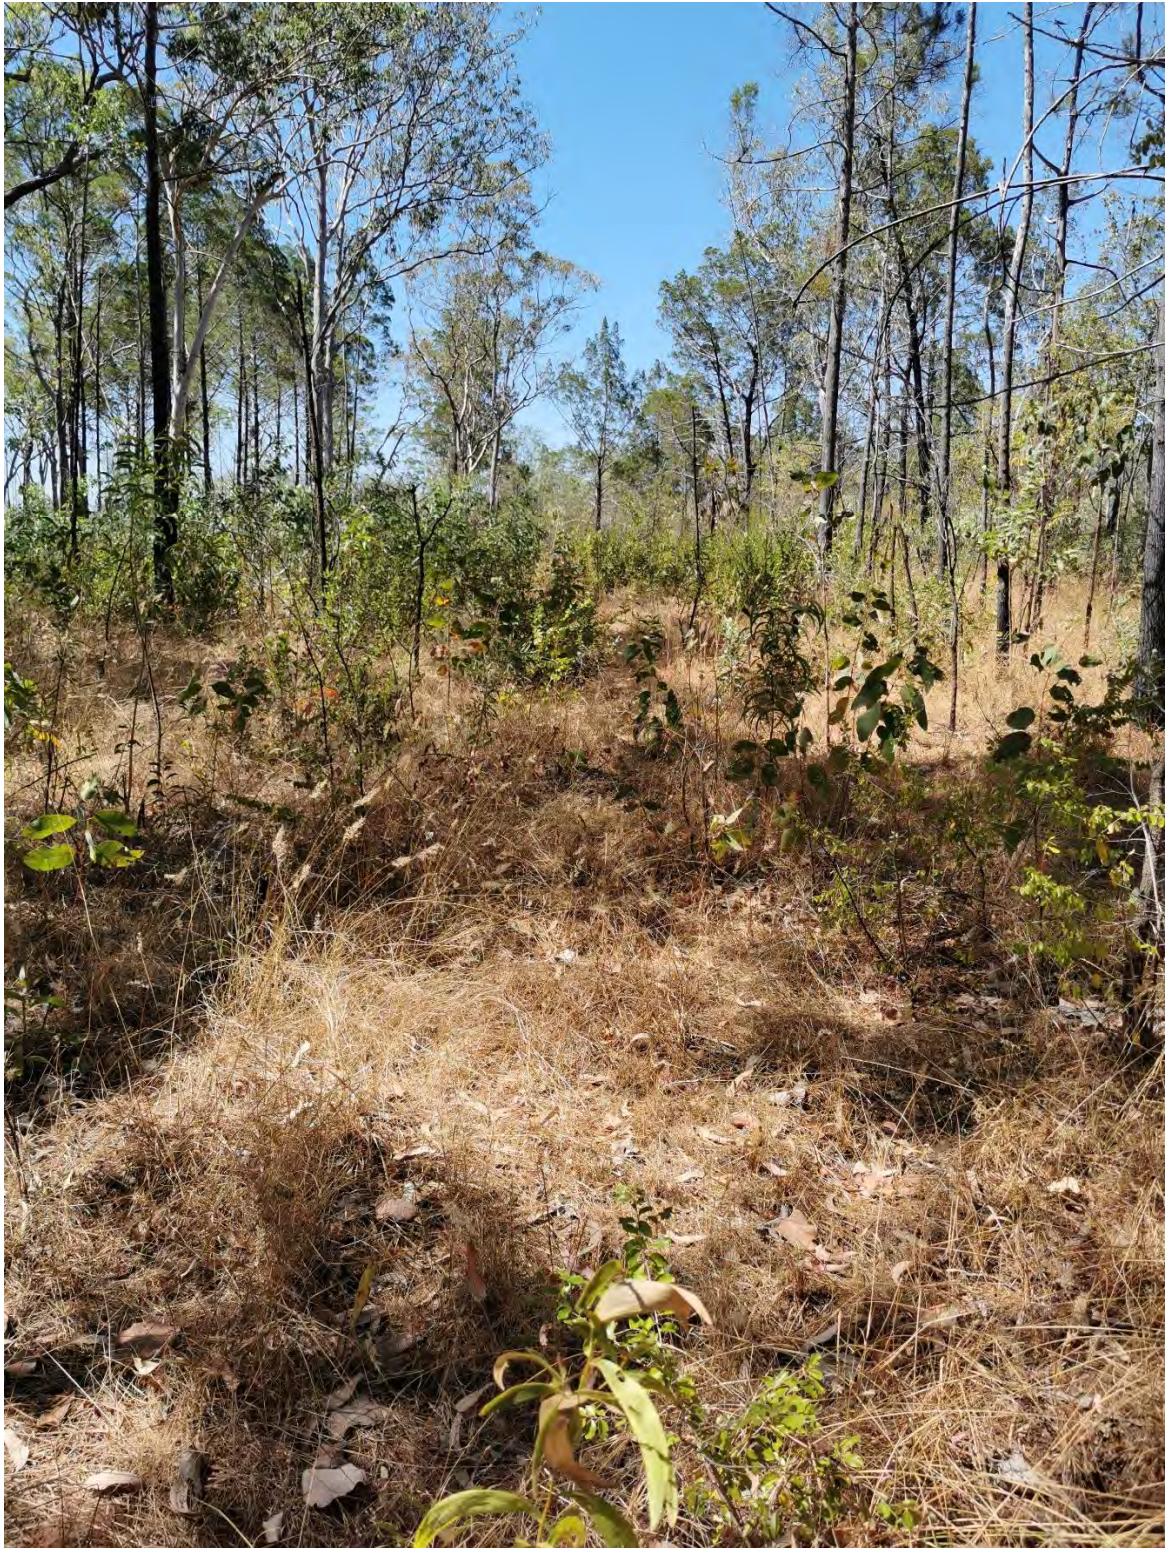
CW001 S 11 42'10.0 E 130 51'22.8

A large permanent spring fed water hole was located at this point. There was a strong flow of water coming from the downstream end of the water hole. The water is located 500m north of the plantation fire break and appears to be relatively easy to access along the ridge from the firebreak. There was an old forestry track approximately halfway between the existing firebreak and the waterhole which may assist with access.

View of the water hole from the southern side looking north.

View of access from the southern edge of the water hole looking south up the ridge towards the firebreak.

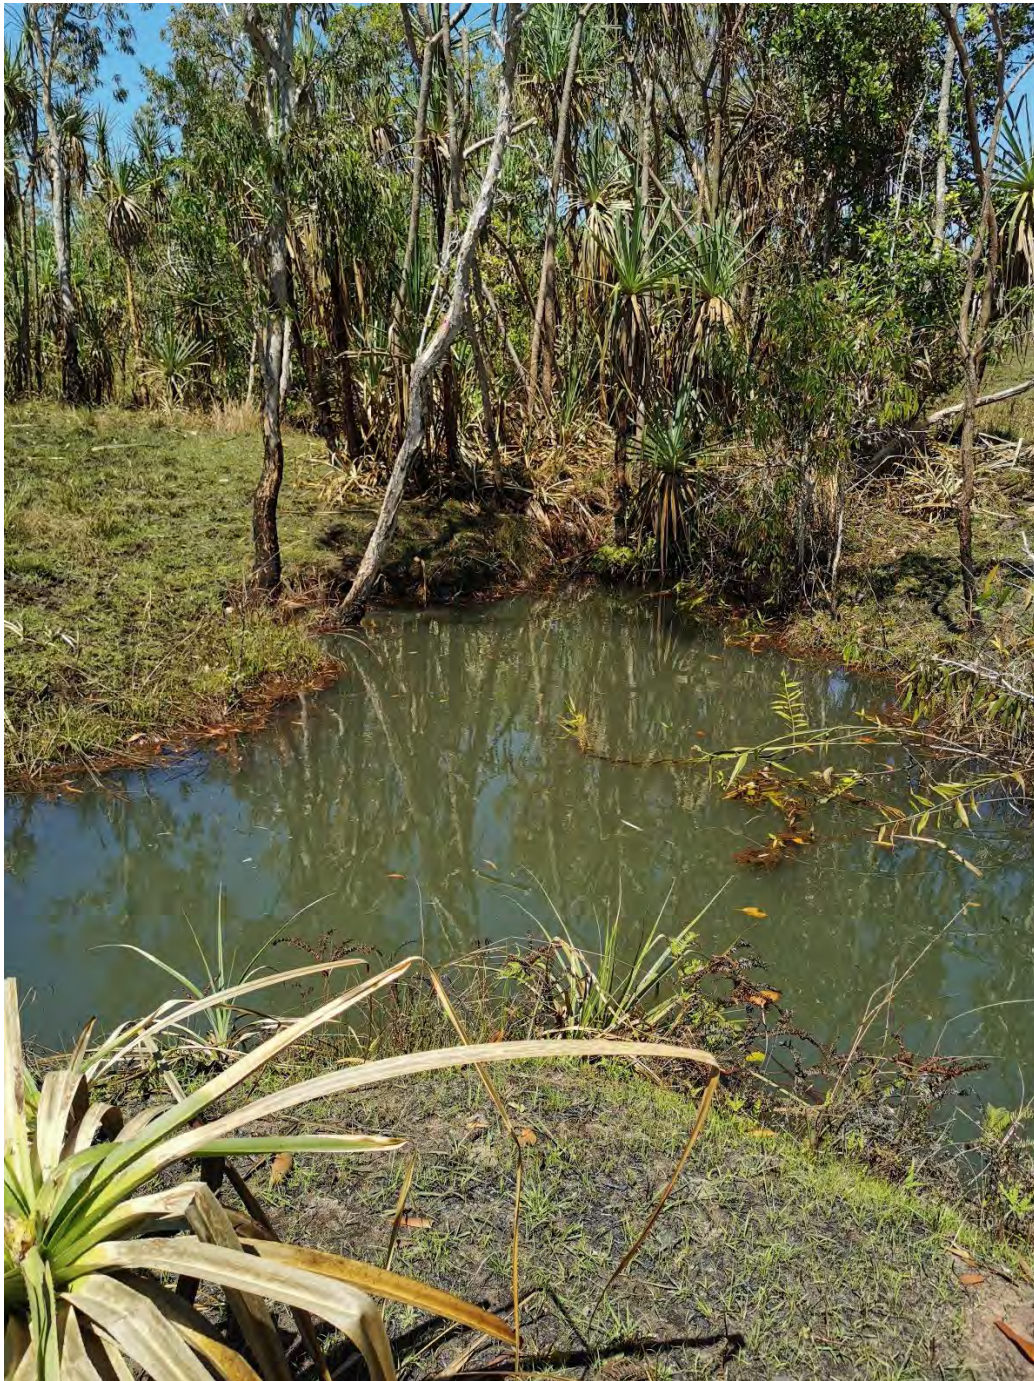
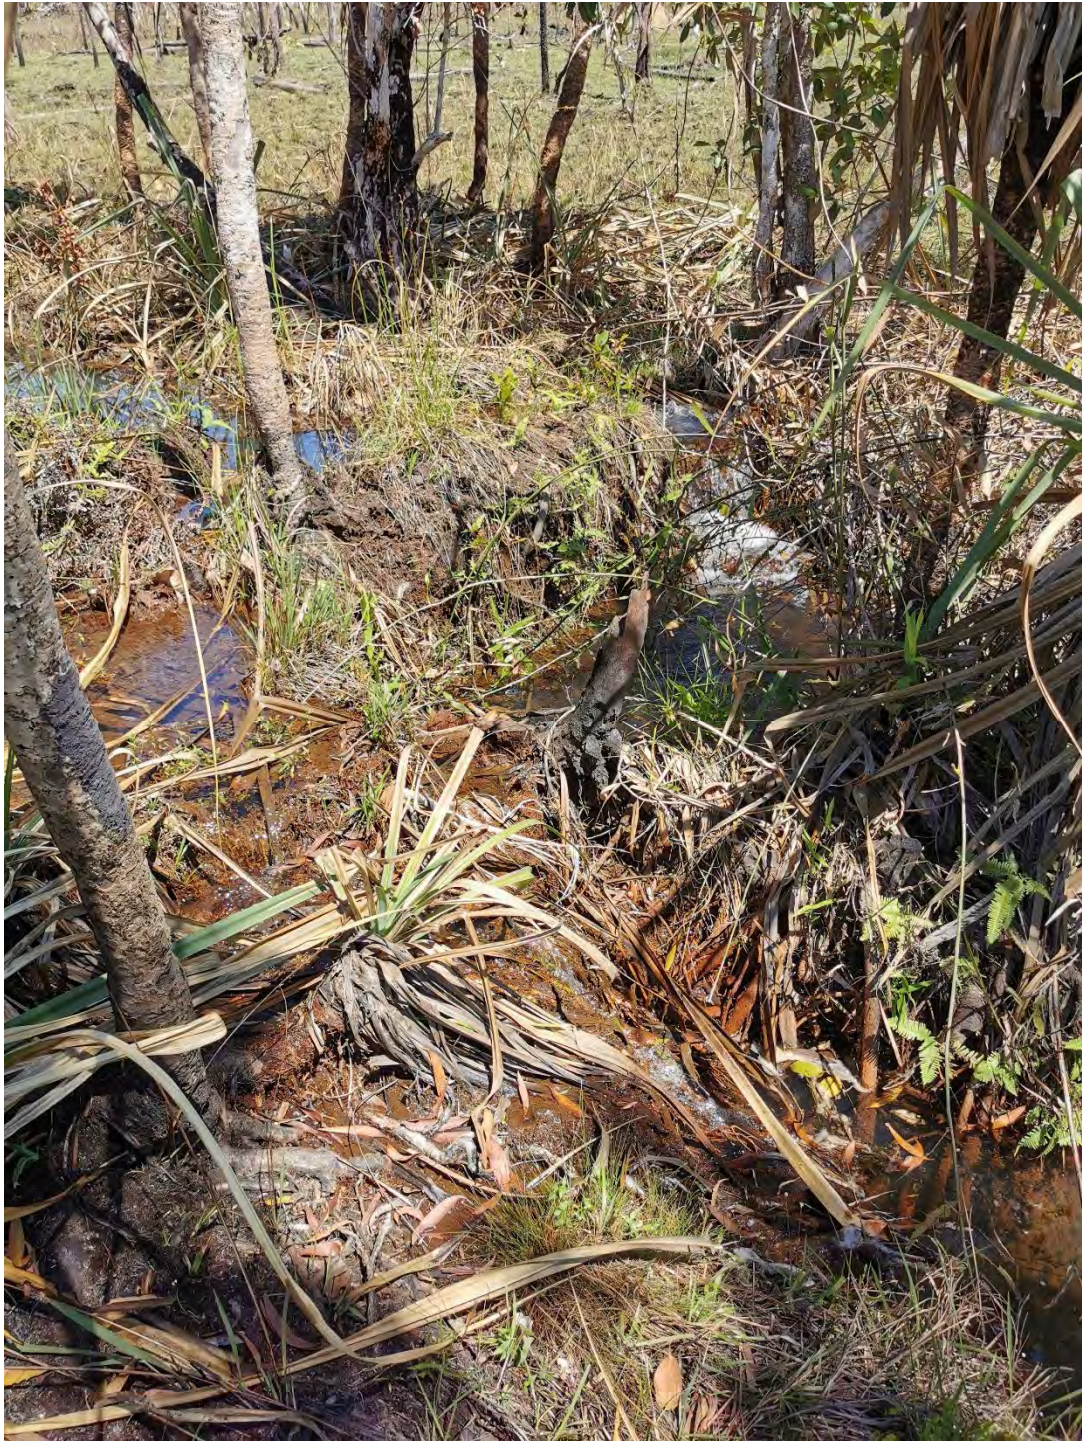
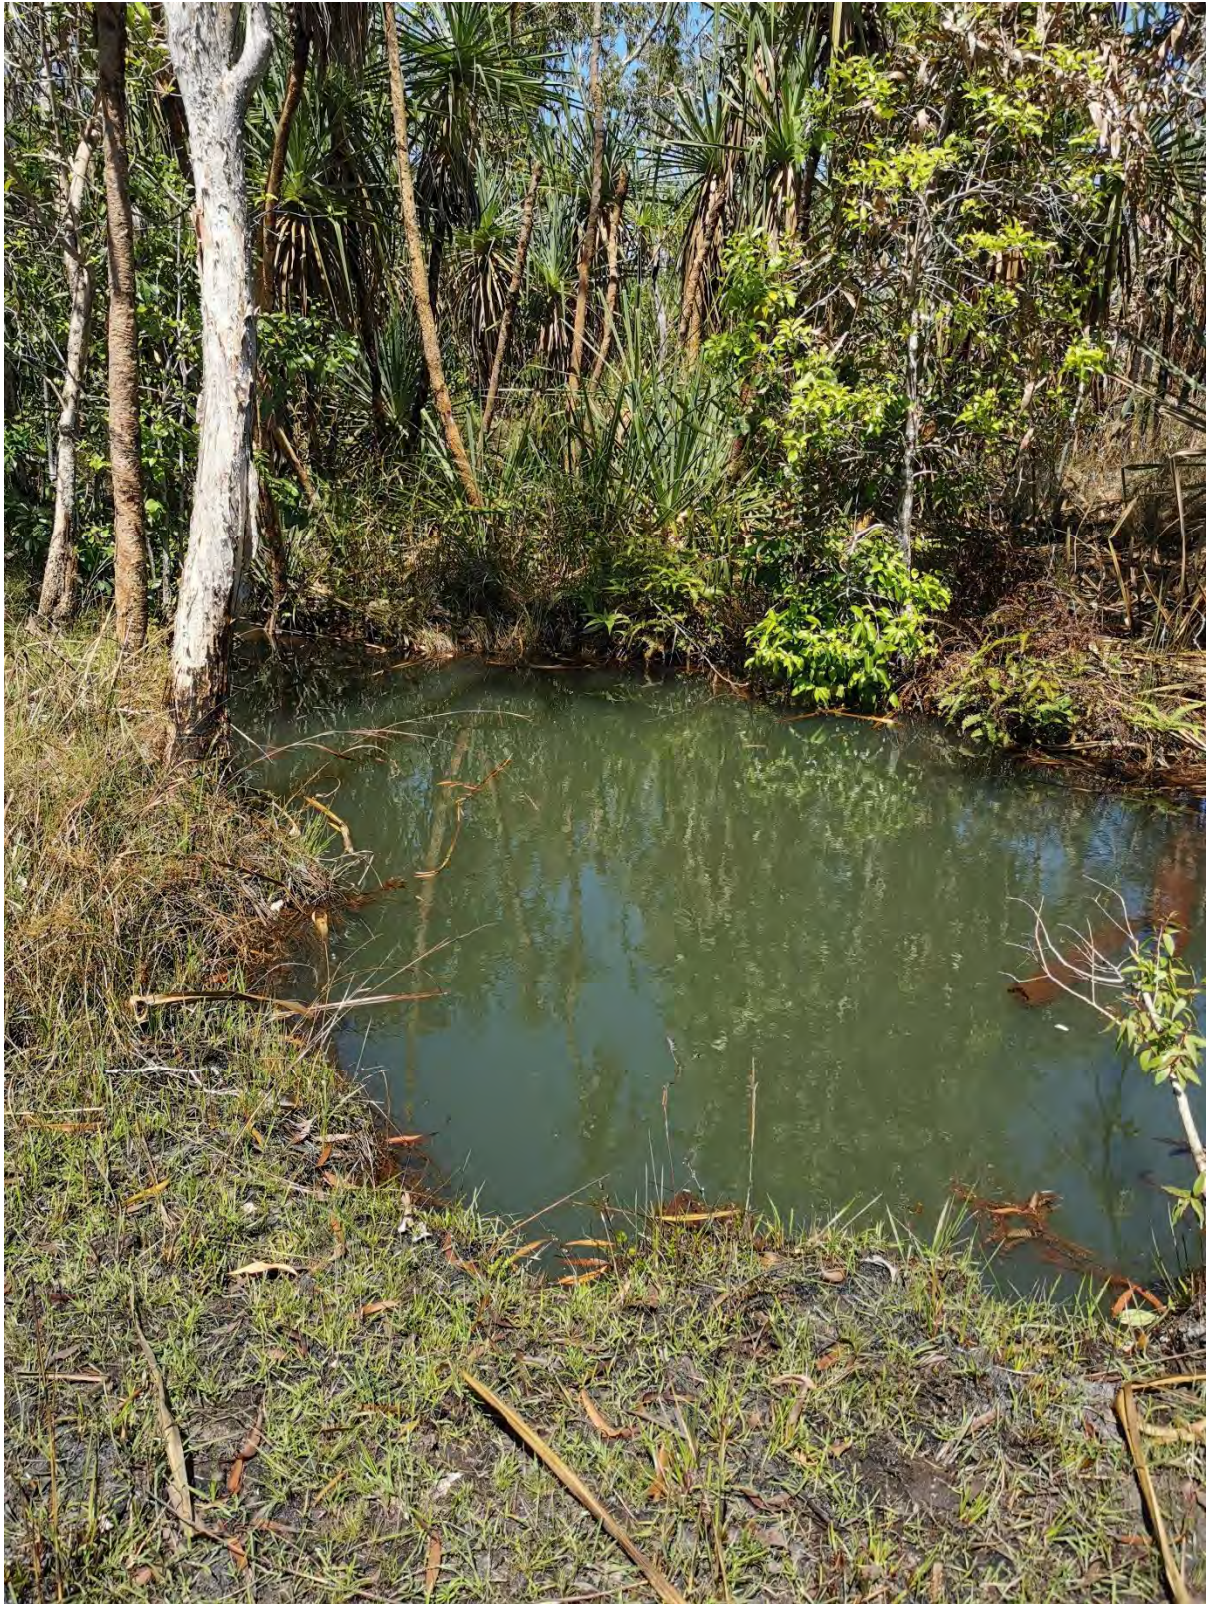
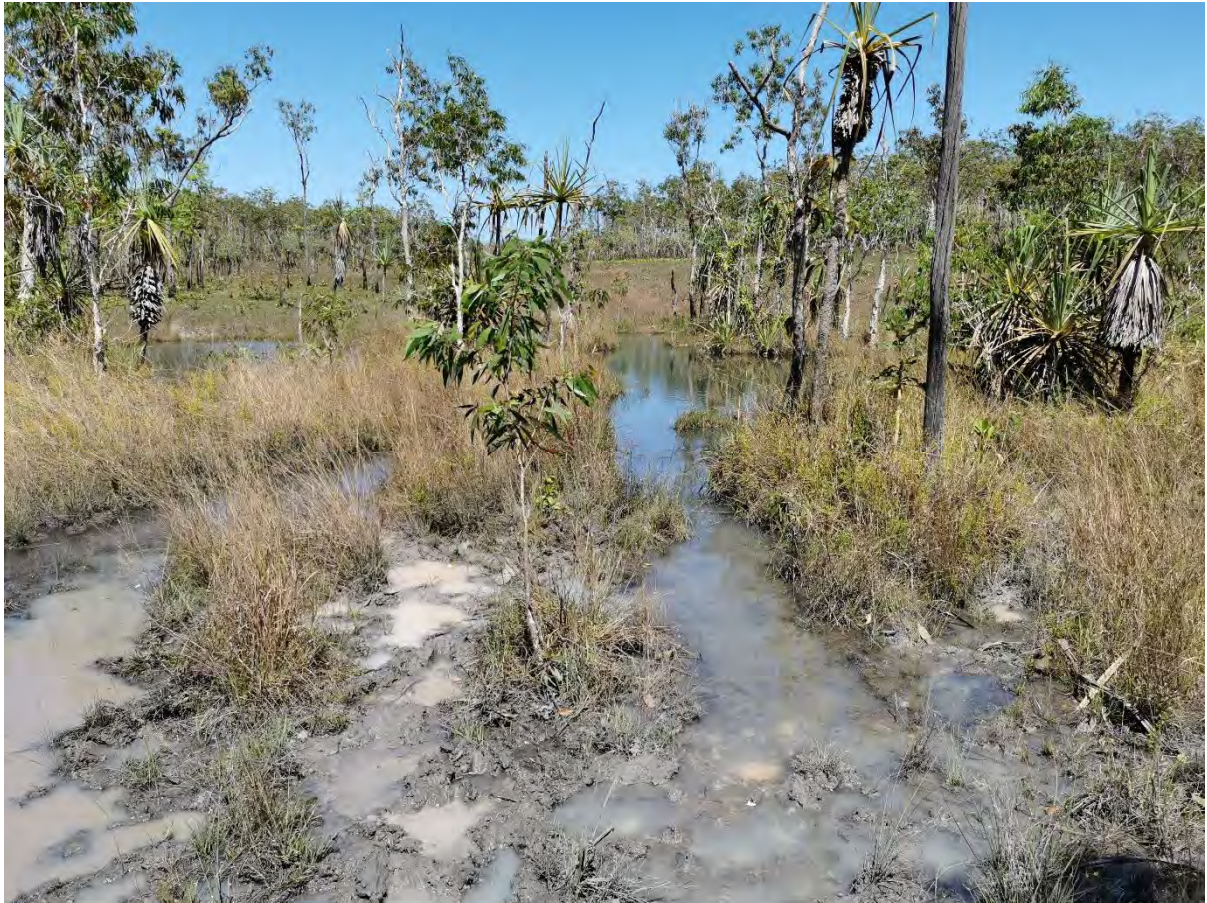
CW002

Spring with several permanent holes and good flow rates lies within a small floodplain area. The area within 50m of the spring is quite soft and wet but access to the edge of the wet area is relatively easy. There is an existing graded road from the forestry firebreak to within 300m of the spring so only a short access track would need to be constructed to use this water source.

One of several permanent spring fed water holes.

Flow rates for late dry season are still quite strong.

One of the deeper permanent water holes.

The top hole in the spring system is larger and shallower than the others but feeds into the smaller water holes.

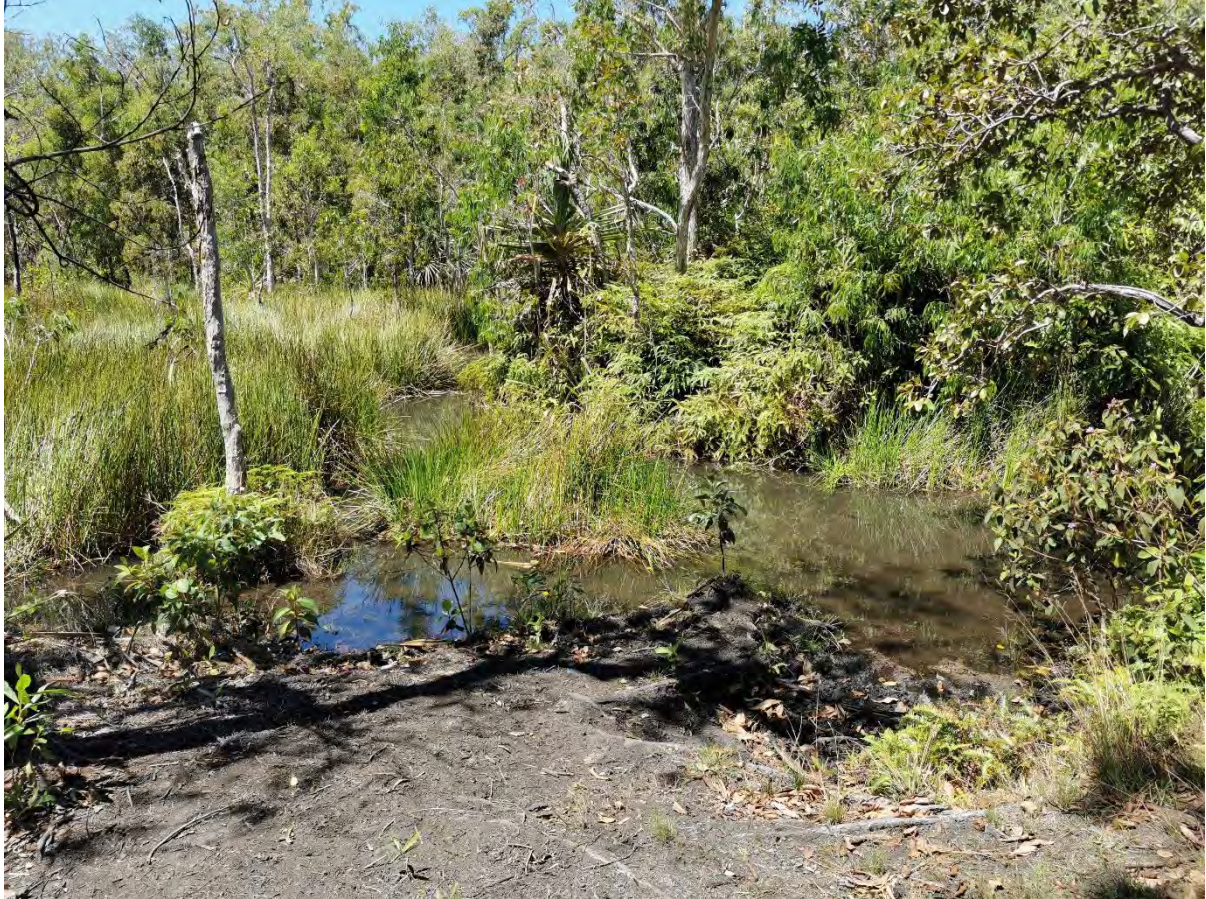
WP007

Surface water was located at this position however the water does not appear to be flowing and consists of a shallow swampy area that is difficult to access. This water point would not be suitable for significant water extraction for roadworks.

Shallow swampy water hole not suitable for large volume water extraction.

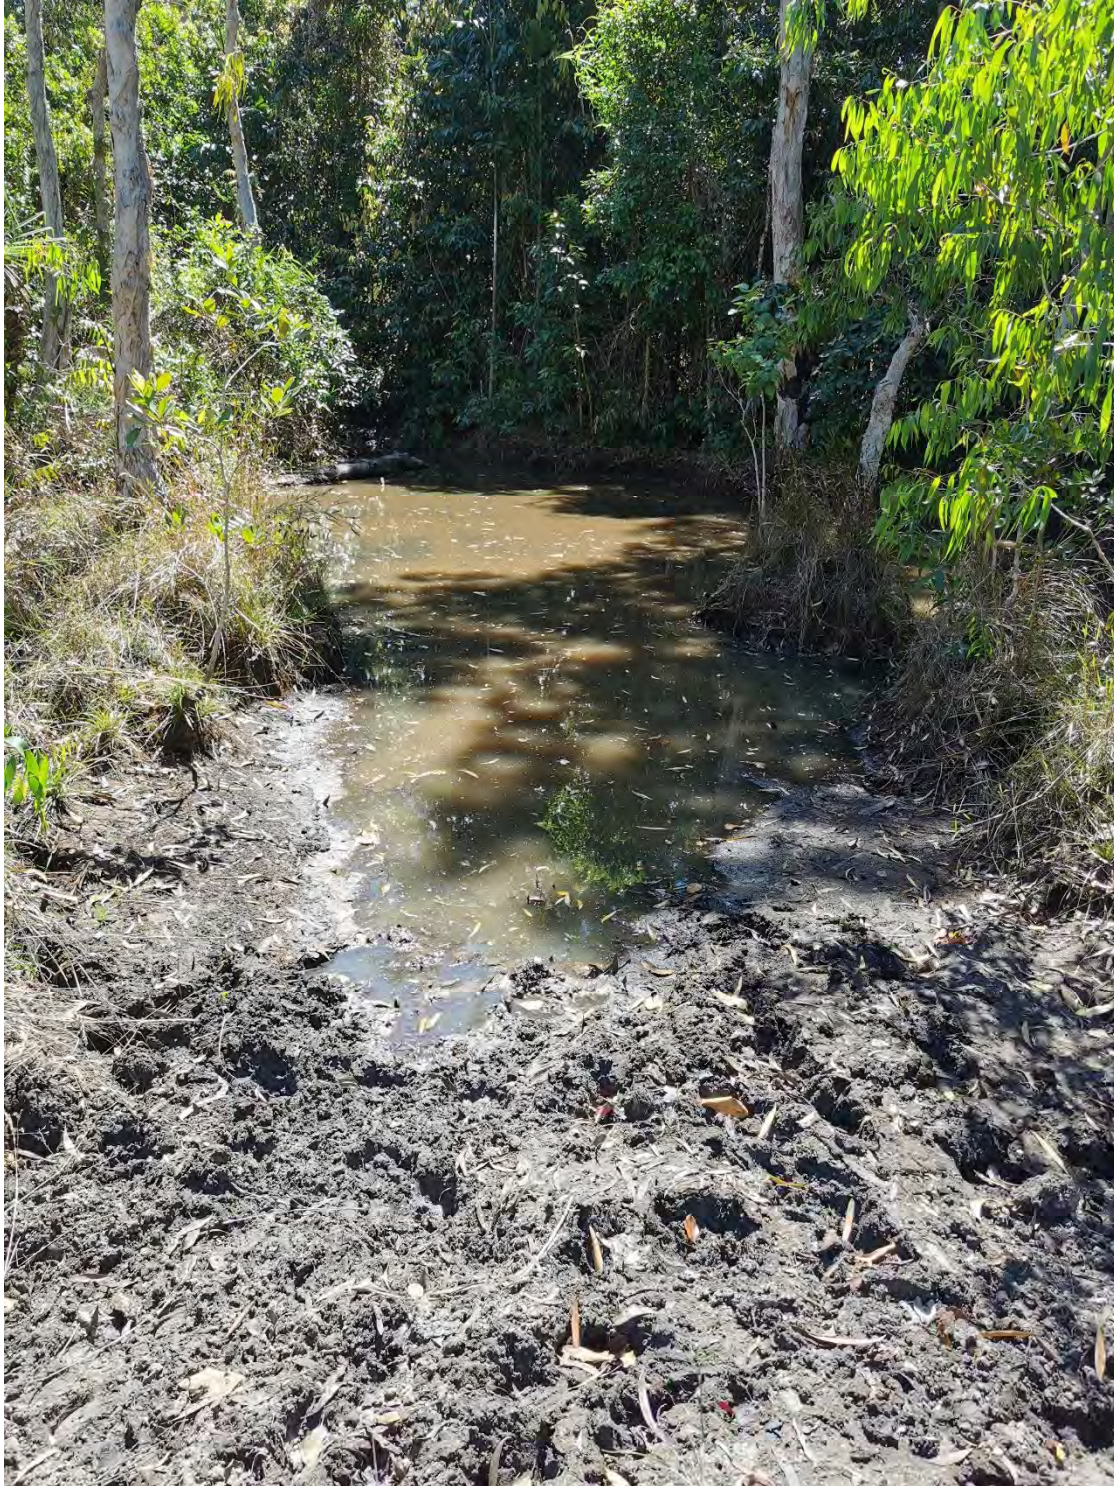
WP002

This site had some small surface water holes that were quite shallow and appeared to have no flow. This site is not suitable for water extraction.

Shallow swampy water hole not suitable for water extraction.

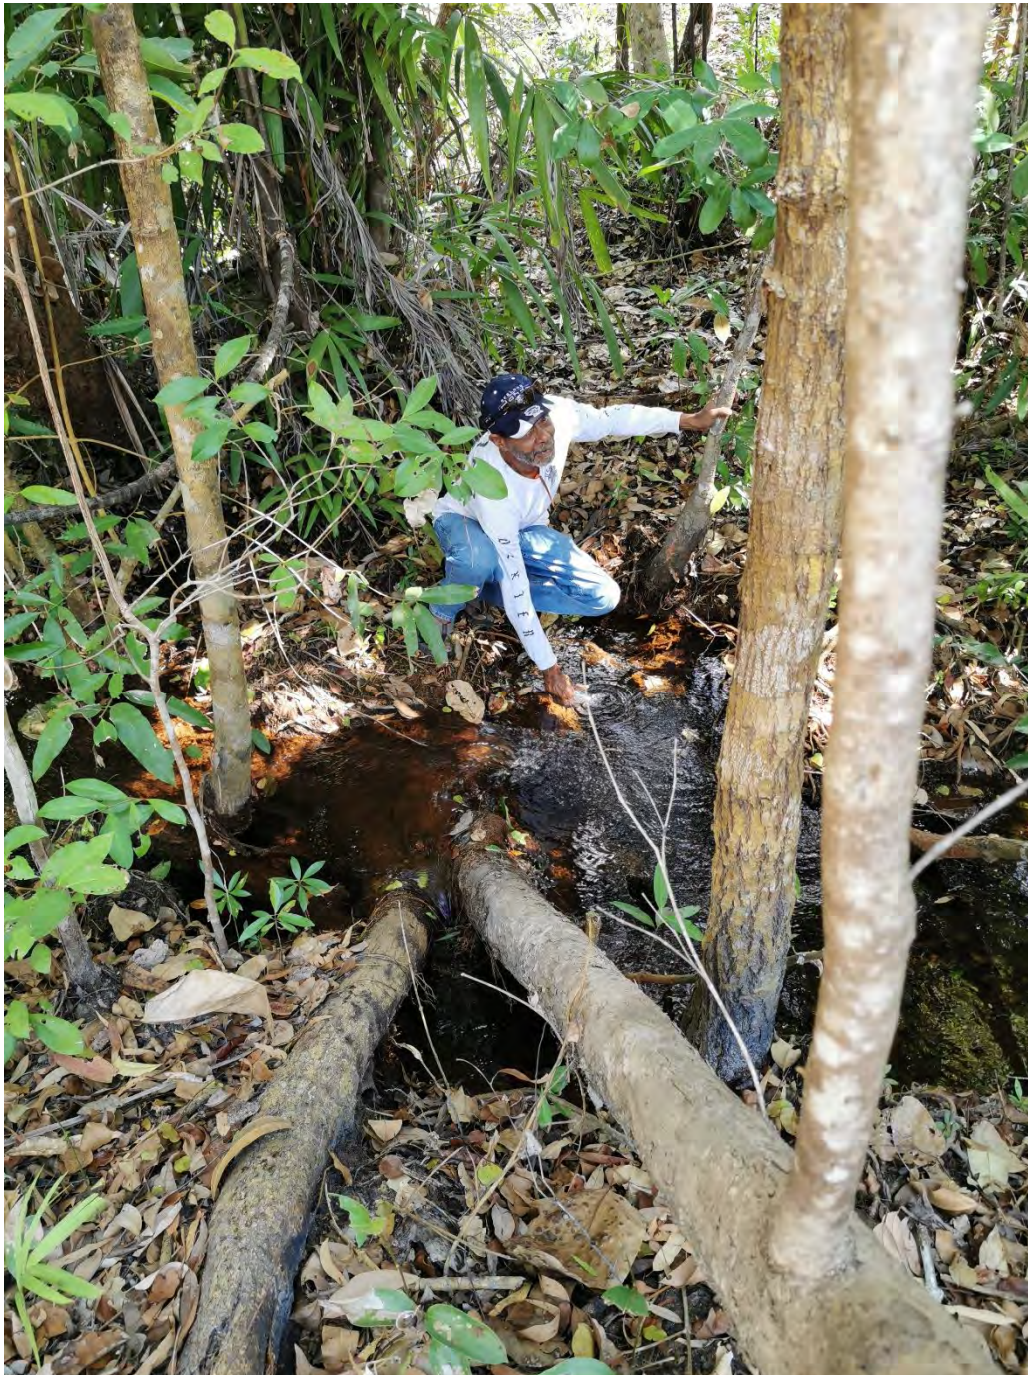
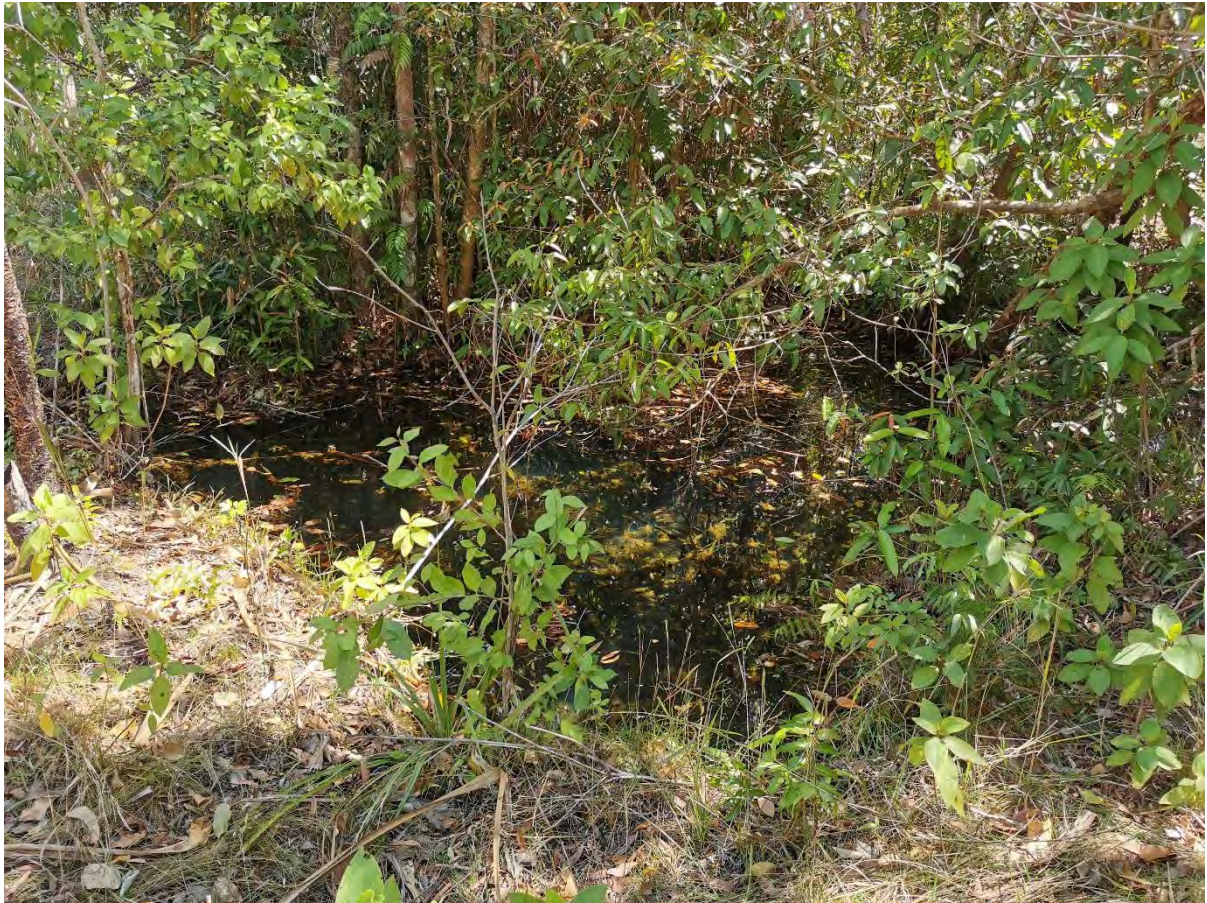
CW003

This spring fed creek is quite deep and has a very good flow rate. The best access would be from the firebreak to the south west and would require an access track to be constructed to follow the ridge. The distance from the firebreak to the water hole is approximately 1km.

Good flow rates would make this spring suitable for water extraction.

Permanent flowing water in one of the larger pools.

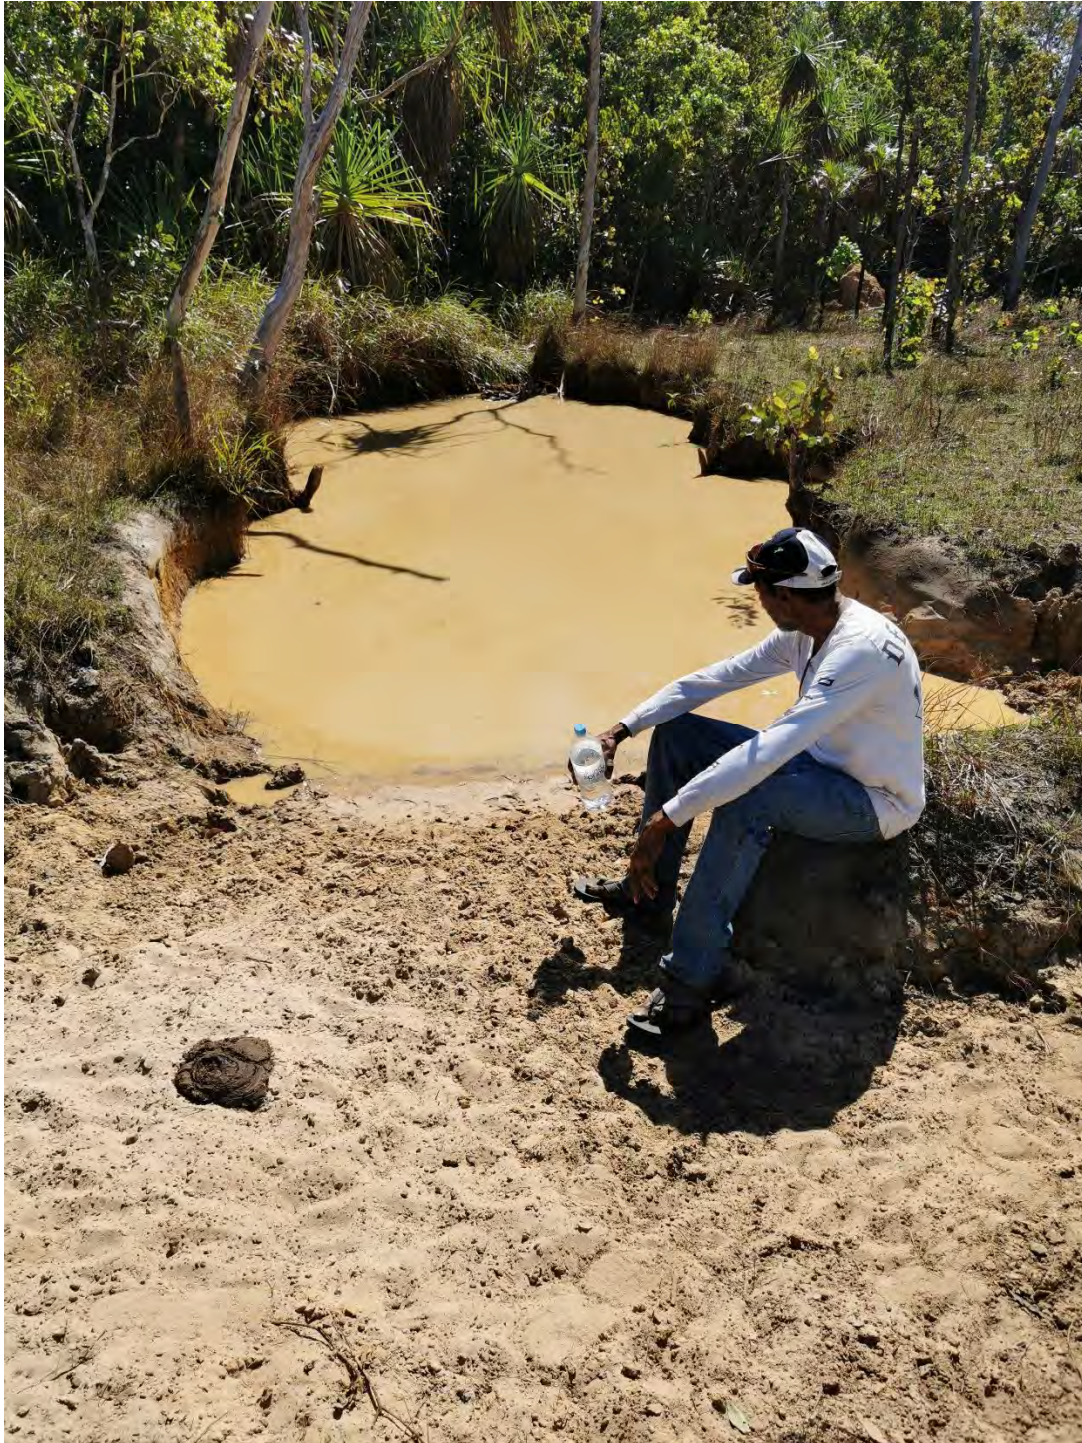
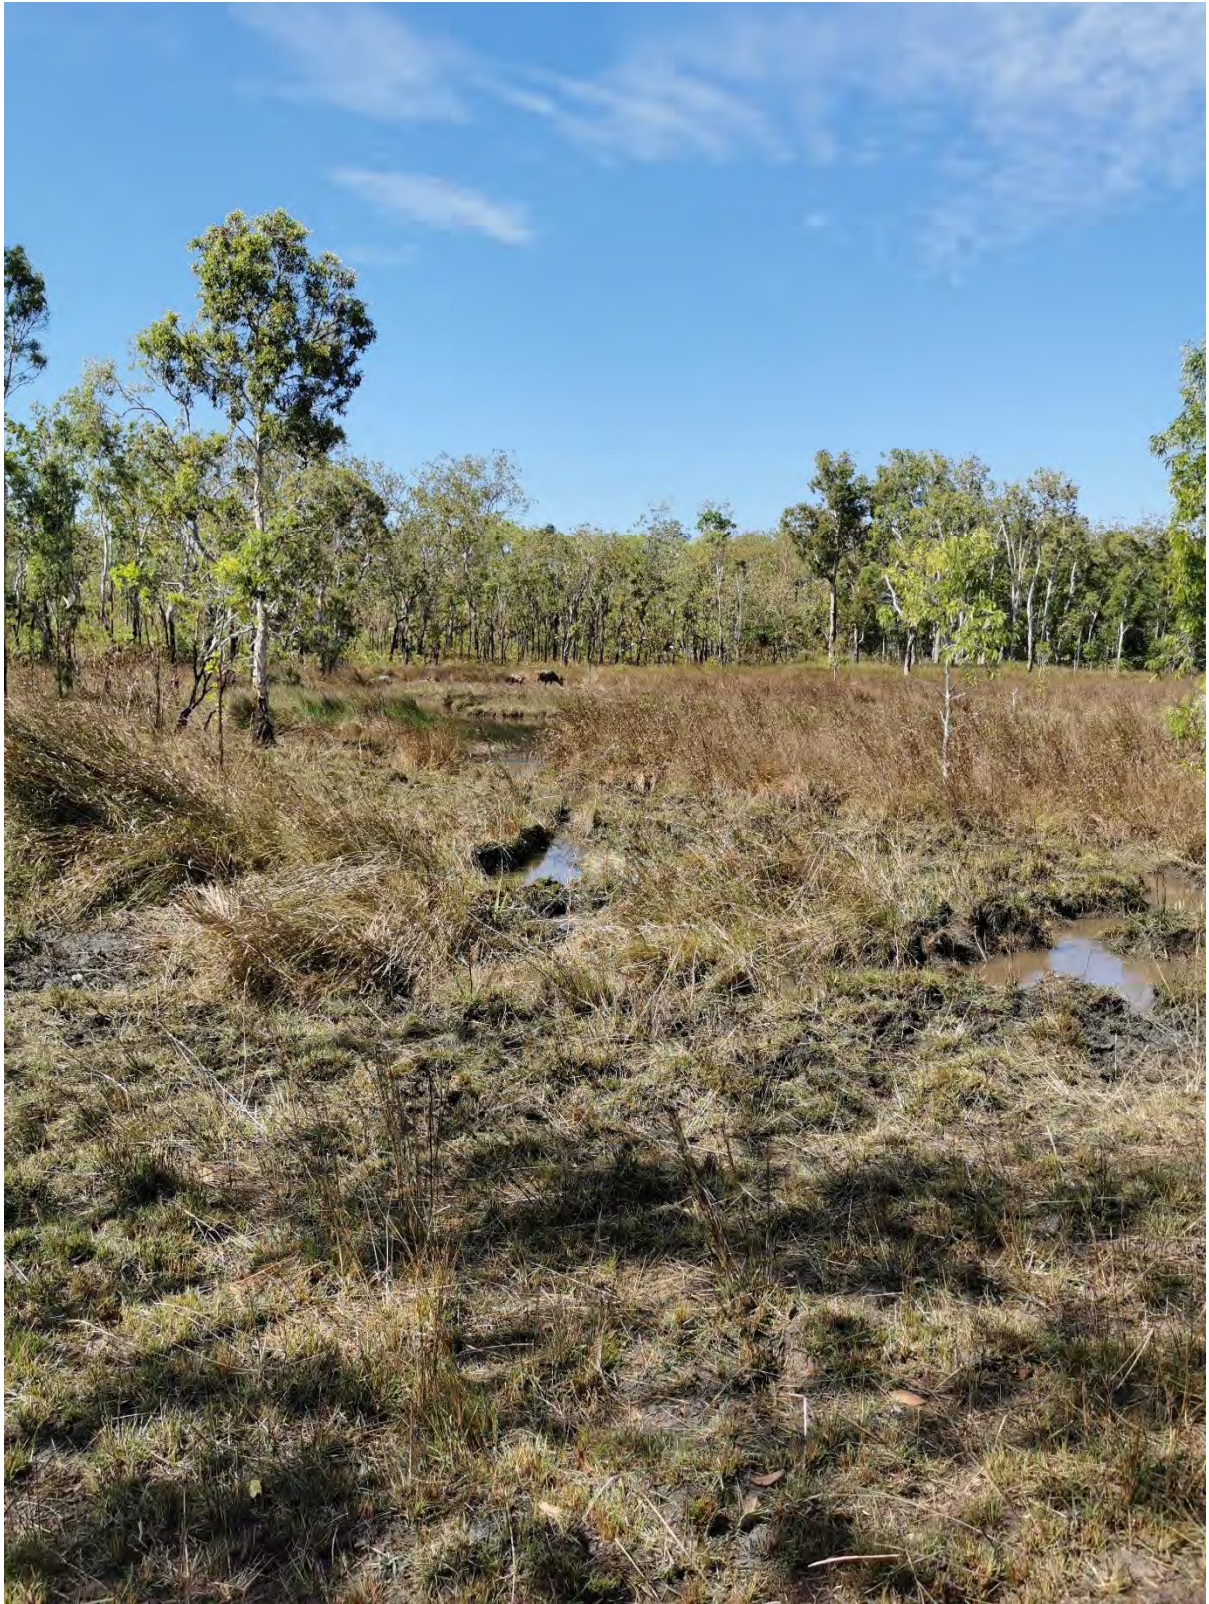
WP004

This water hole contained shallow swampy water with no flow. This site is not suitable for water extraction.

Buffalo have been using this area as a source of water.

Buffalo were observed grazing around the shallow swamp that has no suitable water for extraction.

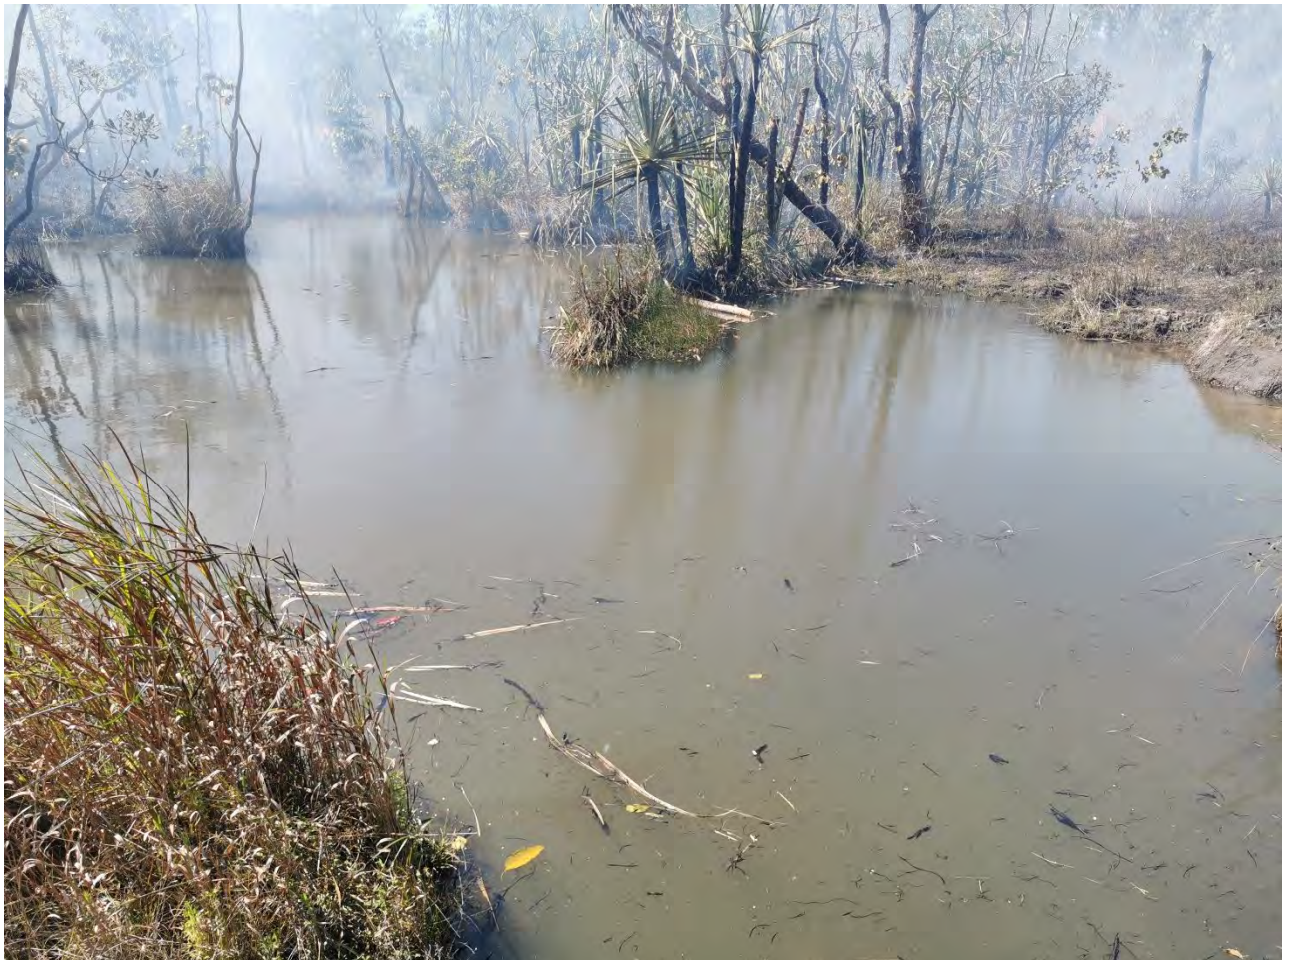
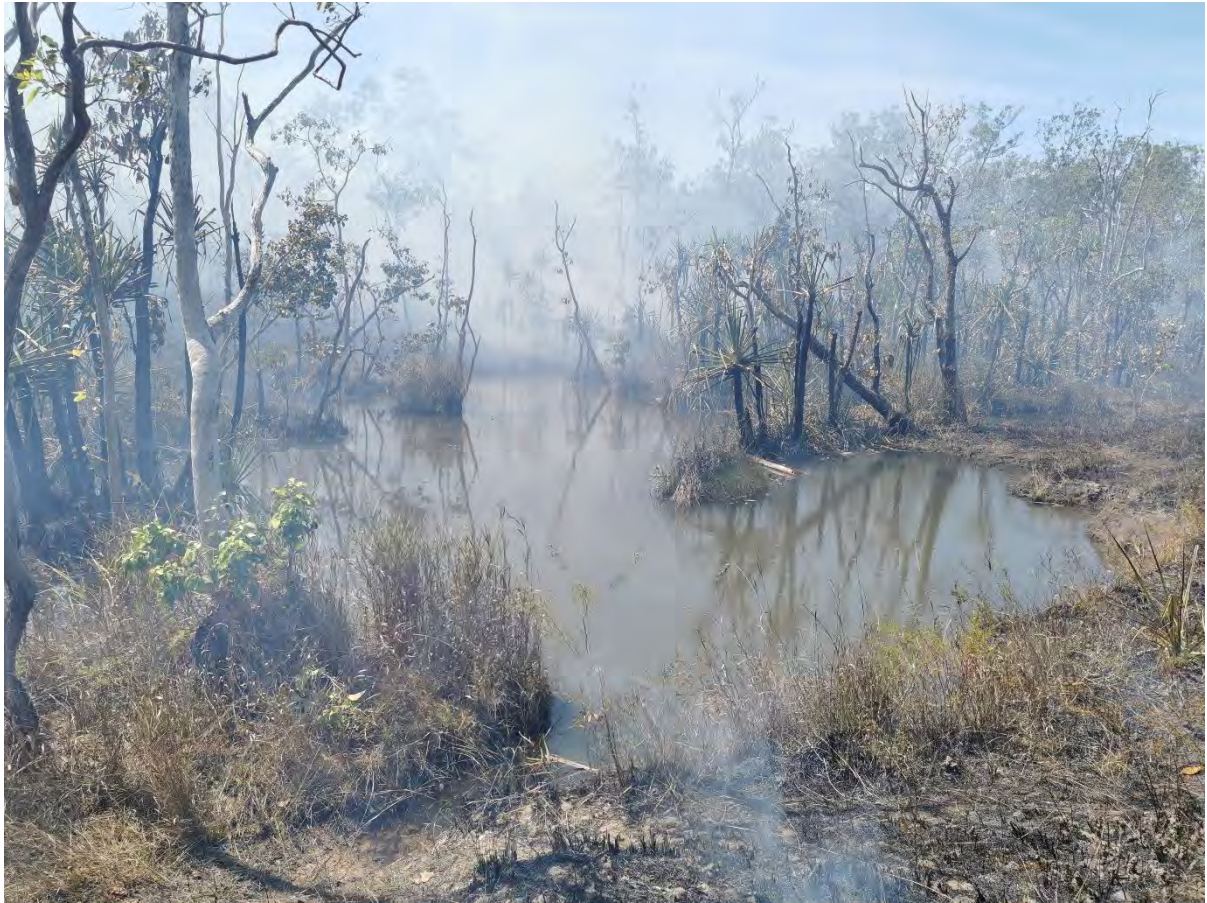
WP008

This is a large deep permanent water hole that does not appear to be flowing. There is a large swamp area on the upstream slope with several smaller waterholes present. This waterhole appears to be spring fed and suitable for water extraction. Access from the gravel pit to the north west following the ridge would be possible via the construction of an access track approximately 1.9km from the main road.

Large permanent water hole that appears suitable for water extraction.

Smaller water hole on the upstream side of the main waterhole.
