**Pirlangimpi, Pickertaramoor and Milikapiti Access Roads
Melville Island, NT**

**Hydrogeological Assessment & Roadworks Water Supply
Strategy**

*A report prepared by Maria Woodgate (TGS) for the Northern Territory Department of
Infrastructure, Planning and Logistics*

September 2020

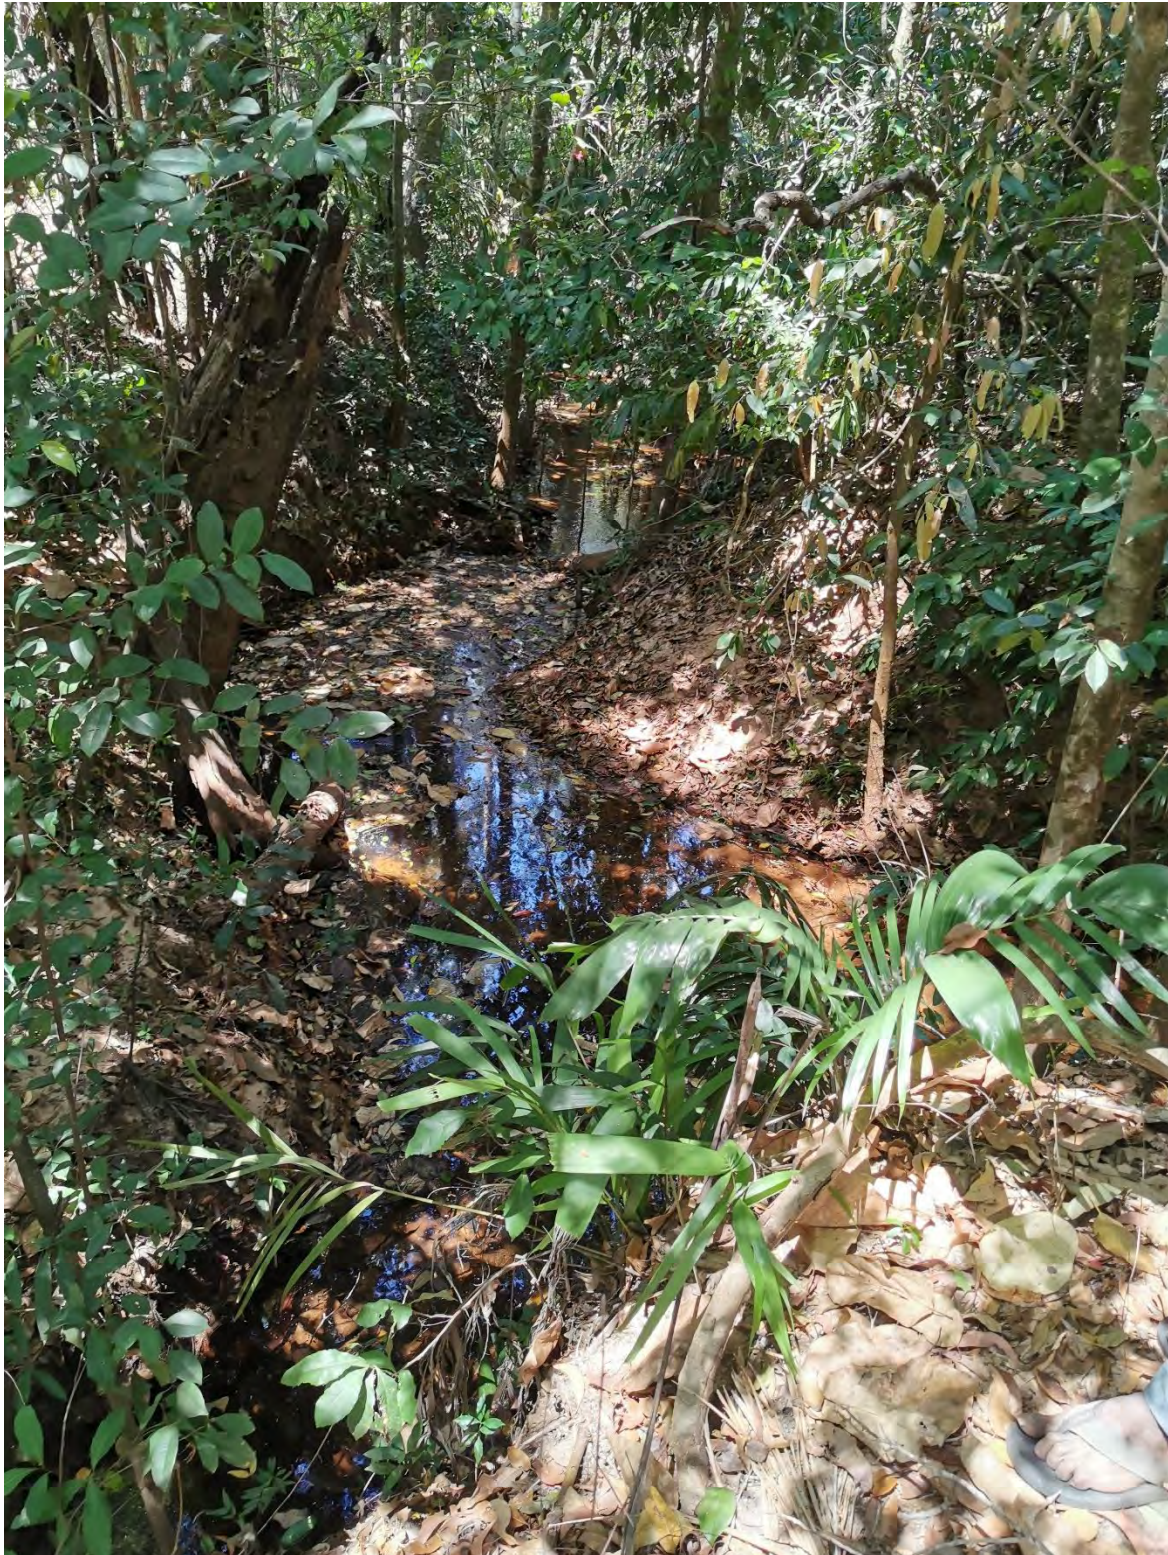
WP001

This spring flows into a narrow but deep creek that has very good flow rates and appears suitable for water extraction. The best access is from the firebreak approximately 900m to the west of the spring. An excess track following the ridge down from the firebreak would provide good all-weather access to the creek.

The spring flows into a deep but narrow creek and appears to be suitable for water extraction.
