SECTION 14 INCIDENT REPORT (*Waste Management and Pollution Control Act*)

Date and Time of Notification:	Monday 7 th February 2022, 16:07hrs
Person / Company:	Power and Water Corporation (PWC)
Incident:	Discharge of sewage from sewerage network, Santa Teresa sewage stabilisation ponds

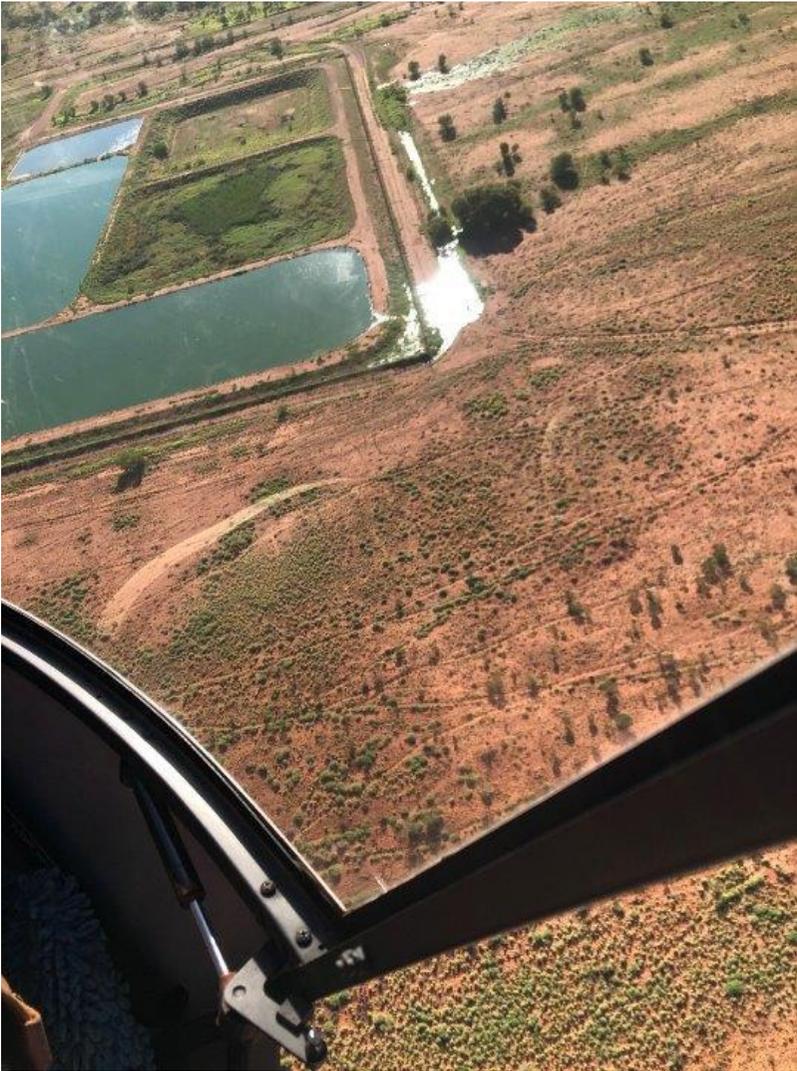
Appendix B – Aerial photograph of spill

<p>The exact timing of the overflow is unknown, but was first observed on Friday 4th February 2022 by the local pastoralist.</p> <p><i>ii. How PWC were notified, or became aware of the discharge.</i></p> <p>The local pastoralist from Allambi Station advised the MacDonnell Regional Council, who in turn advised the PWC Water and Sewer Technical Coordinator.</p> <p><i>iii. The process by which the discharge occurred.</i></p> <p>The valve that joins ponds 2 and 4 had been inadvertently left closed. If this valve was in the open position, as it would be for normal operation, there would have been sufficient capacity for the additional inflow and rainfall and the overflow would not have happened. The valve has since been opened to prevent further overflows from occurring.</p> <p><i>iv. The reason why the discharge occurred.</i></p> <p>As per (c) iii, Operator error, inadvertently leaving valve in closed position following maintenance works.</p>

(d) how the pollution has occurred, is occurring or may occur	As per (c) iii & (c) iv.
(e) the attempts made to prevent, reduce, control, rectify or clean up the pollution or resultant environmental harm caused or threatening to be caused by the incident	<p><i>i. Confirmation signage and fencing has been erected, as appropriate.</i></p> <p>Fencing and signage has not been erected in this instance, as access is possible from all directions and is not practicable. Also, due to the location of the ponds being over a kilometre away from the community, it is not expected for this area to be frequented by the public.</p> <p><i>ii. Decontamination of the site as appropriate.</i></p> <p>Clean up consistent with Sewage Spills/Overflow Response Work Instruction as appropriate to the location. Site was inspected for any wastewater gross pollutants, of which none were observed.</p>
