SECTION 14 INCIDENT REPORT (*Waste Management and Pollution Control Act*)

| Incident: | Discharge of sewage from sewerage network |

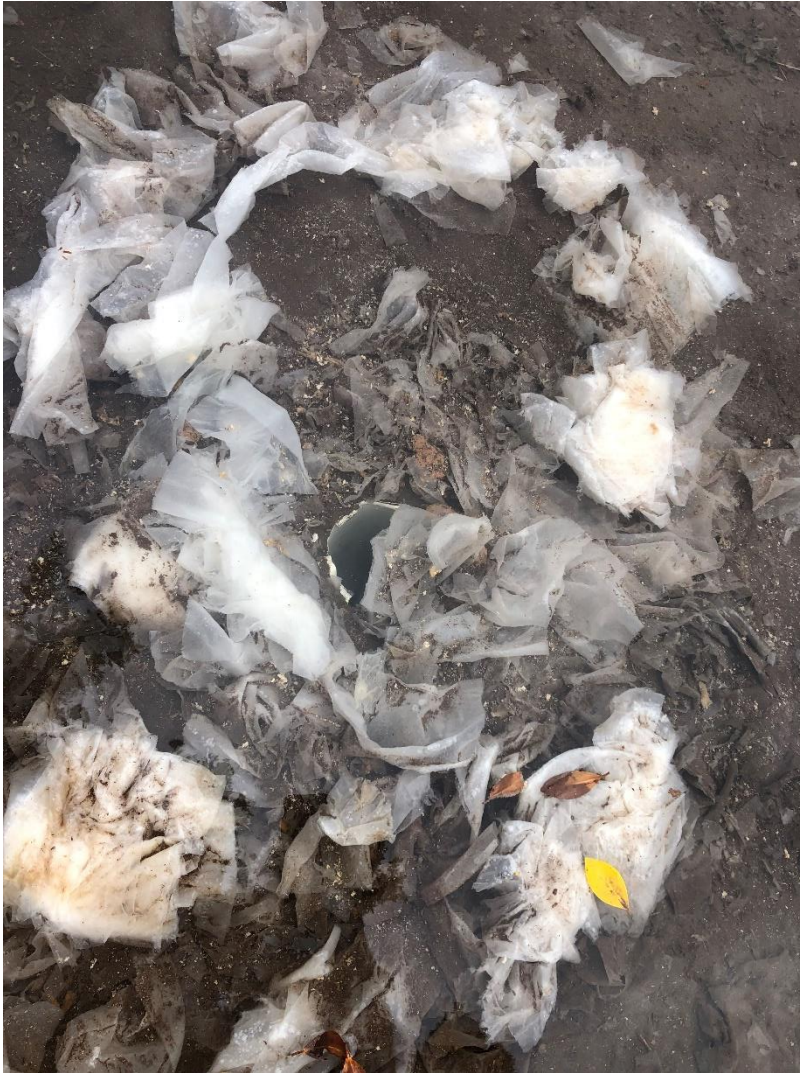
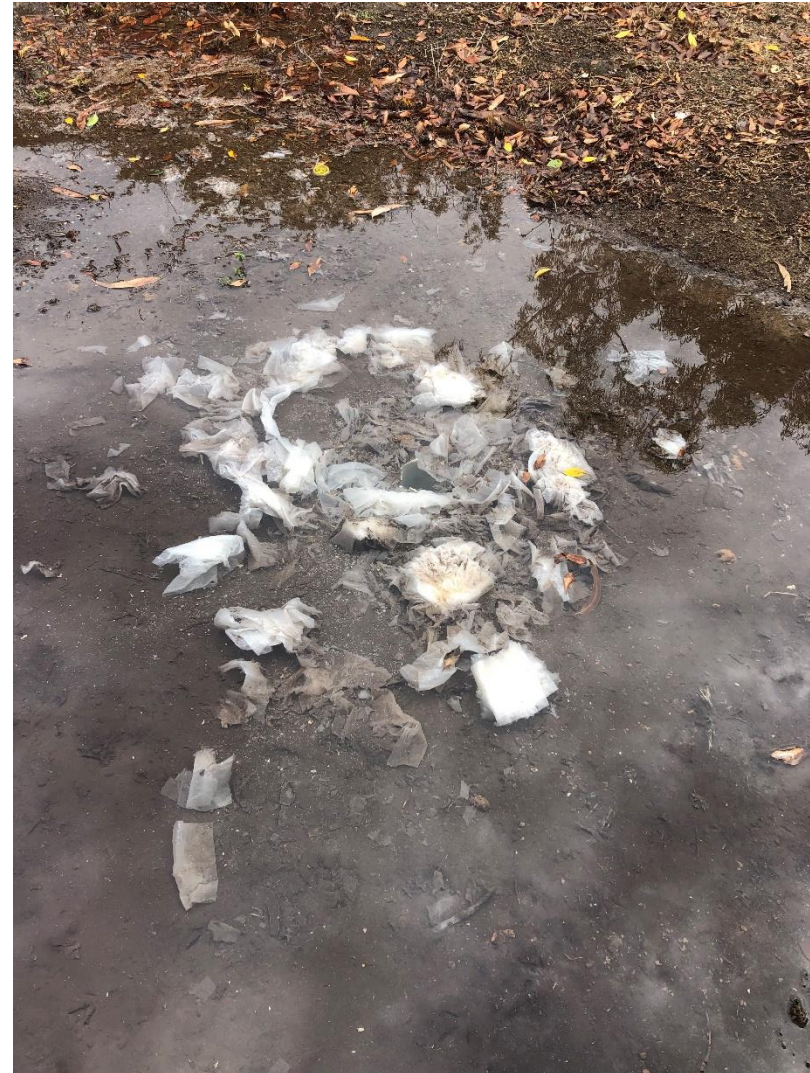
Appendix – Location photographs.

| <p>(a) the incident causing or threatening to cause pollution</p> | <p><i>i. Description of the waste that was discharged.</i></p> <p>Raw sewage</p> <p><i>ii. Indicative wastewater quality for the discharge.</i></p> <p>See below for indicative wastewater quality data.</p> <table border="1"> <thead> <tr> <th>Sample Date</th> <th>Description</th> <th>Total Suspended Solids (mg/L)</th> <th>Biochemical Oxygen Demand (mg/L)</th> <th>Dissolved Oxygen (lab) (mg/L)</th> </tr> </thead> <tbody> <tr> <td>9/07/2024</td> <td>WQ-Angurugu Pond 1 Inlet</td> <td>115.0</td> <td>52.0</td> <td><0.1</td> </tr> <tr> <td>11/06/2024</td> <td>WQ-Angurugu Pond 1 Inlet</td> <td>103.0</td> <td>44.0</td> <td>0.73</td> </tr> <tr> <td>13/03/2024</td> <td>WQ-Angurugu Pond 1 Inlet</td> <td>64.0</td> <td>38.0</td> <td>0.51</td> </tr> <tr> <td>9/01/2024</td> <td>WQ-Angurugu Pond 1 Inlet</td> <td>63.0</td> <td>37.0</td> <td>0.32</td> </tr> </tbody> </table> <table border="1"> <thead> <tr> <th>Sample Date</th> <th>Description</th> <th>Nitrate + Nitrite as N (NOx-N) (mg/L)</th> <th>(pH units)</th> <th>Turbidity (lab) (NTU)</th> </tr> </thead> <tbody> <tr> <td>9/07/2024</td> <td>WQ-Angurugu Pond 1 Inlet</td> <td><0.1</td> <td>6.85</td> <td>150.0</td> </tr> <tr> <td>11/06/2024</td> <td>WQ-Angurugu Pond 1 Inlet</td> <td>0.4</td> <td>6.78</td> <td>150.0</td> </tr> <tr> <td>13/03/2024</td> <td>WQ-Angurugu Pond 1 Inlet</td> <td><0.1</td> <td>6.6</td> <td>70.0</td> </tr> <tr> <td>9/01/2024</td> <td>WQ-Angurugu Pond 1 Inlet</td> <td><0.1</td> <td>7.02</td> <td>74.0</td> </tr> </tbody> </table> <p><i>iii. Volume of the waste that was discharged.</i></p> <p>The volume of waste discharged is unknown. No telemetric monitoring occurs at these location. An estimate based on the duration and area covered by the overflow, is approximately 5KL.</p> | Sample Date | Description | Total Suspended Solids (mg/L) | Biochemical Oxygen Demand (mg/L) | Dissolved Oxygen (lab) (mg/L) | 9/07/2024 | WQ-Angurugu Pond 1 Inlet | 115.0 | 52.0 | <0.1 | 11/06/2024 | WQ-Angurugu Pond 1 Inlet | 103.0 | 44.0 | 0.73 | 13/03/2024 | WQ-Angurugu Pond 1 Inlet | 64.0 | 38.0 | 0.51 | 9/01/2024 | WQ-Angurugu Pond 1 Inlet | 63.0 | 37.0 | 0.32 | Sample Date | Description | Nitrate + Nitrite as N (NOx-N) (mg/L) | (pH units) | Turbidity (lab) (NTU) | 9/07/2024 | WQ-Angurugu Pond 1 Inlet | <0.1 | 6.85 | 150.0 | 11/06/2024 | WQ-Angurugu Pond 1 Inlet | 0.4 | 6.78 | 150.0 | 13/03/2024 | WQ-Angurugu Pond 1 Inlet | <0.1 | 6.6 | 70.0 | 9/01/2024 | WQ-Angurugu Pond 1 Inlet | <0.1 | 7.02 | 74.0 |
|--|---|---|---|---|---|---|---|---|---|---|---|---|---|---|---|---|---|---|---|---|---|---|---|---|---|---|---|---|---|---|---|---|---|---|---|---|---|---|---|---|---|---|---|---|---|---|---|---|---|---|---|
| <p>(b) the place where the incident occurred</p> | <p><i>i. Description of the Power & Water asset from which the discharge occurred.</i></p> <p>The overflow emanated from a 100mm riser associated with the sewer main located on lot 1632, which is immediately adjacent to the public open space of lot 570.</p> <p><i>ii. GPS coordinates of the discharge point from the Power & Water asset, and the final coordinates of the final discharge point.</i></p> <p>Discharge Point: 136.4621391E, 13.9834282S Final discharge point, immediately surrounding the discharge point.</p> | | | | | | | | | | | | | | | | | | | | | | | | | | | | | | | | | | | | | | | | | | | | | | | | | | |

| (e) the attempts made to prevent, reduce, control, rectify or clean up the pollution or resultant environmental harm caused or threatening to be caused by the incident | <p><i>i. Confirmation signage and fencing has been erected, as appropriate.</i></p> <p>Fencing in this instance was not erected as the cause of the overflow was rectified in a timely manner and the area was cleaned up as per the Power & Water Sewer Overflow Response procedure, straight after the sewer main was unblocked, making the area same for public access.</p> <p><i>ii. Decontamination of the site as appropriate.</i></p> <p>The gross pollutants that were discharged were picked up and disposed of appropriately, and the area was cleaned as per the Power & Water Sewer Overflow Response procedure.</p> |
