# Waterway Crossing Assessment North to East Australia Pipeline (NEA Pipeline): Stage 1 (Northern Territory) APT Management Services Pty Ltd (APA)

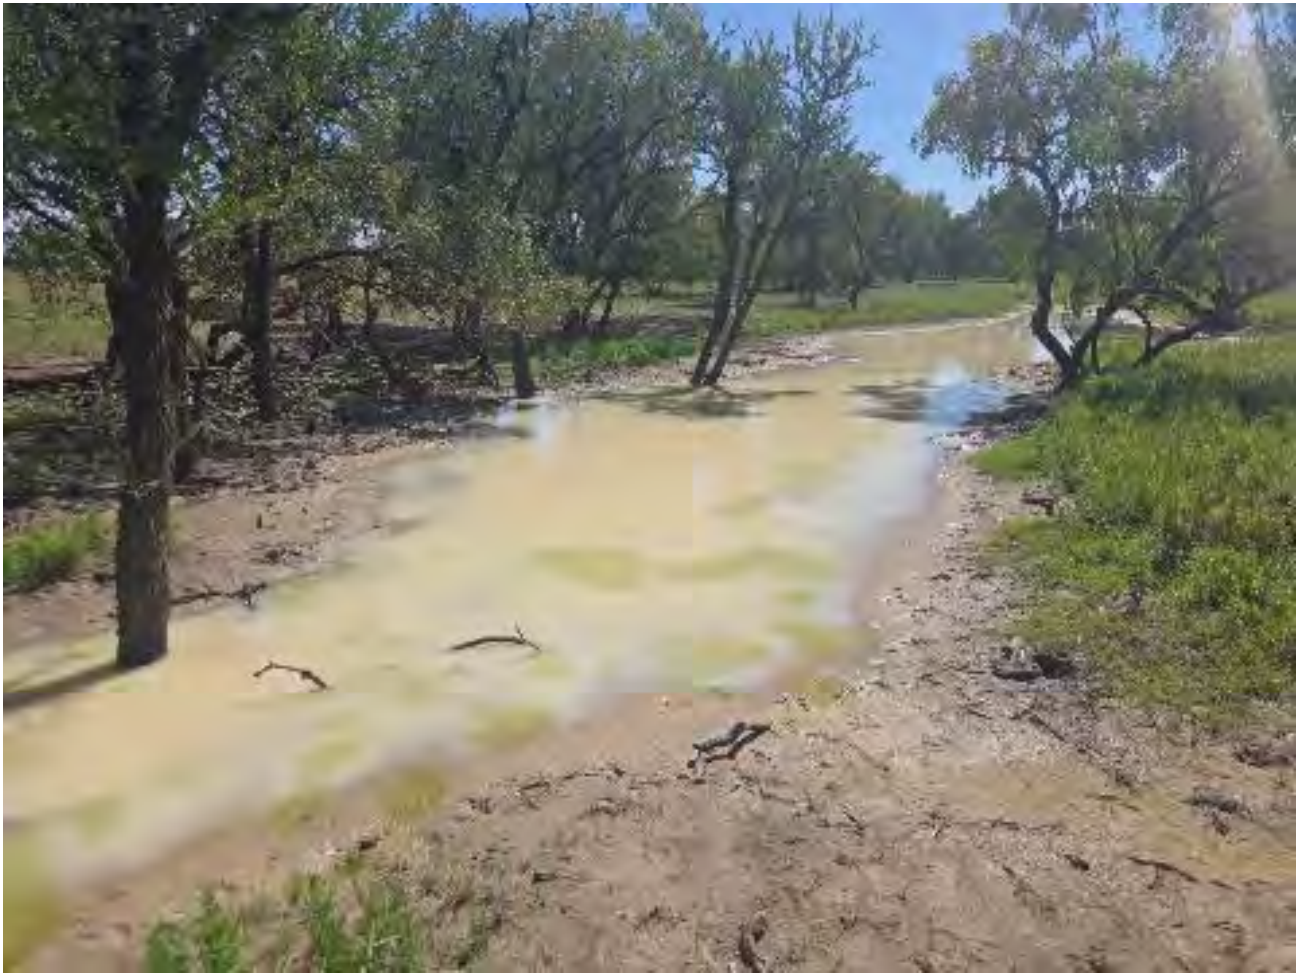
Parkinsonia scattered in area (declared weed)

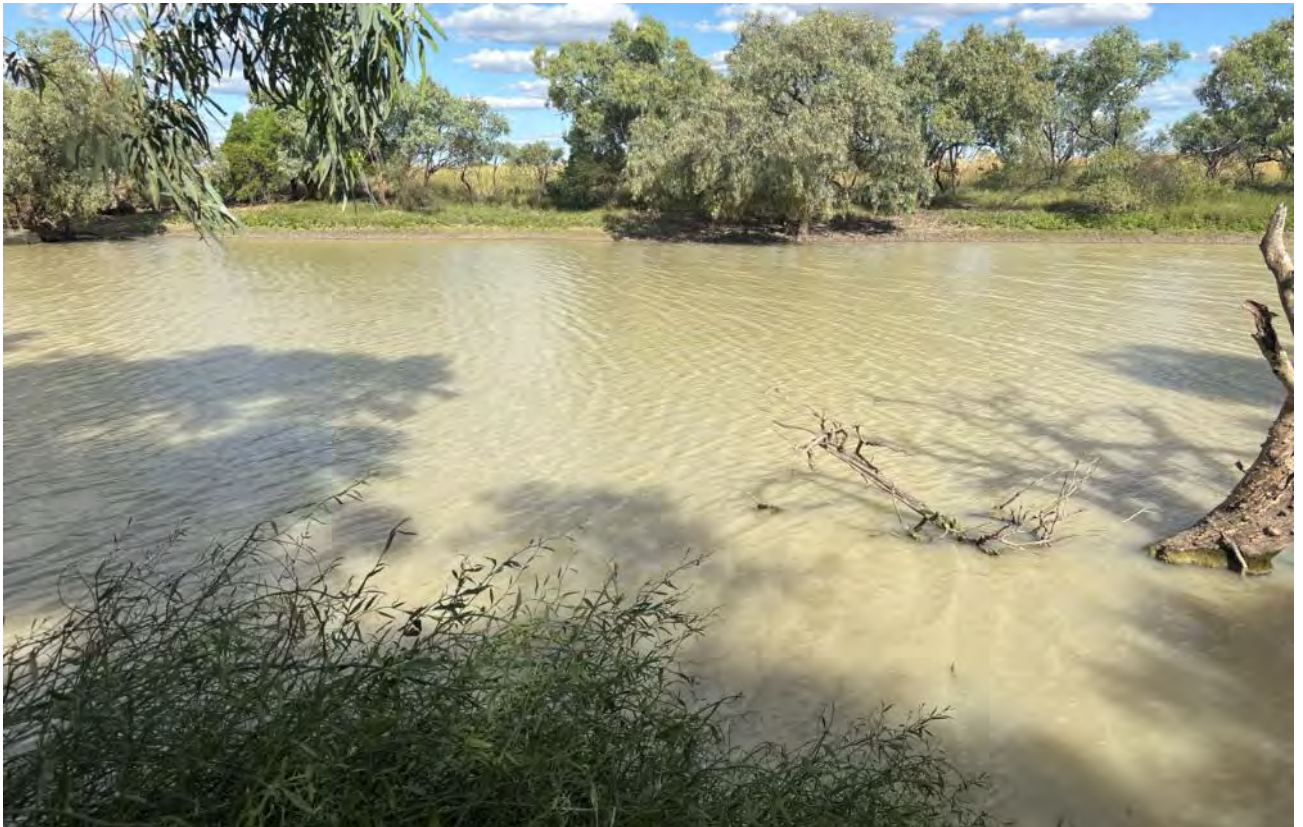
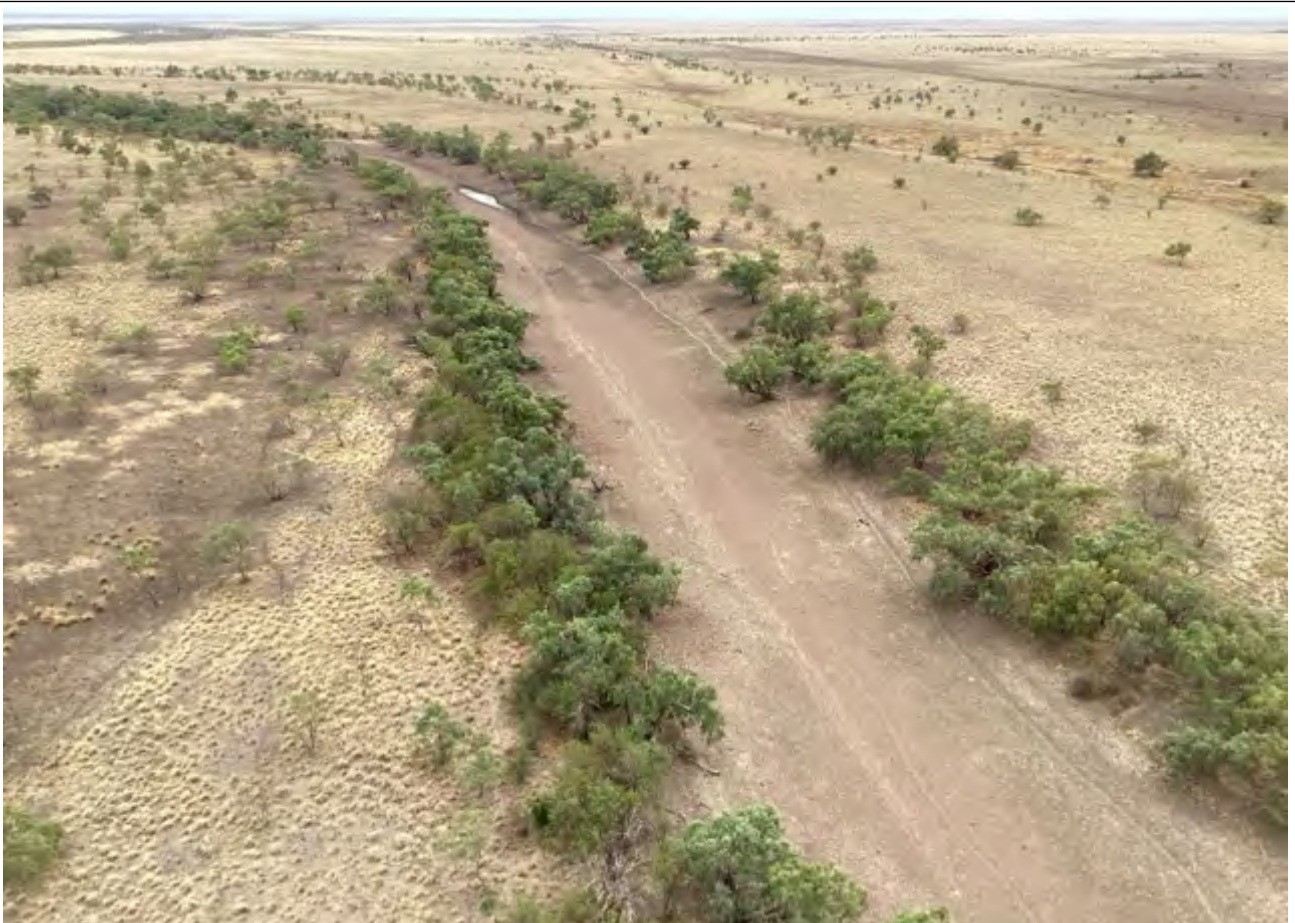
End of dry season photo (November 2025) indicates waterhole dries up to small pool.

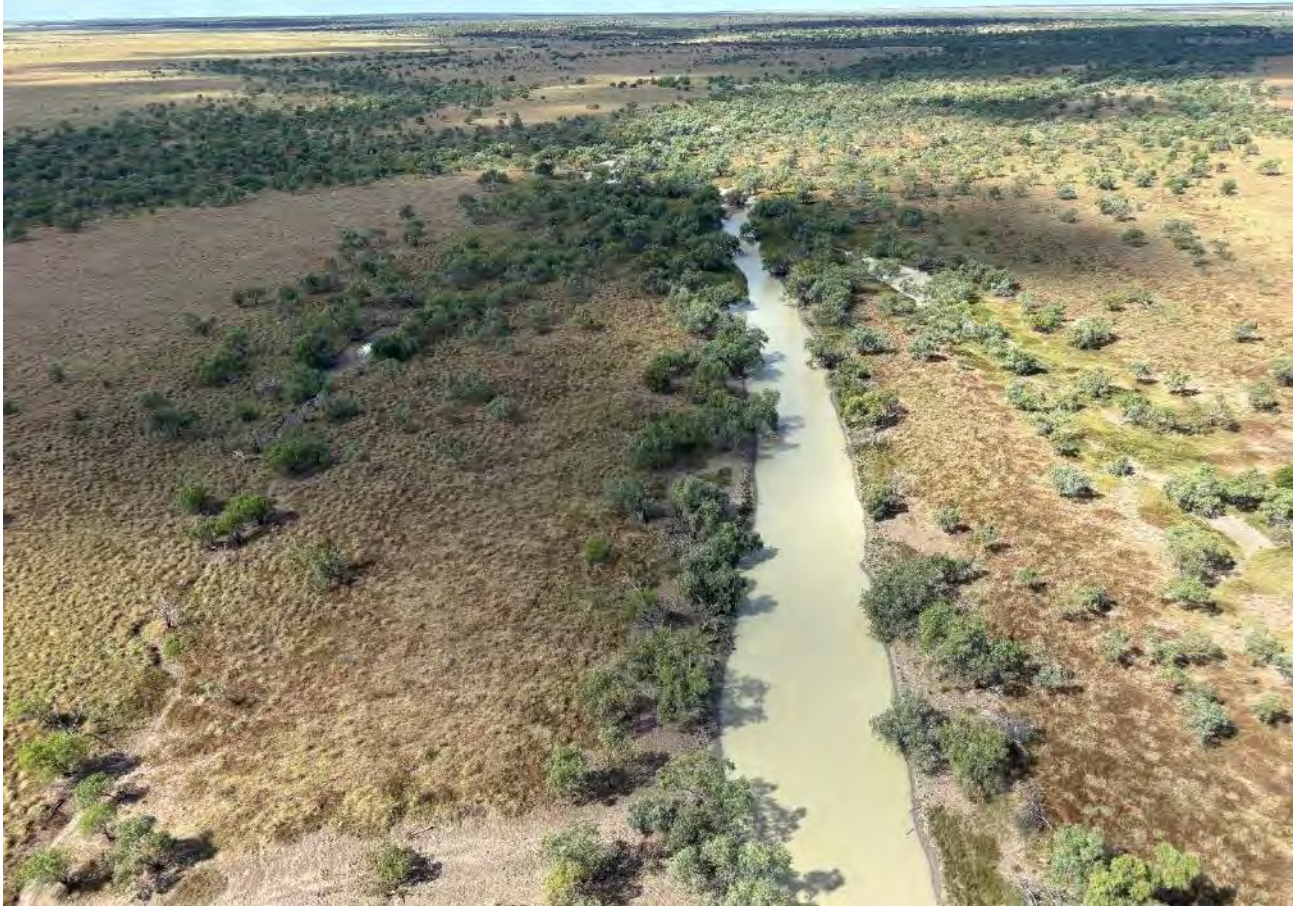
Dry season photo indicates water present (Nov 2025)

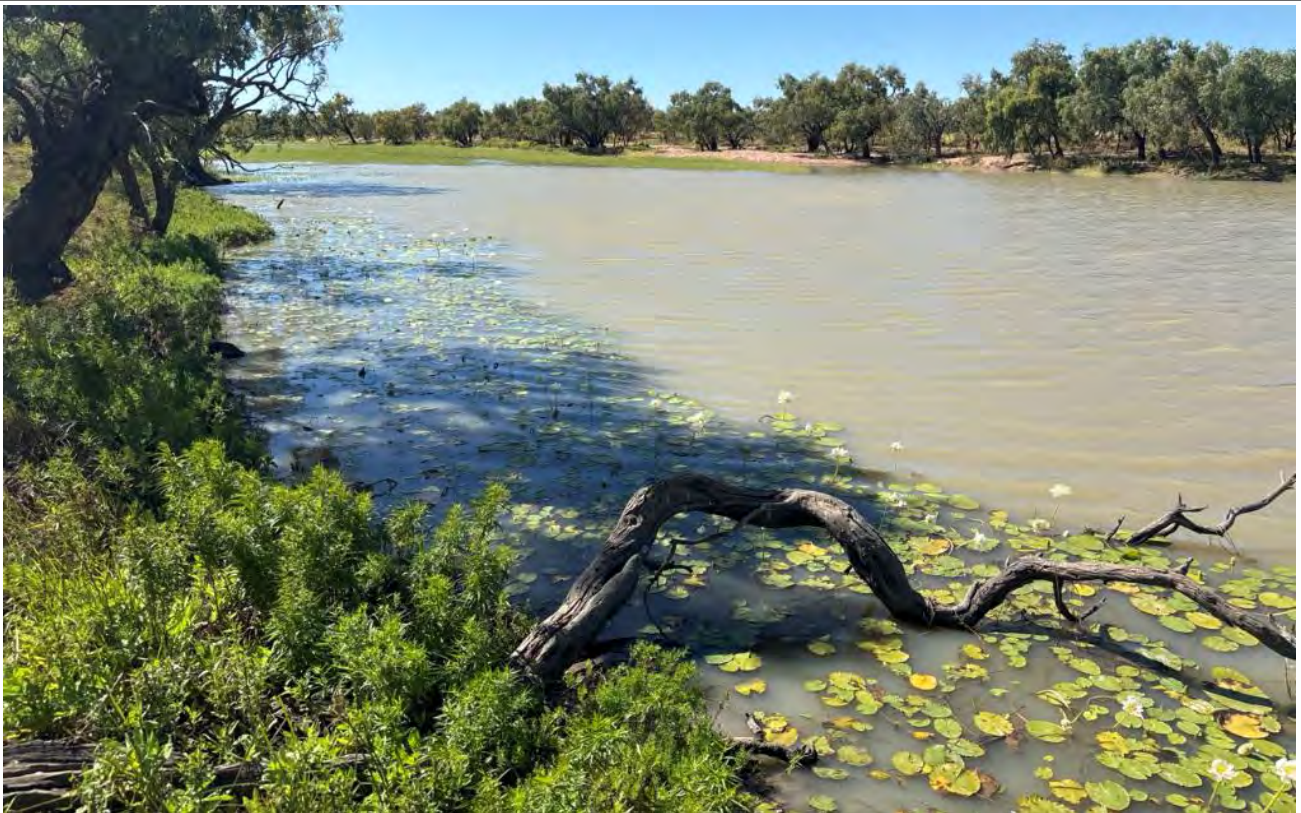
Downstream waterhole with Water Lilly

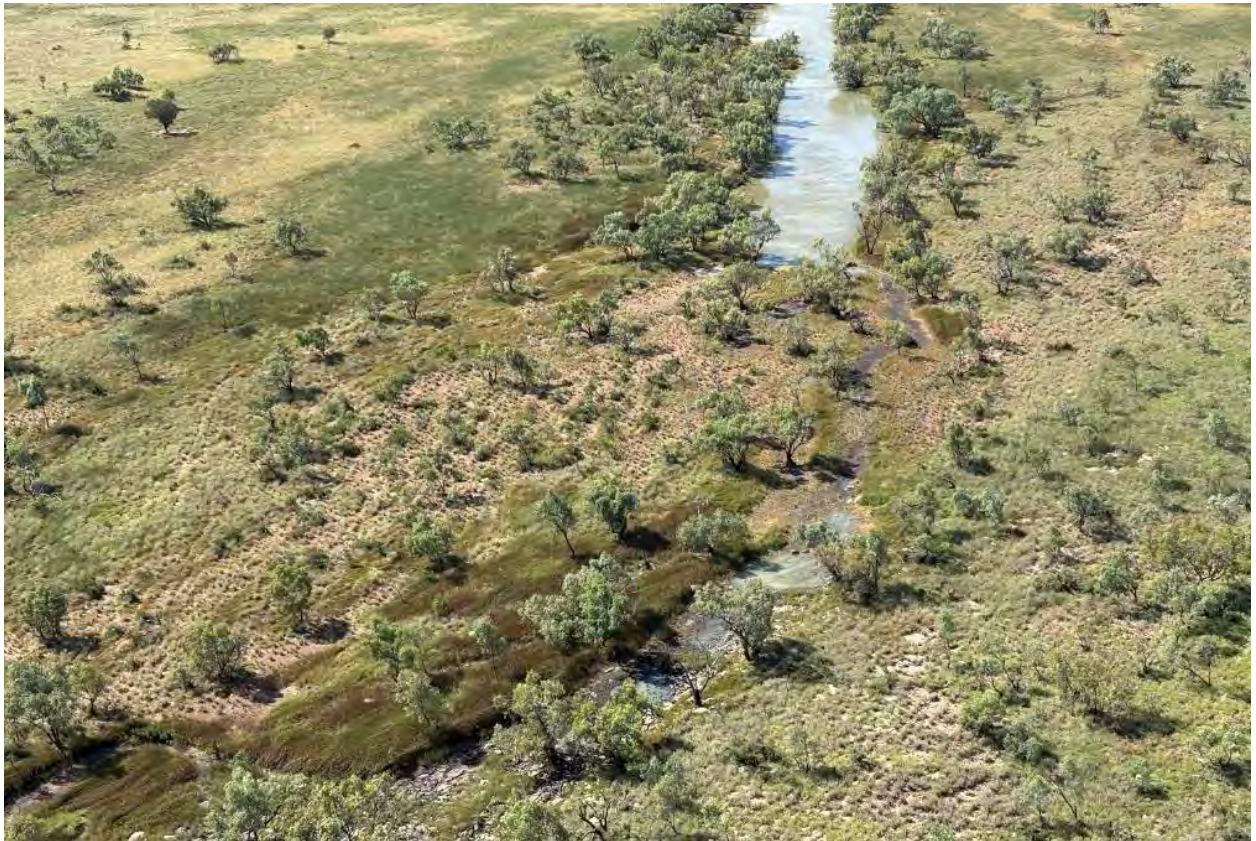
Potential alternative crossing point to the south that avoids drainage waterhole (Site 119)

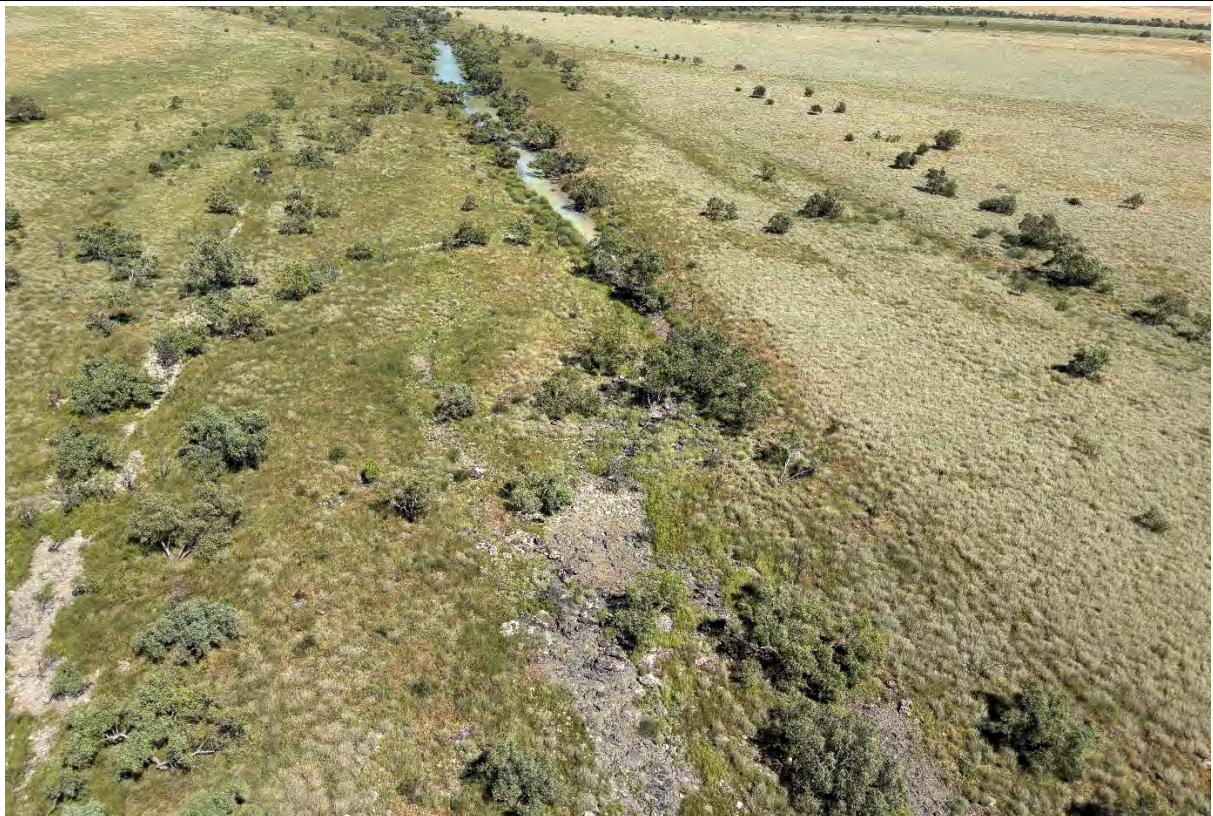
Potential alternative crossing point to avoid disturbance of ephemeral pool / waterhole

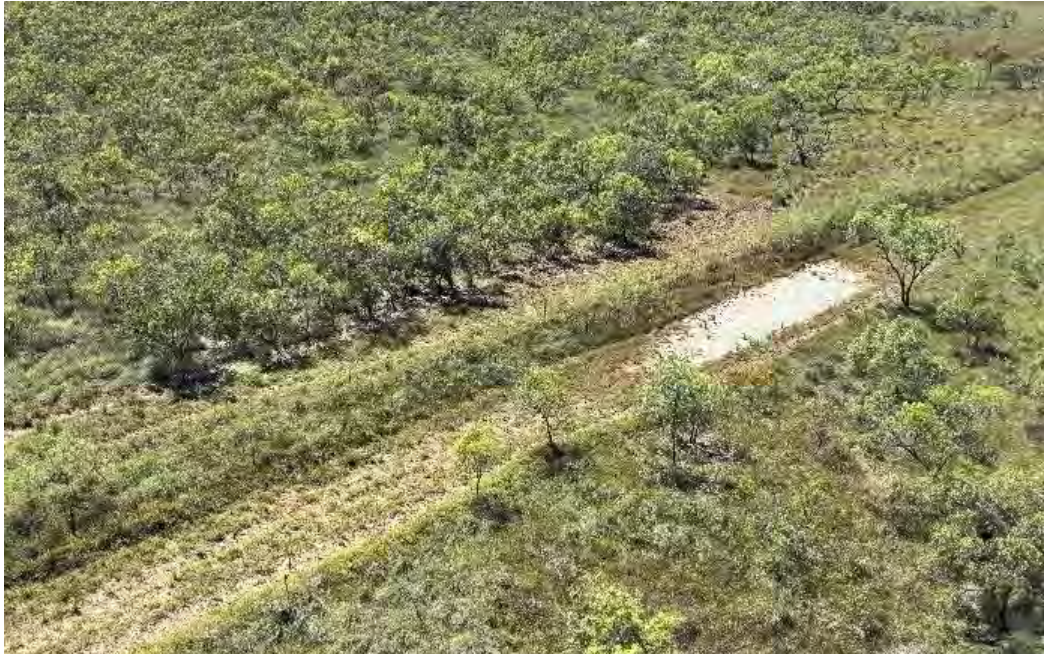
| Site ID | Photograph |
|---|---|
| AC-MD-03<br>(Site 390) | An aerial photograph of a wetland area. A reddish-brown dirt road or track runs diagonally from the bottom left towards the top right. The landscape is covered in dense green vegetation. A small, light-colored pond or wet area is visible on the right side of the road. |

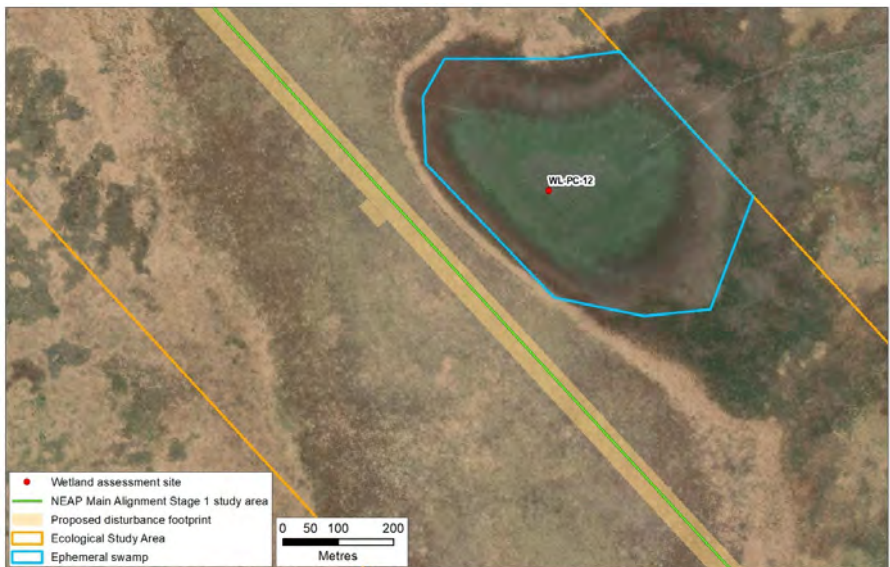
| Wetland site details | | Map snip | Photograph |
|---|---|---|---|
| Wetland ID | WL-PC-12 | | |

| Wetland site details | | Map snip | Photograph |
|---|---|---|---|
| Wetland description | Ephemeral swamp<br>Avoided by proposed footprint (65m) | | |
