# **SITE & SOILS INVESTIGATION REPORT**

## **Darwin Beef Processing Facility**

DRAWING :  
SOIL SAMPLE PIT LOCATIONS

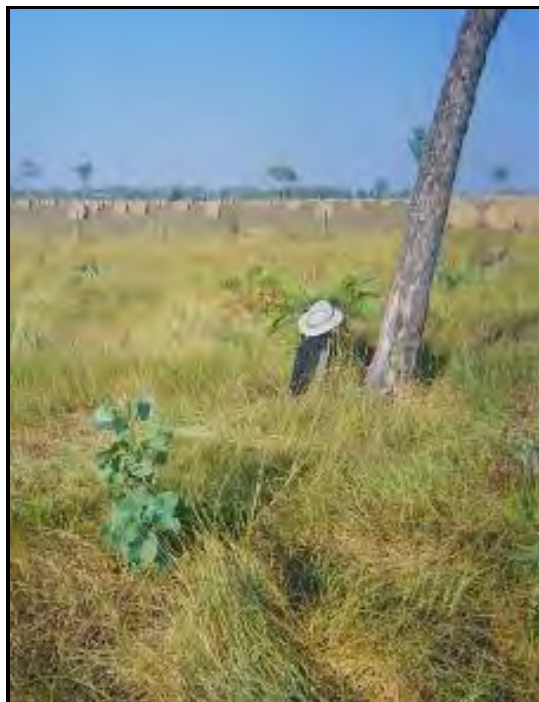
**Figure 1. Extensive Haymaking Operations**

Land use on the property mainly comprises the management of improved pastures to support cattle grazing and dry season haymaking operations.

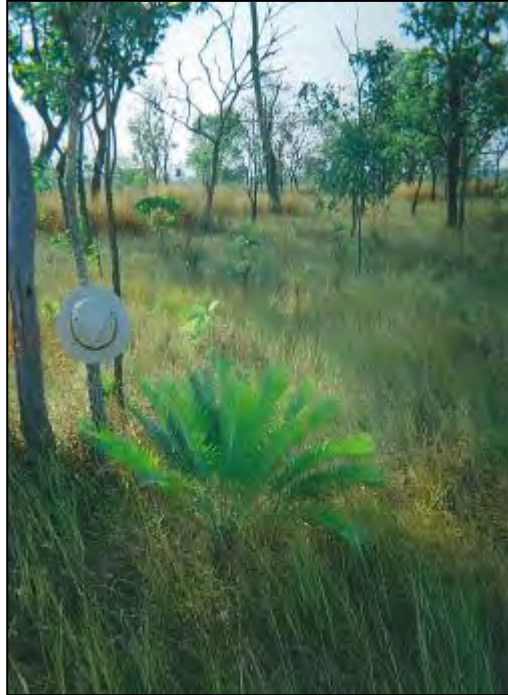
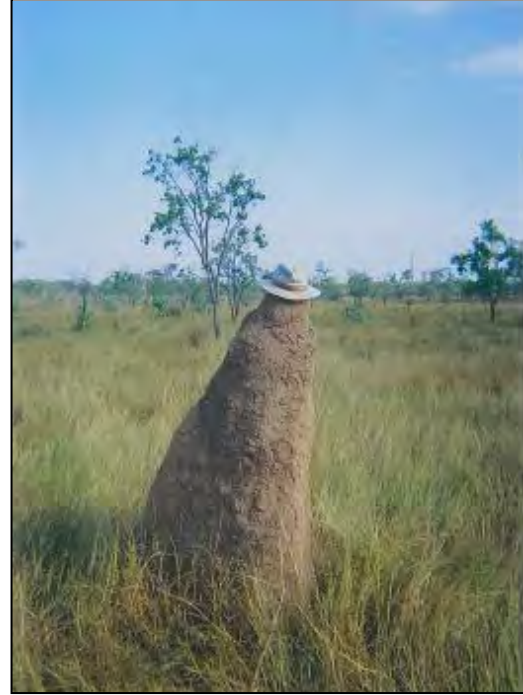
**Figure 2. Natural Revegetation & Prolific Grassy Regrowth**

The two main improved pastures that have been established on the arable areas across the property are the wet season grasses Humidicola (Tully grass) and Jarra (Digit grass). The lower and less well drained terrain is dominated by a range of water tolerant grass species with the taller Pandanus trees being prominent.
