SECTION 14 INCIDENT REPORT (*Waste Management and Pollution Control Act*)

Date and Time of Notification:	Tuesday 05 March 2019 (reference: D2019/116734)
Person / Company:	Power and Water Corporation.
Incident:	Overflow of sewage resulting from a blockage within the sewerage mains system.

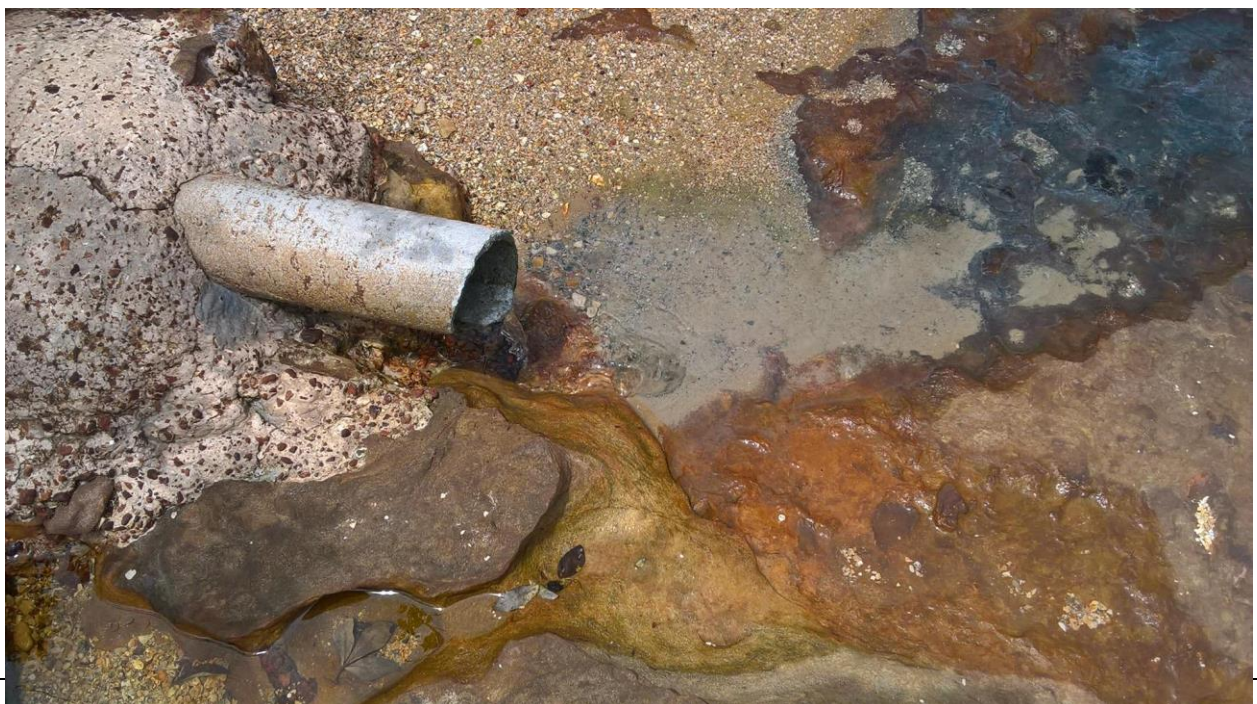
Photo: SPS1 overflow pipe on beach at Maningrida 05/03/2019

<p>inspected. Sewage discharging from the overflow pipe onto the beach was clear. No gross pollutants or solids were observed. A collection chamber is located prior to the overflow relief valve, which removes solids from the sewage before entering the overflow pipe.</p> <p>It is considered that significant flushing within the area has occurred following the next high tide on the beach.</p> <p>Based on historic flows it is estimated that the overflow from SPS1 was 171kL.</p> <p>This is the estimated overflow volume, however PWC predict that not all sewage has reached the overflow pipe. There are 3 sections of the sewage system that are designed to have storage capacity prior to the overflow valve. Some of the sewage may be stored in these areas:</p> <ul style="list-style-type: none"> • A pre-storage tank before SPS • SPS pit / collection chamber • Sewage backs up into mains before overflow occurs

<p>(e) the attempts made to prevent, reduce, control, rectify or clean up the pollution or resultant environmental harm caused or threatening to be caused by the incident</p>	<p>Prevention/reduction: ESO completes daily check for blockages at SPS. High water alarm is installed at SPS 1.</p> <p>Rectify: Sewage Pumping Stations were brought back into operation as soon as ESO became aware of blockage at 11 am on Tuesday.</p> <p>Control: ESO reported that no solid matter / paper overflow / was evident. Collection chamber collects solids prior to overflow valve.</p> <p>Clean-up: ESO inspected area but observed no gross pollutants on beach. Signage has been erected.</p> <p>The period that pumps have not operated has been reduced. If another blockage occurs alarm will be raised earlier reducing overflow volume.</p>
<p>(f) the identity of the person notifying the NT EPA</p>	<p>Laura Haycock on behalf Power and Water Corporations Remote Water Services.</p>
