SECTION 14 INCIDENT REPORT (*Waste Management and Pollution Control Act*)

Date and Time of Notification:	Wednesday 17/03/2021 16:16hrs
Person / Company:	Power and Water Corporation (PWC)
Incident:	Overflow of diluted treated effluent

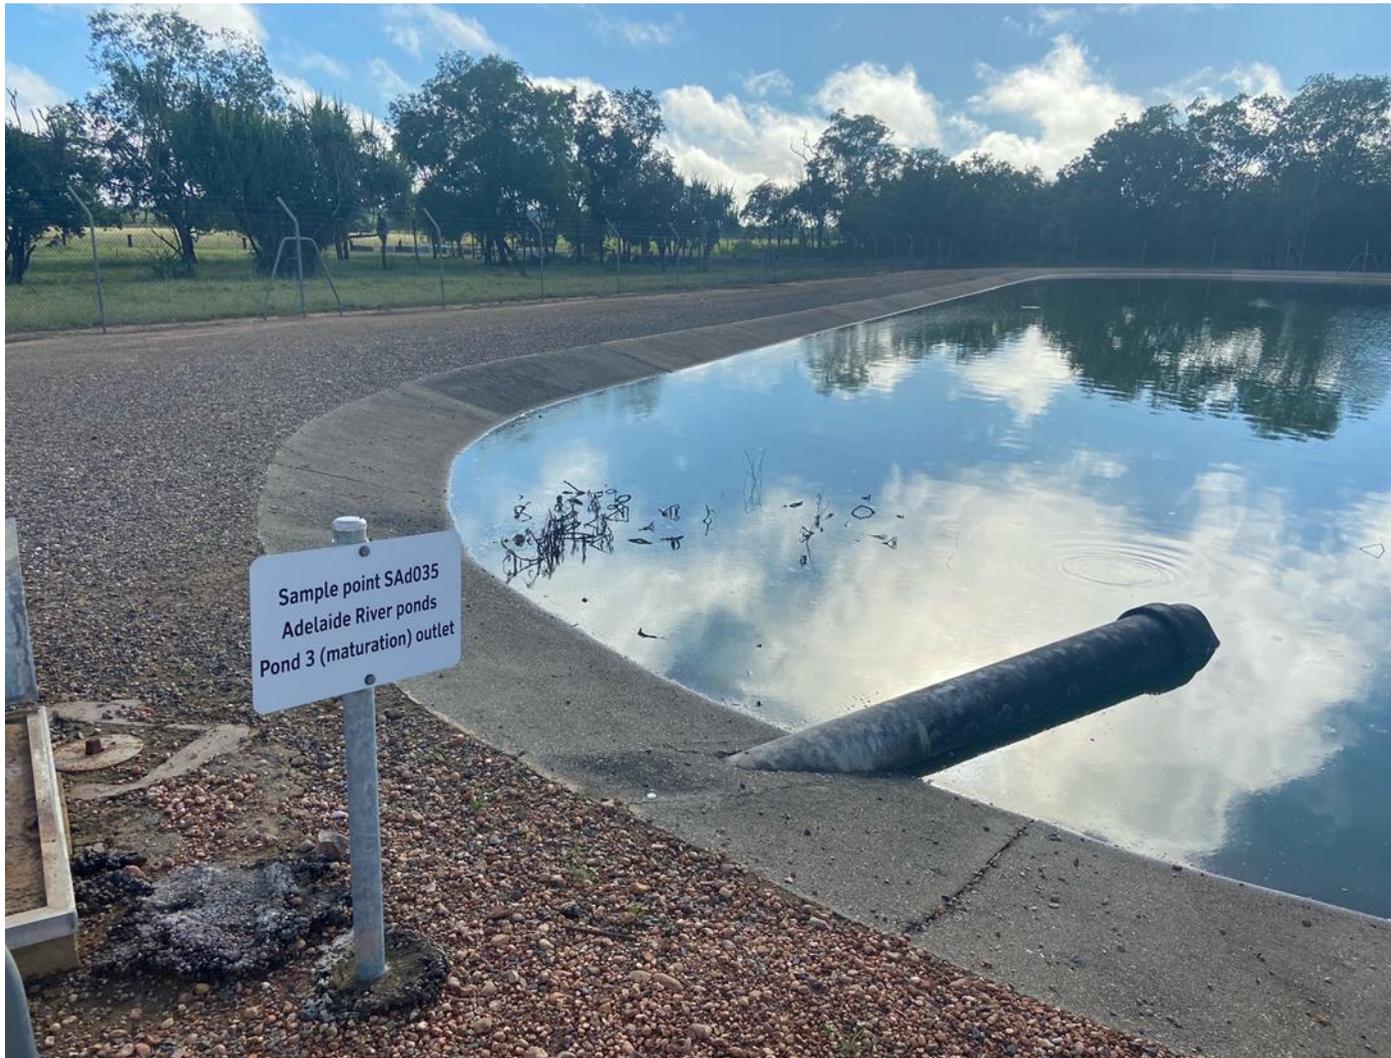
Appendix A – Photograph of the elevated pond level

(c) the date and time of the incident	<p><i>i. The time and date of commencement and cessation of the discharge.</i></p> <p>Exact time of commencement and cessation is unknown. It was first observed around 09:00hrs 17/03/2021. Ongoing at the time of initial reporting. It was confirmed on Friday 16/04/2021 that the overflow had ceased, although it is more than likely that the overflow will have stopped well prior to this date, as the overflow was the result of heavy rainfall within the catchment. A more accurate time and date cannot be determined</p> <p><i>ii. How PWC were notified, or became aware of the discharge.</i></p> <p>The Power and Water operator noticed the spill at around 09:00hrs on the 17/03/2021, when conducting his routine checks.</p> <p><i>iii. The process by which the discharge occurred.</i></p> <p>A significant rainfall event inundated the sewer system with stormwater run-off resulting in an overflow from the pond outfall.</p> <p><i>iv. The reason why the discharge occurred.</i></p> <p>Due to high rainfall, stormwater infiltration to the sewerage network resulted in an increase in the effluent volume within the ponds. The effluent volume within the wastewater ponds is beyond its capacity resulting in an offsite discharge.</p>

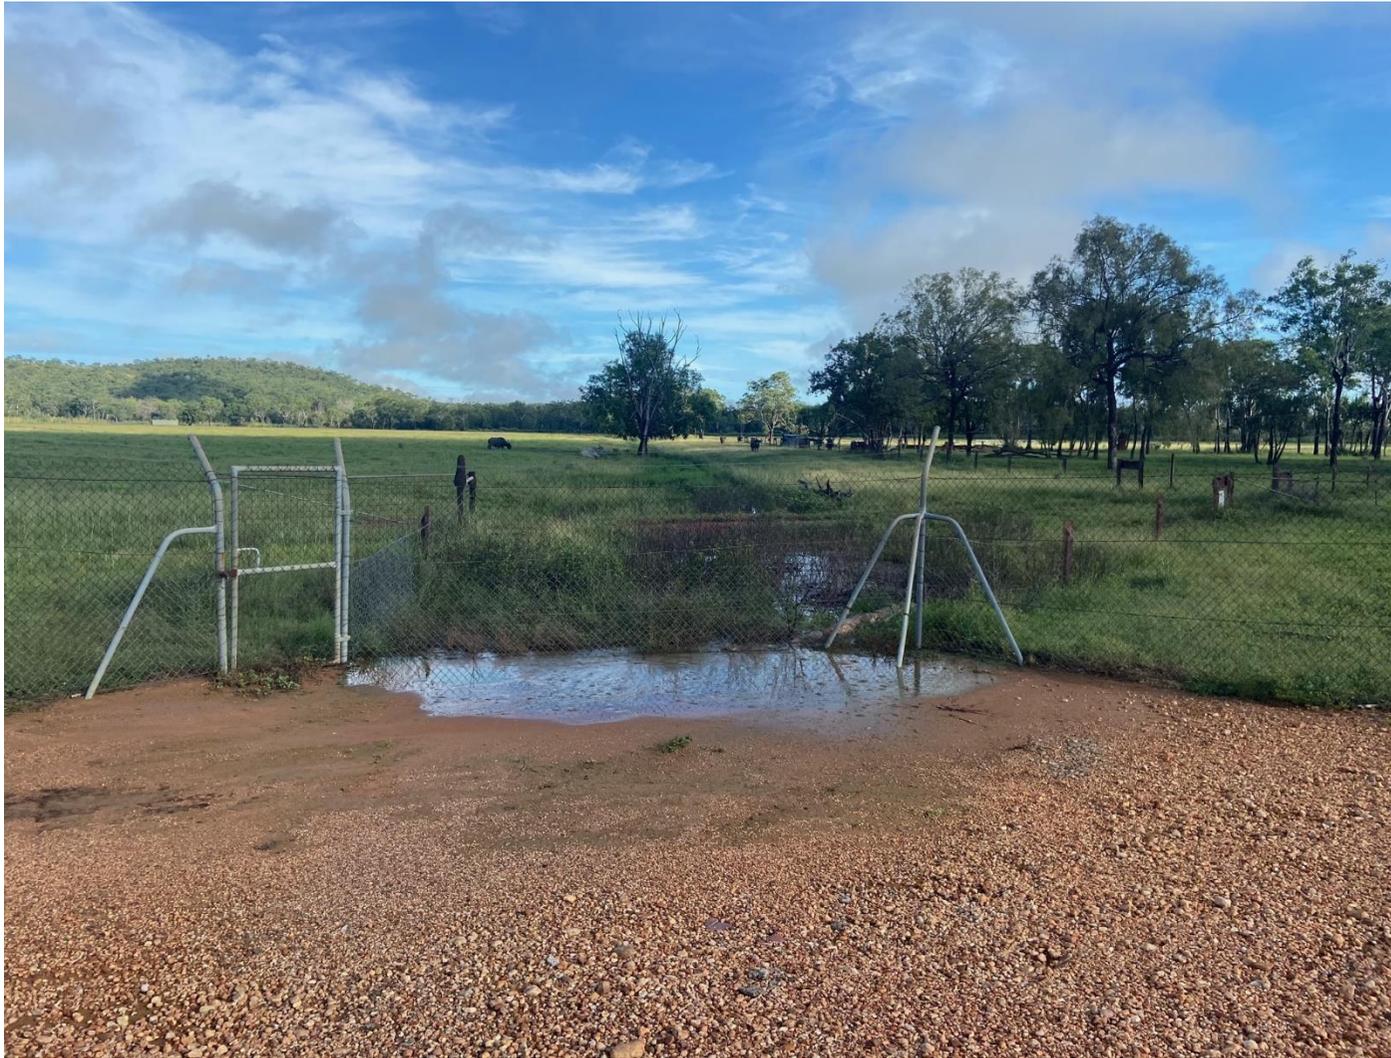
Appendix B – Photograph of the drain running through neighbouring property to Snake Gully

<p>Discharge is to an open unlined drain/channel on a fenced neighbouring private property, where there is no public access. This channel then flows through to bushland and ultimately to Snake Creek, which is away from normal public access locations, however is accessible to the public.</p>
