SECTION 14 INCIDENT REPORT (*Waste Management and Pollution Control Act*)

Date and Time of Notification:	Wednesday 9 th February 2022, 17:00hrs
Person / Company:	Power and Water Corporation (PWC)
Incident:	Discharge of sewage from sewerage network, Yuendumu wastewater stabilisation ponds

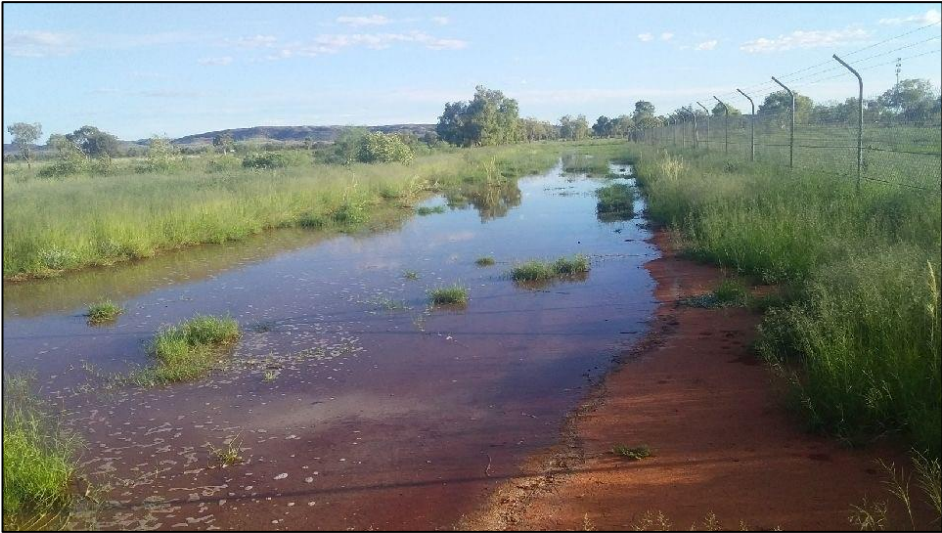
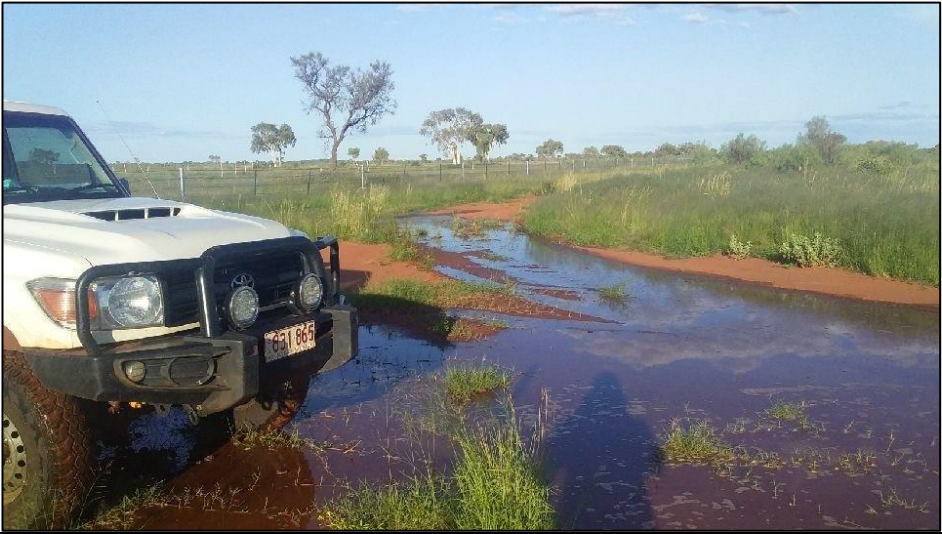
Appendix B – Photographs of spill

<p>(c) the date and time of the incident</p>	<p><i>i. The time and date of commencement and cessation of the discharge.</i></p> <p>The start time of the overflow is unknown, but was first observed at 6:00pm on Tuesday 8th February 2022.</p> <p><i>ii. How PWC were notified, or became aware of the discharge.</i></p> <p>The spill was identified by a Power and Water Service Coordinator during a site inspection in the community.</p> <p><i>iii. The process by which the discharge occurred.</i></p> <p>The irrigation system pumps water from pond 5 to an irrigation area, with any additional overflow from pond 5 entering ponds 6 and 7 for evaporation and disposal. The irrigation pump faulted on 28/1/22 and due to the high rainfall and high volume of sewage production by the community ponds 6 and 7 reached capacity and ultimately overflowed.</p> <p><i>iv. The reason why the discharge occurred.</i></p> <p>As per (c) iii, As above.</p>

<p>(d) how the pollution has occurred, is occurring or may occur</p>	<p>As per (c) iii & (c) iv.</p>
<p>(e) the attempts made to prevent, reduce, control, rectify or clean up the pollution or resultant environmental harm caused or threatening to be caused by the incident</p>	<p>On discovering the overflow the Service Coordinator reconfigured the system and used the irrigation pump to redirect the contents of the ponds to a holding basin within the PWC site. By 14:00hrs on 09/2/22 the overflow through the site boundary had ceased.</p> <p><i>i. Confirmation signage and fencing has been erected, as appropriate.</i></p> <p>Fencing and signage have not been erected in this instance, due to the high quality of the dilute treated water in the overflow and as the opportunity for public to have contact with the standing water outside the fence is minimal. It is expected that the spill will rapidly dry up.</p> <p><i>ii. Decontamination of the site as appropriate.</i></p> <p>Clean up consistent with Sewage Spills/Overflow Response Work Instruction as appropriate to the location. Site was inspected for any wastewater gross pollutants, of which none were observed.</p>
