SECTION 14 INCIDENT REPORT (*Waste Management and Pollution Control Act*)

Date and Time of Notification:	Wednesday 29 th March 2022, 9:45hrs
Person / Company:	Power and Water Corporation (PWC)
Incident:	Discharge of treat effluent from Finke Waste Water Treatment Ponds.

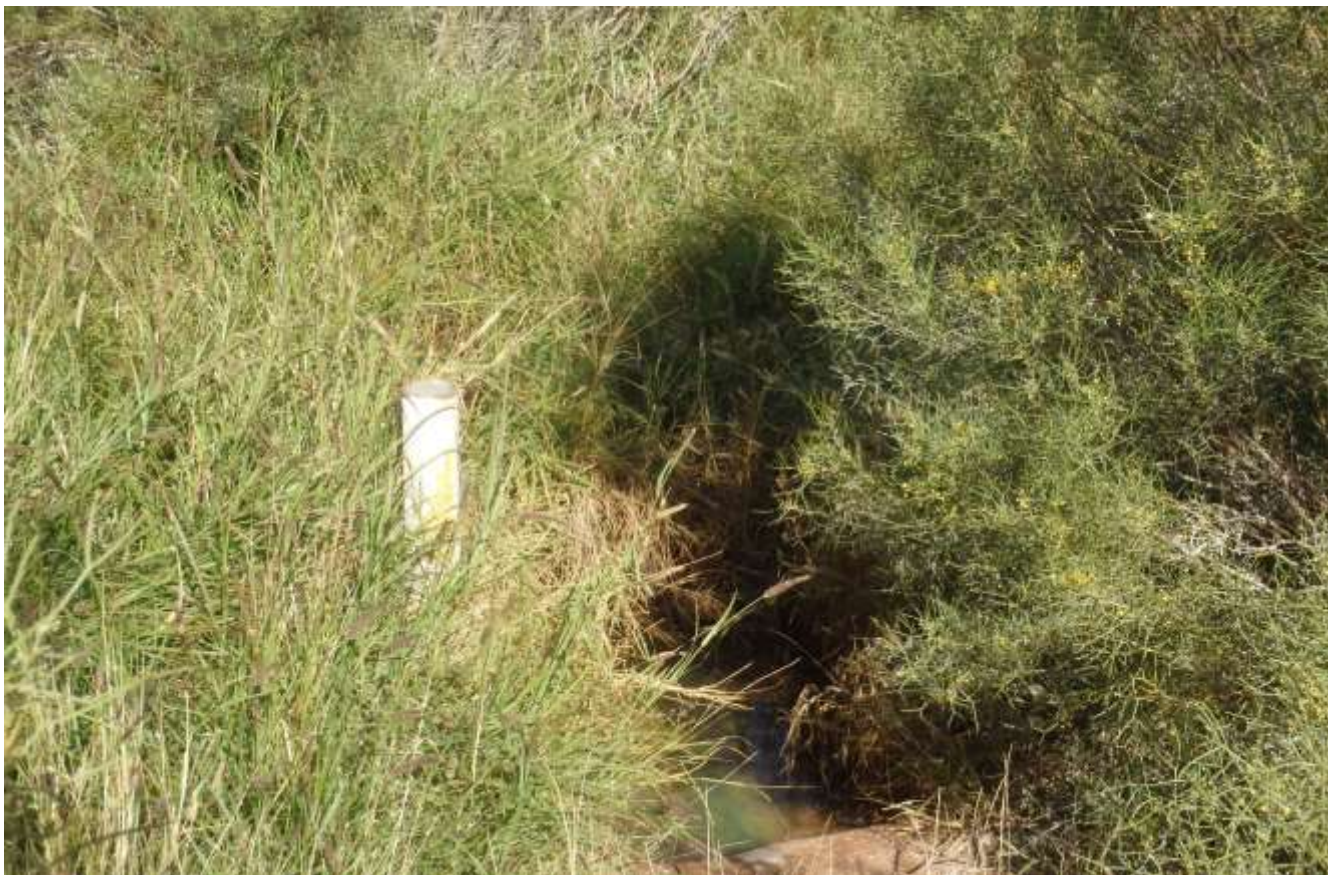
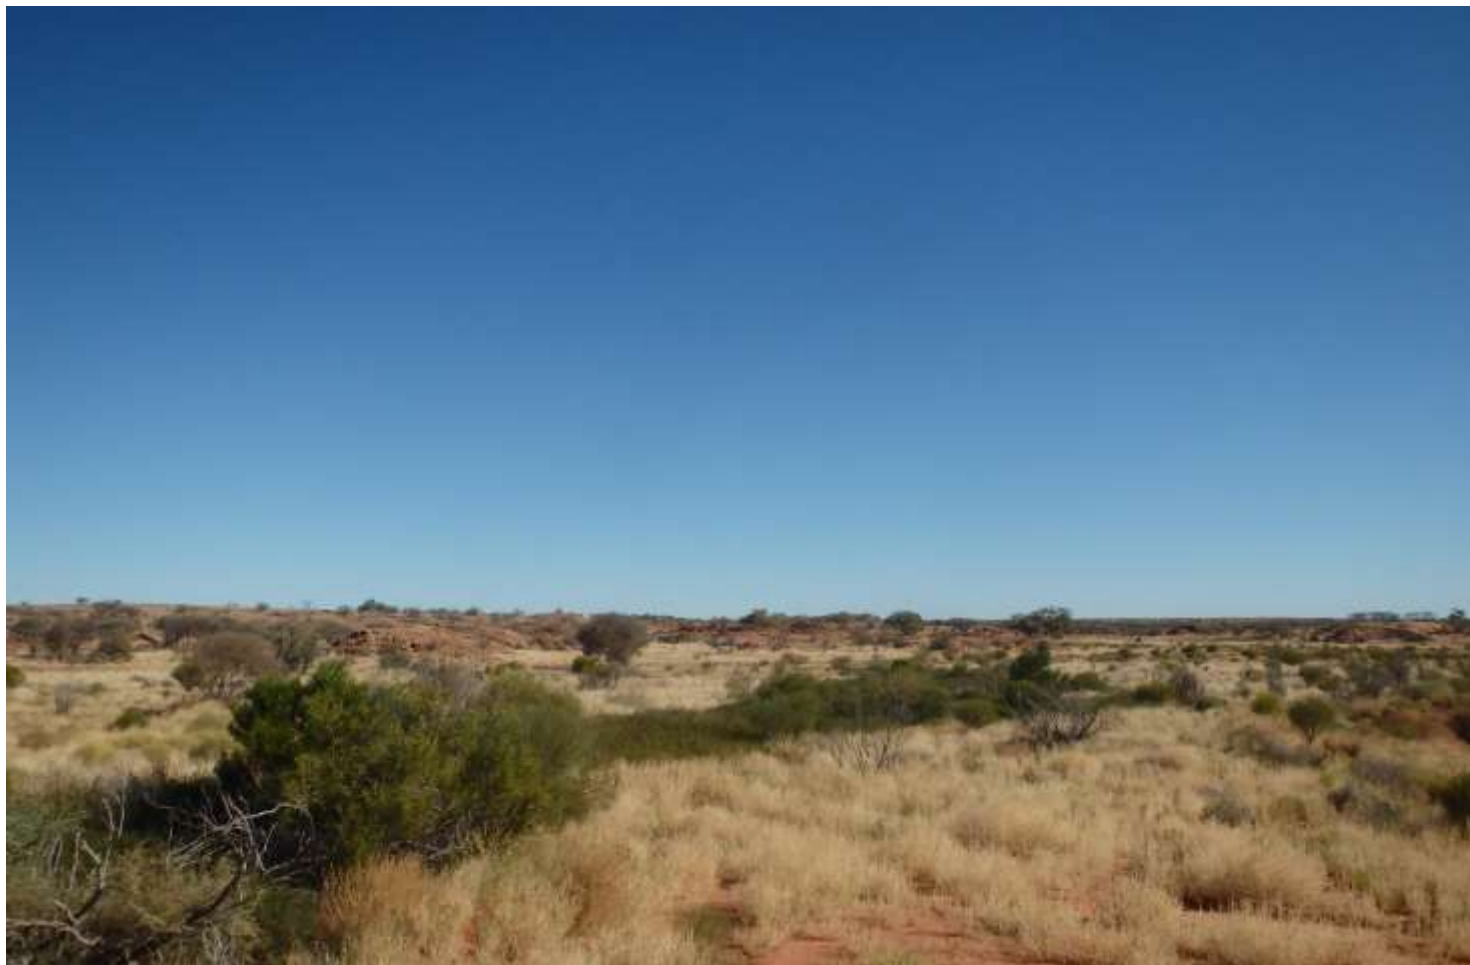
Appendix B – Site Photos

The discharge is via open drain in public accessible location, within close proximity of public track.
(c) the date and time of the incident	<p><i>i. The time and date of commencement and cessation of the discharge.</i></p> <p>The time observed; Observed (approx.) – 2:21pm Monday 27th June 2022 Stop (approx.) – Ongoing</p> <p><i>ii. How PWC were notified, or became aware of the discharge.</i></p> <p>PWC's Technical Coordinator attended site on 27th June and identified the discharge.</p> <p><i>iii. The process by which the discharge occurred.</i></p> <p>Capacity of pond 3 exceeded, resulting in discharge from the relief point to open drain.</p> <p><i>iv. The reason why the discharge occurred.</i></p> <p>The Coordinator advised that the likely cause is the ponds reaching the service capacity, as a result of increased visitor population. This coupled with low evaporation during winter, has led to inflows exceeding the capacity of the ponds.</p>

(d) how the pollution has occurred, is occurring or may occur	As per (c) iii & (c) iv.
(e) the attempts made to prevent, reduce, control, rectify or clean up the pollution or resultant environmental harm caused or threatening to be caused by the incident	<p><i>i. Confirmation signage and fencing has been erected, as appropriate.</i></p> <p>Signage to be erected notifying the public of discharge and to deter access to the area.</p> <p><i>ii. Decontamination of the site as appropriate.</i></p> <p>Discharge is ongoing. Site inspected for gross pollutants of which none were observed. Clean up will be undertaken as per PWC Sewage Spills/Overflows Response Work Instruction upon cessation of the discharge.</p> <p><i>iii. Attempts made to prevent, reduce or control the discharge</i></p> <p>No immediate reasonable or practical steps available to prevent, reduce or control the discharge from occurring. Overflow will cease once inflows have reduced below capacity.</p>
