**Re: Direction for further information Sherwin Creek Iron Ore Project**

## **1. Ore haulage on the Roper Highway: Status of Agreements**

## **2. Erosion and sediment control**

**Re: Sherwin Iron Project – Investigation Report on Haul road failure 14 February 2014.**

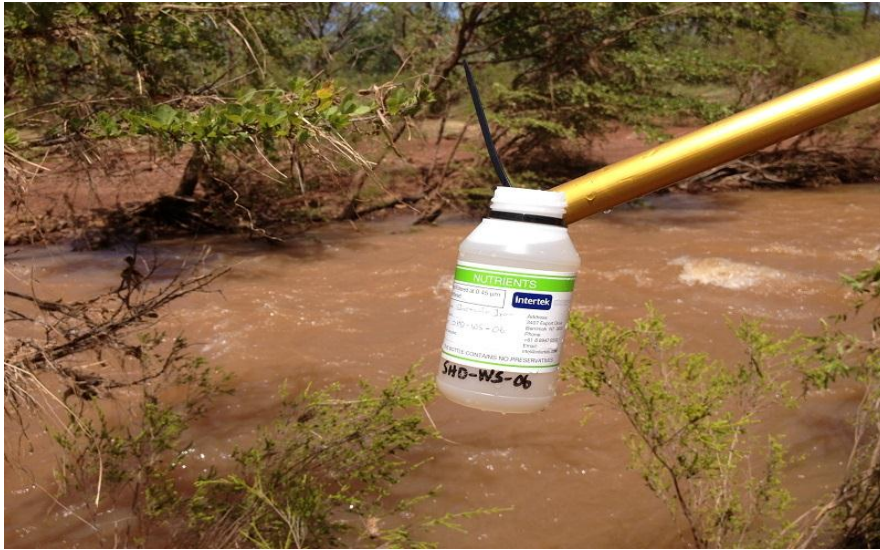
Picture 1. Sample collection process

Immediately following the incident, Sherwin personnel contacted EcOz Environmental Services to assist with sampling methodology, correct sample collection technique, sample storage and analysis. Due to the Roper Highway being cut from flooding EcOz personnel were not able to attend the site in a reasonable timeframe so sample collection was undertaken by Sherwin Personnel. Samples were then transported directly to ALS laboratories for analysis, and results reviewed by EcOz personnel.

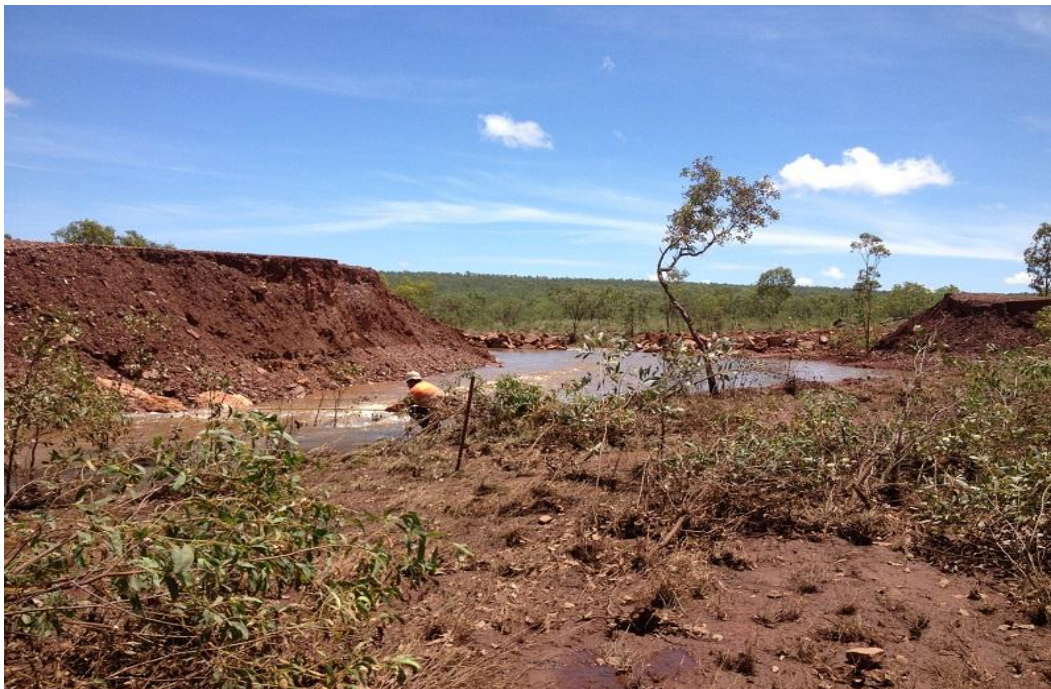
Picture 2. Water sampling at the access road incident site

During the incident, a large section of the access road was washed out, sending local rock used to construct the access road down the Sherwin Creek causing temporary discolouration.

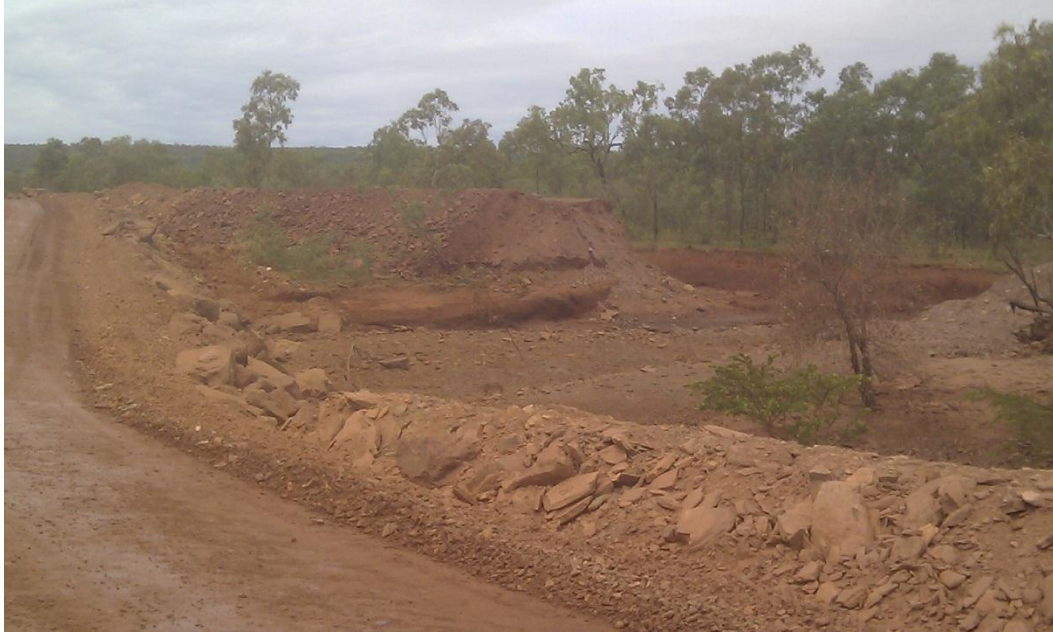
**Picture 3. Actual location of access road failure**

On Wednesday 12<sup>th</sup> February 2014, the storm water topped the main access road and commenced eroding the side walls and top of the access road. Sherwin maintained visual and photographic monitoring of the situation from a safe distance. Sherwin continued to monitor the increased flow in to the Sherwin Creek but was unable to access the area to install any form of breakwater, due to the volume of flow in the creek. Access to heavy earth moving equipment onsite was also prevented due to loss of access across the access road.

Unfortunately, the culvert pipes were not delivered to site at the time of construction of the main access road. However, it was always Sherwin's intention to install the culvert pipes at the earliest possible time.

A Civil Engineer is currently confirming, and if required redesigning the access road including stormwater management parameters. This activity has yet to be received by Sherwin, however culvert pipes in excess of the anticipated capacity have been delivered to the site and shall be installed once the final engineering redesign is received.

The access road is yet to be prepared, until such time as we have an approved engineered design for the access road, and confirmation that the stormwater pipes are suitably over designed.

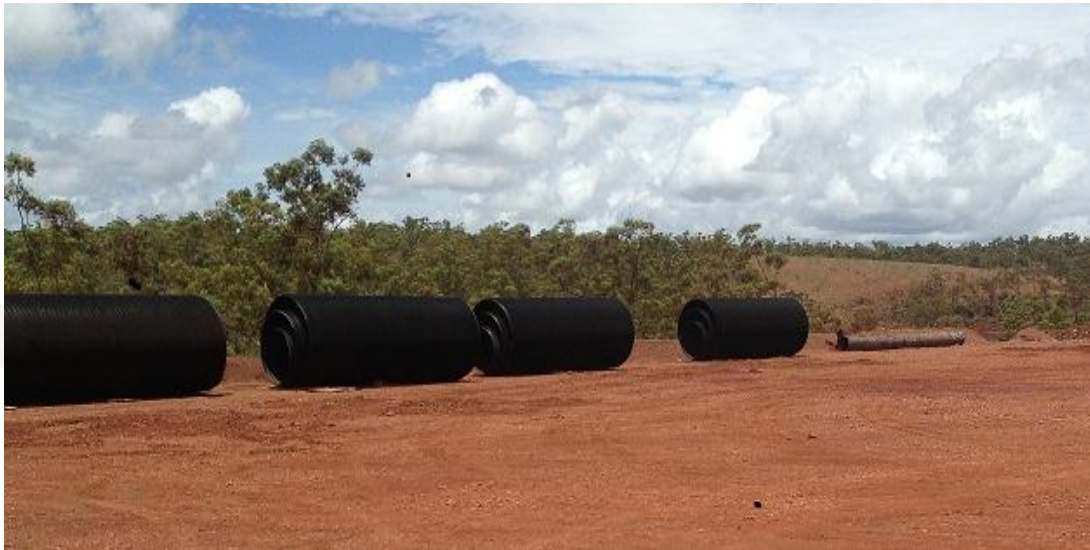
**Picture 4. Storm water culverts delivered to Sherwin site awaiting installation**

Stormwater pipes have been delivered to site in preparation for installation, once an engineering redesign is completed. These stormwater pipes have been over-sized to ensure future stormwater can travel unimpeded down the Sherwin Creek and prevent a reoccurrence of this incident.
